Basis of Design

Repair and Preservation of Matthew Jones House

Project #: HERT 20-2645

100% Design Submission

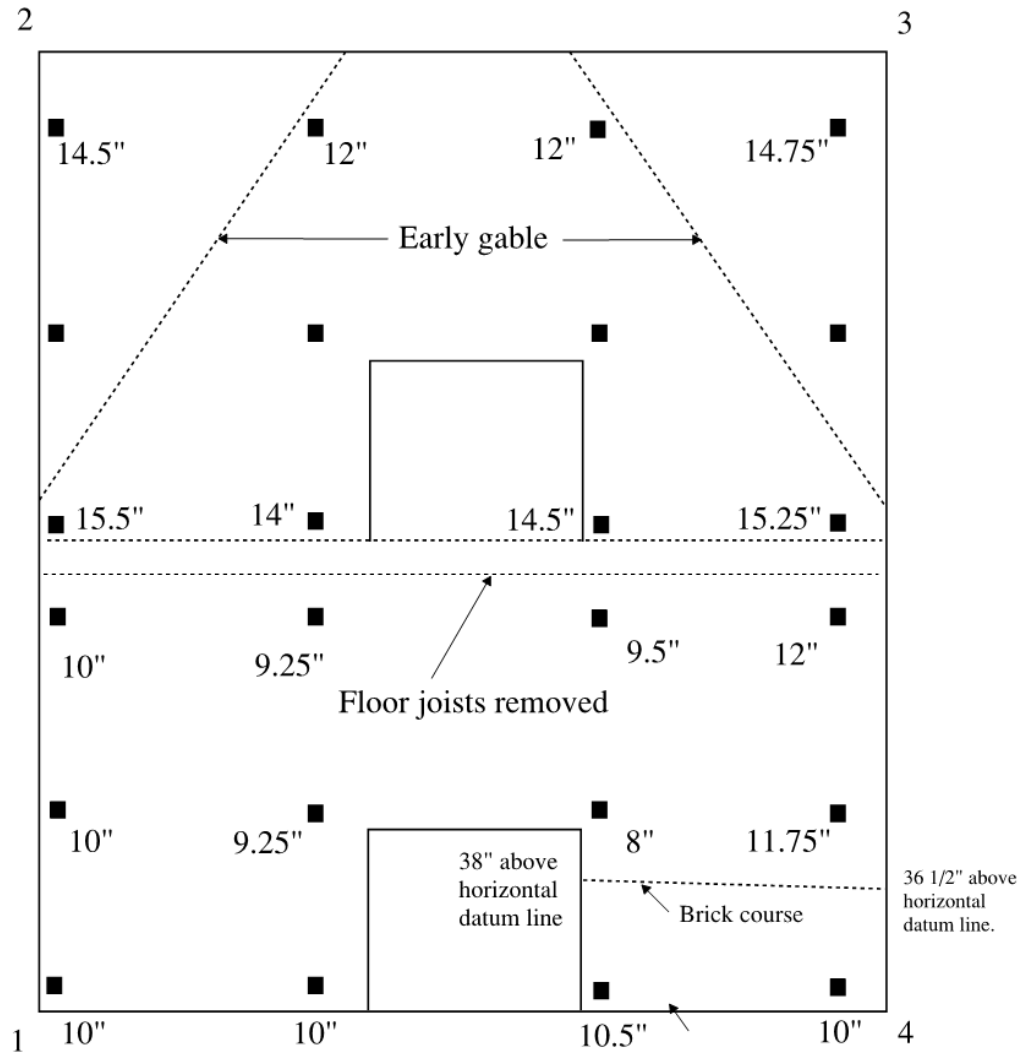
Vertical datum plane 1 2 3 4 at west, gable-end wall.

Datum plane stands 10" from the wall at points 1 and 4.

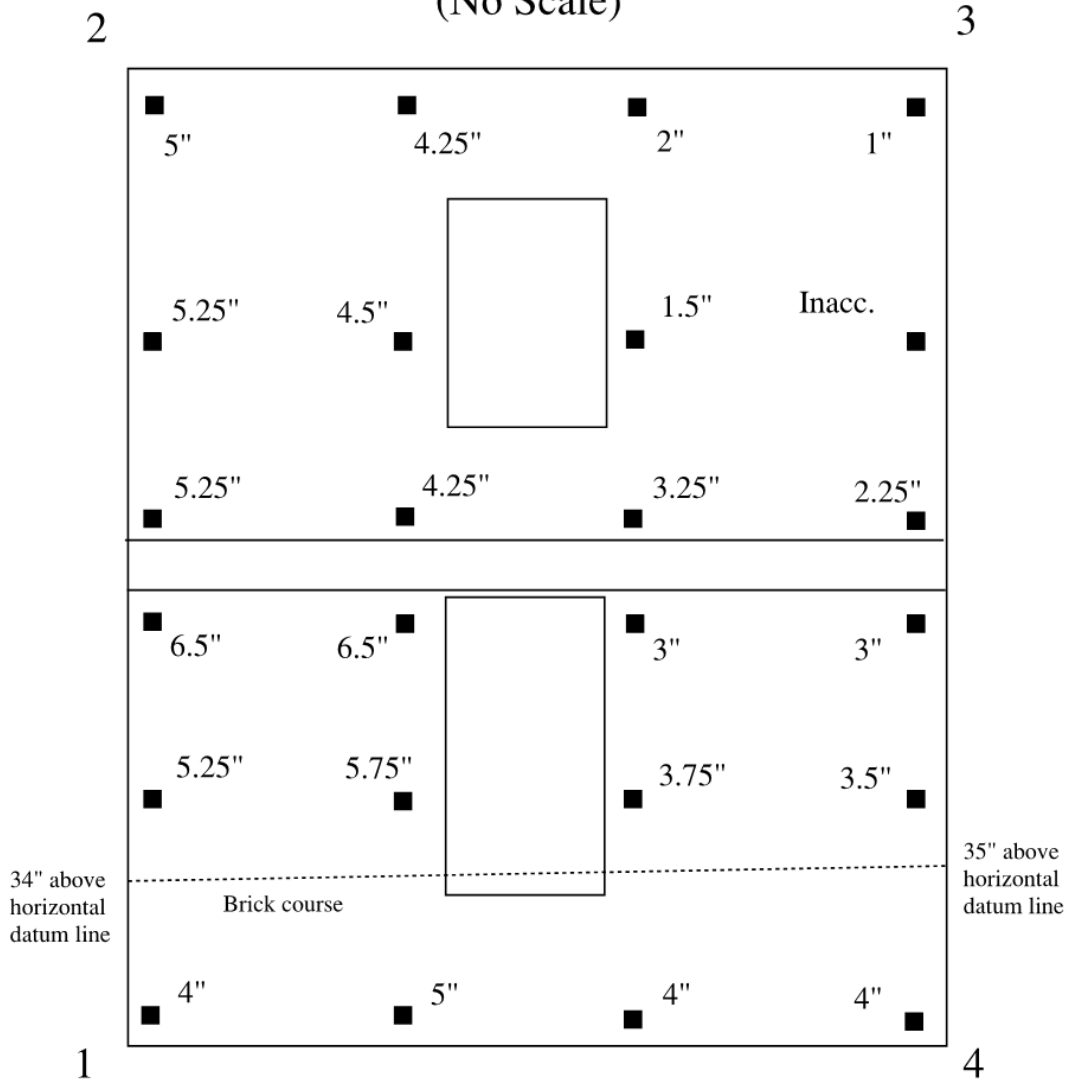
Deformation of Rear Wall Between NW Corner and Rear Shed (No Scale)

Vertical datum plane 1 2 3 4 at rear wall
Plane stands 4" from rear wall at 1 and 4
All dimensions measure from wall out to datum plane

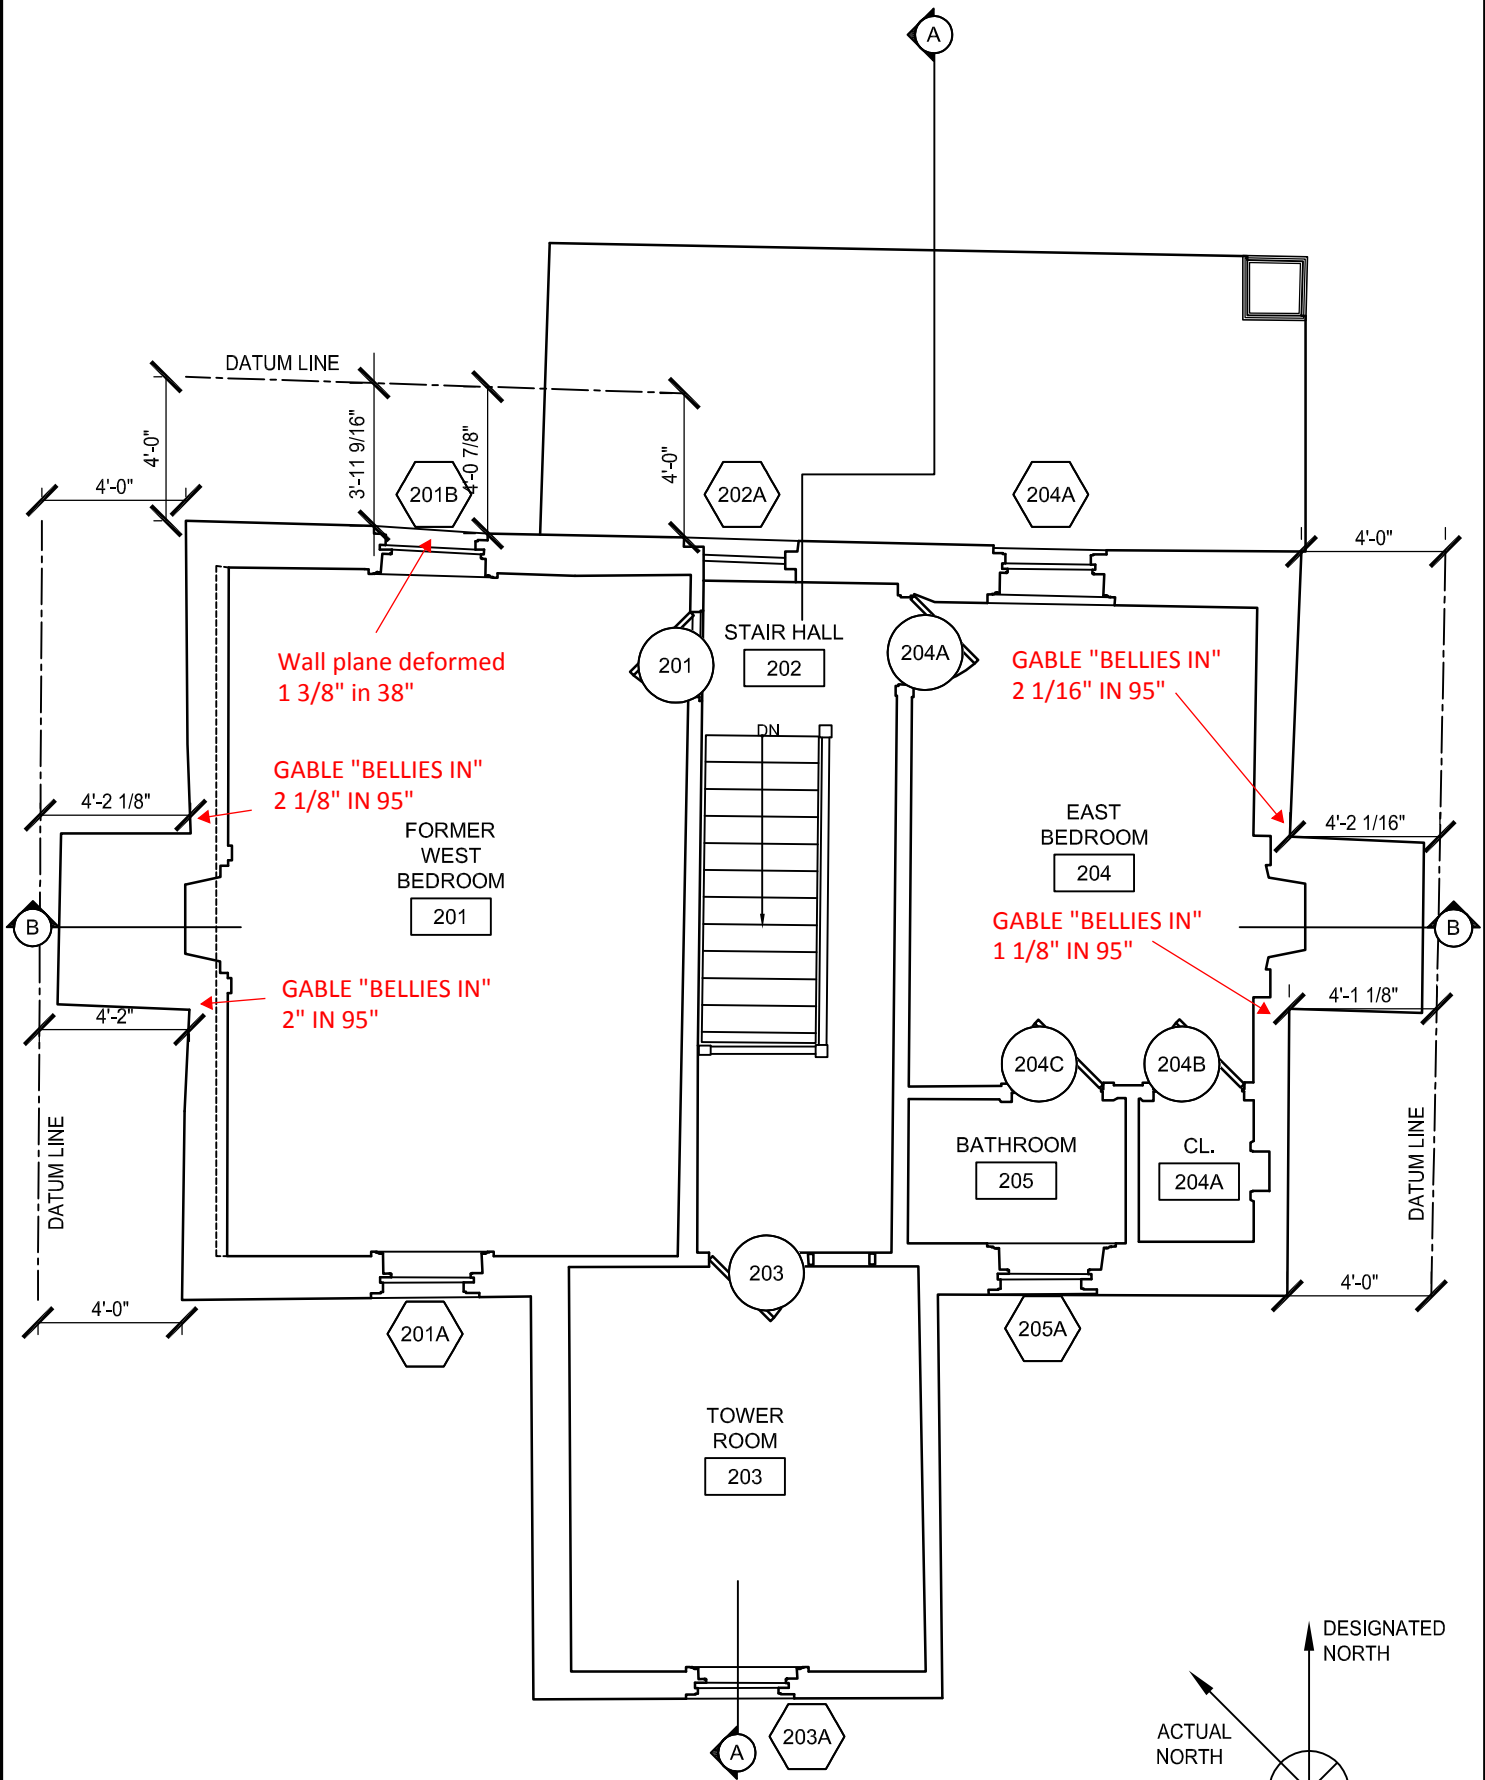
SECOND FLOOR PLAN

CHIMNEY LEANS
INWARD 4 3/34"

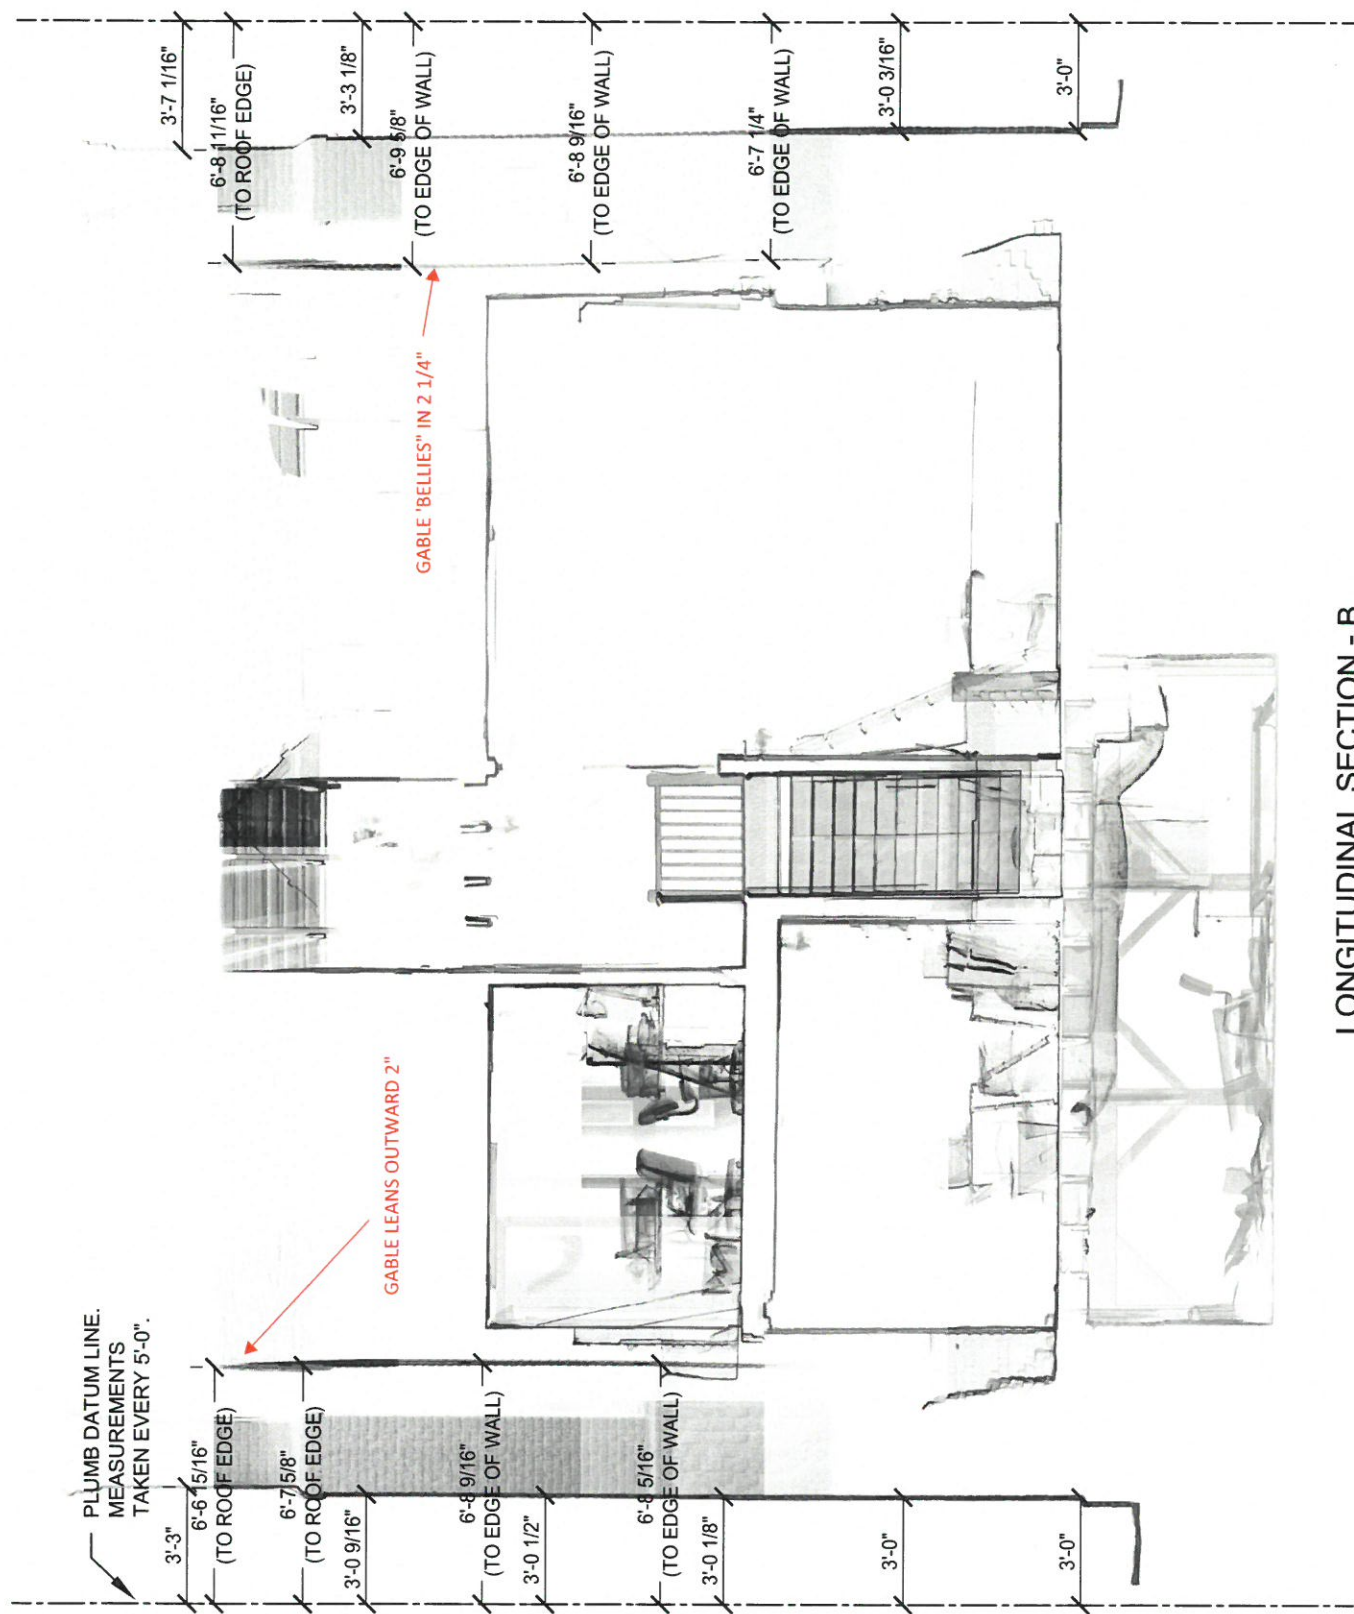
LONGITUDINAL SECTION - B

GABLE LEANS INWARD 2 1/8"

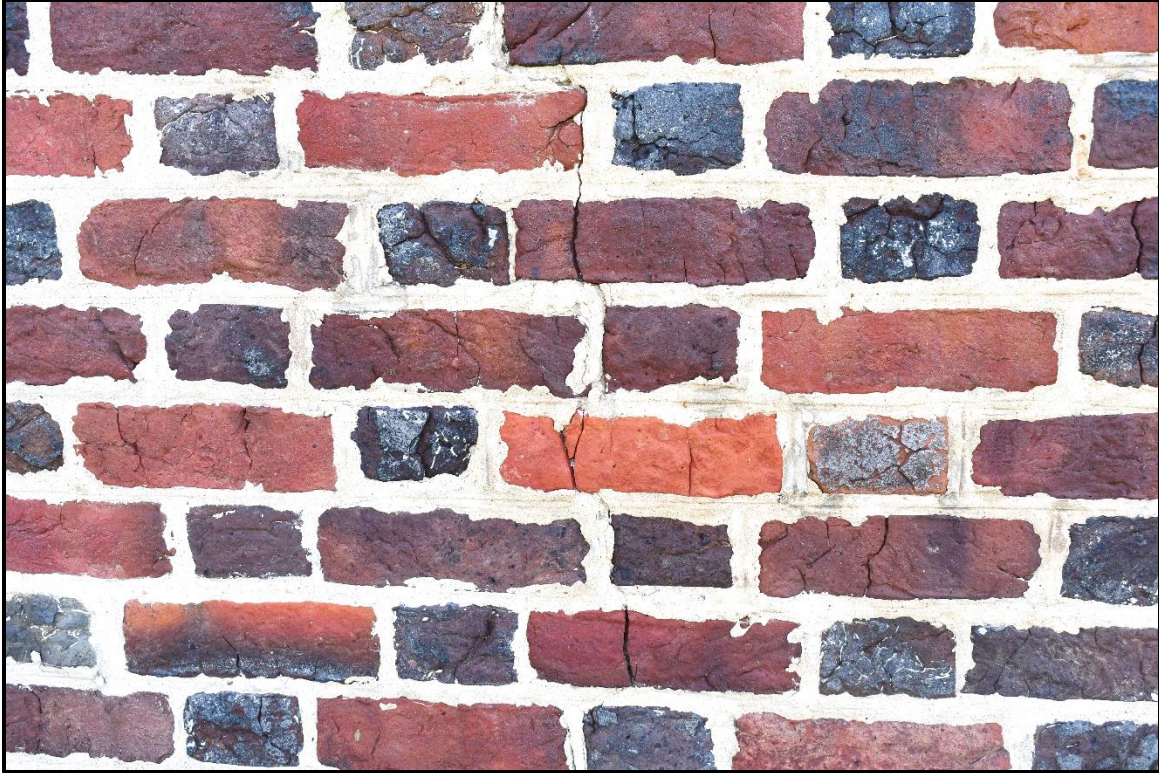
Photo 5: Representative view of cracking in brick masonry units observed at scattered locations throughout the building's façade.

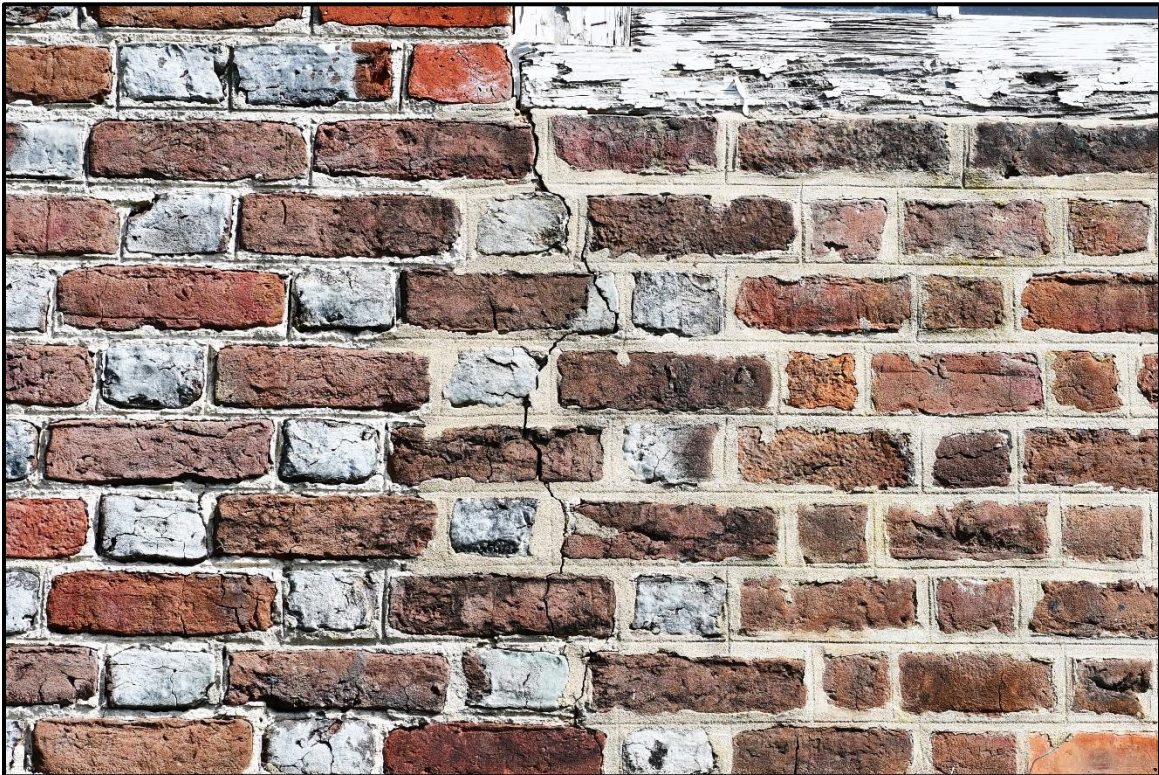
Photo 6: Vertical cracking in masonry observed emanating from the second floor window located above the main entrance along the south elevation.

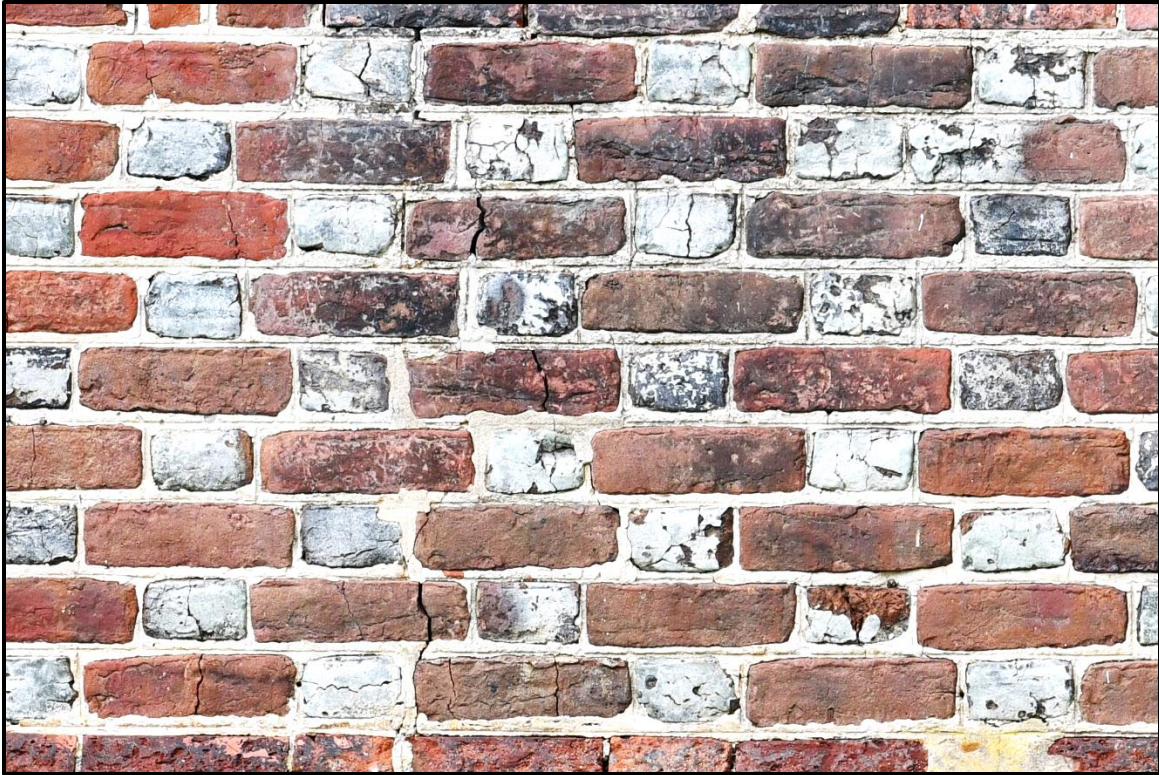
Photo 7: Vertical cracking in brick masonry units at a wall area located on the east elevation south of the chimney.

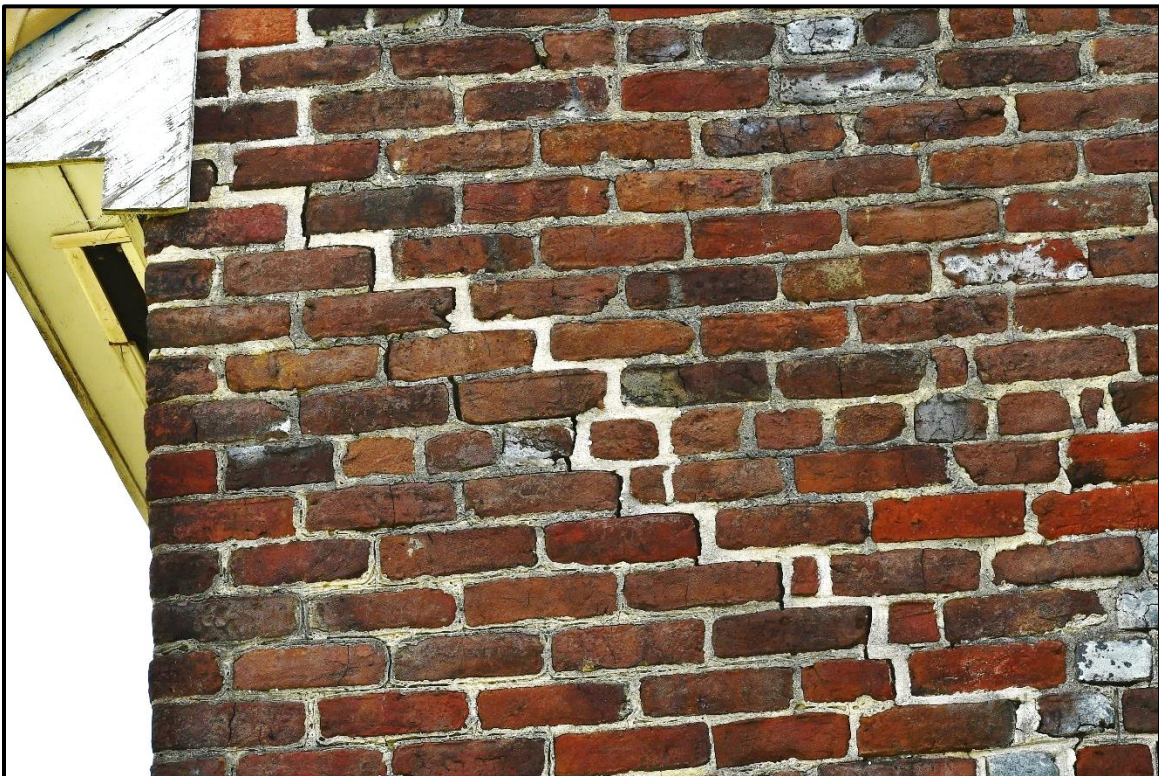
Photo 8: Step crack emanating from the upper northwest corner of the building on the west elevation.

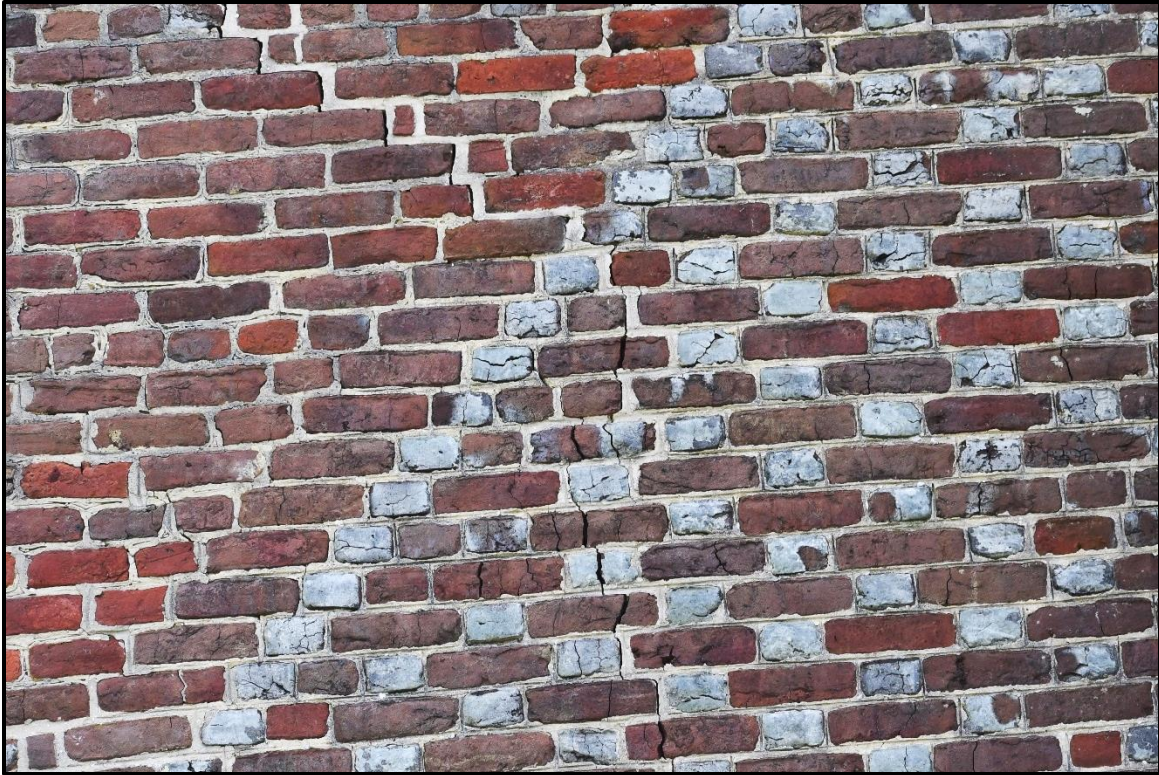
Photo 9: Step crack at the northwest corner of the building transitioning into a vertical crack through the homes original brick masonry.

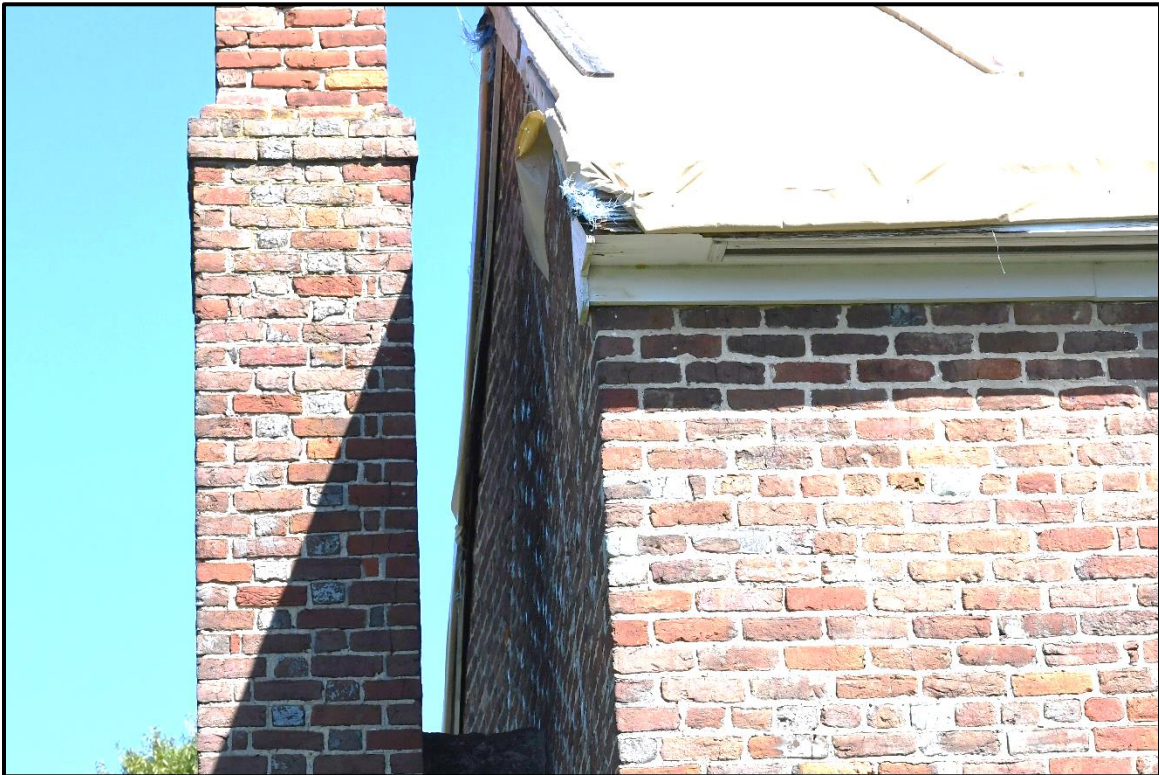
Photo 10: Photograph taken at a view parallel to the west elevation that exhibits the bow in the west elevation gable wall.

Foundations: The west gable end wall and west portion of the north wall is to be underpinned with reinforced concrete. This is to provide additional load distribution at portions of the wall that appear to be out of plumb and bowed.

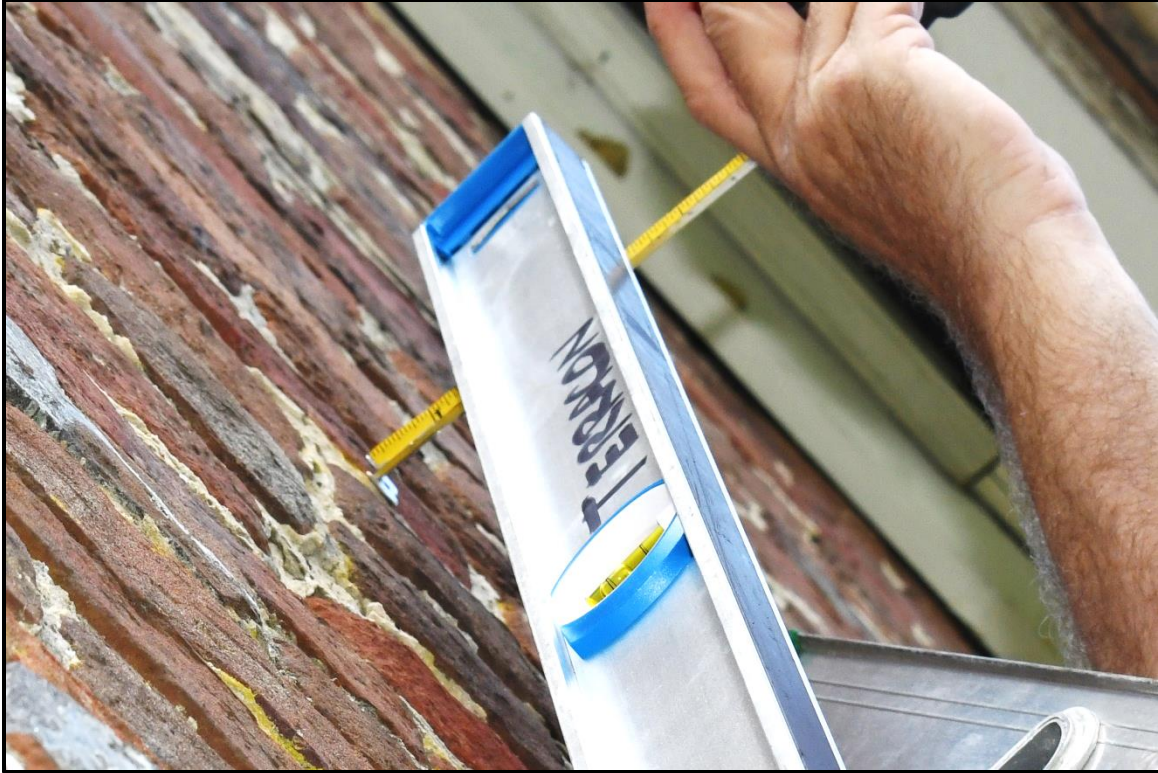
Photo 11: Out of plumb measurement taken at the mid height of the bowed wall area on the north elevation west of the rear shed.

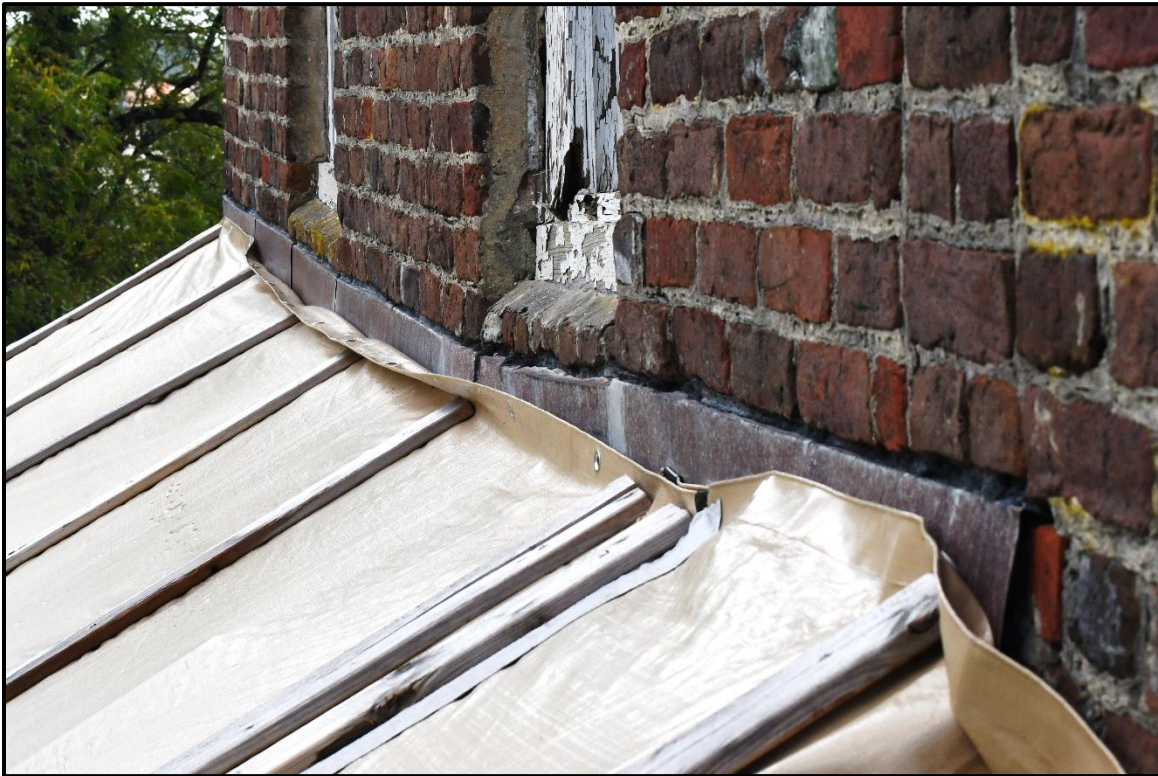
Photo 12: Deflected brick masonry above the shed structure viewed along the north elevation.

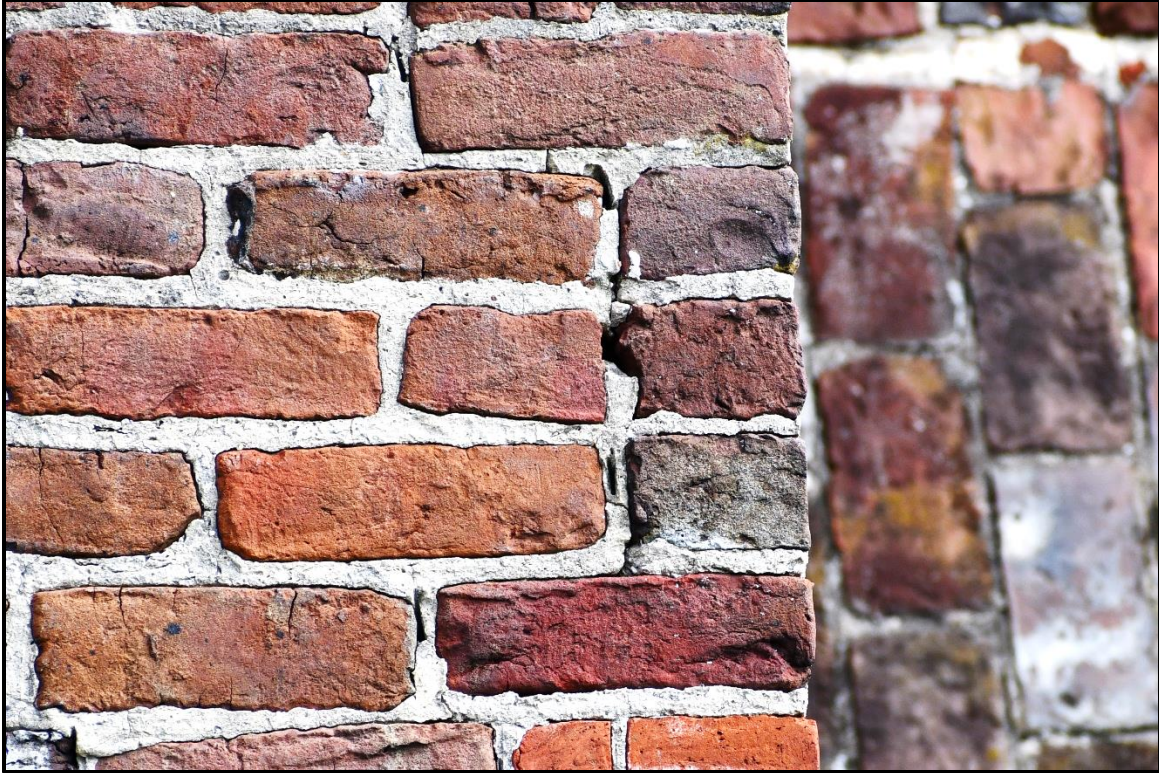
Photo 13: Open brick masonry mortar joints located at the southeast corner of the building.

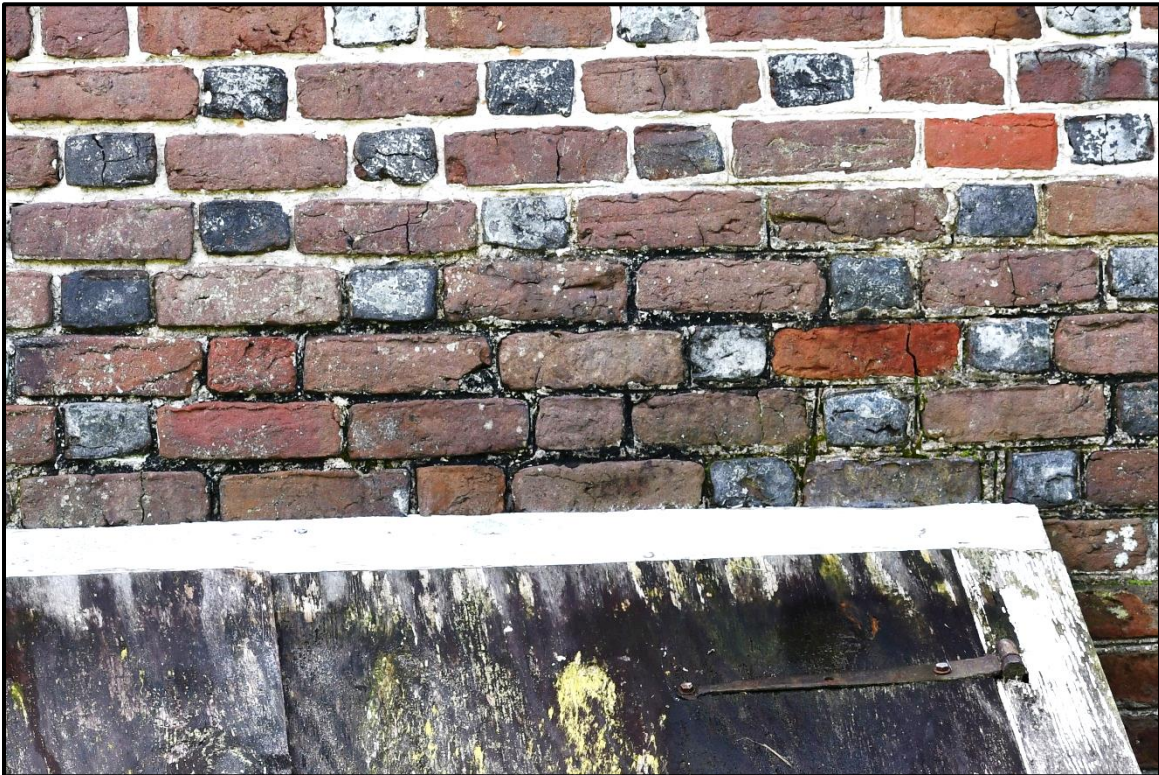
Photo 14: Deteriorated and weathered brick masonry mortar joints located above the cellar door on the north elevation.

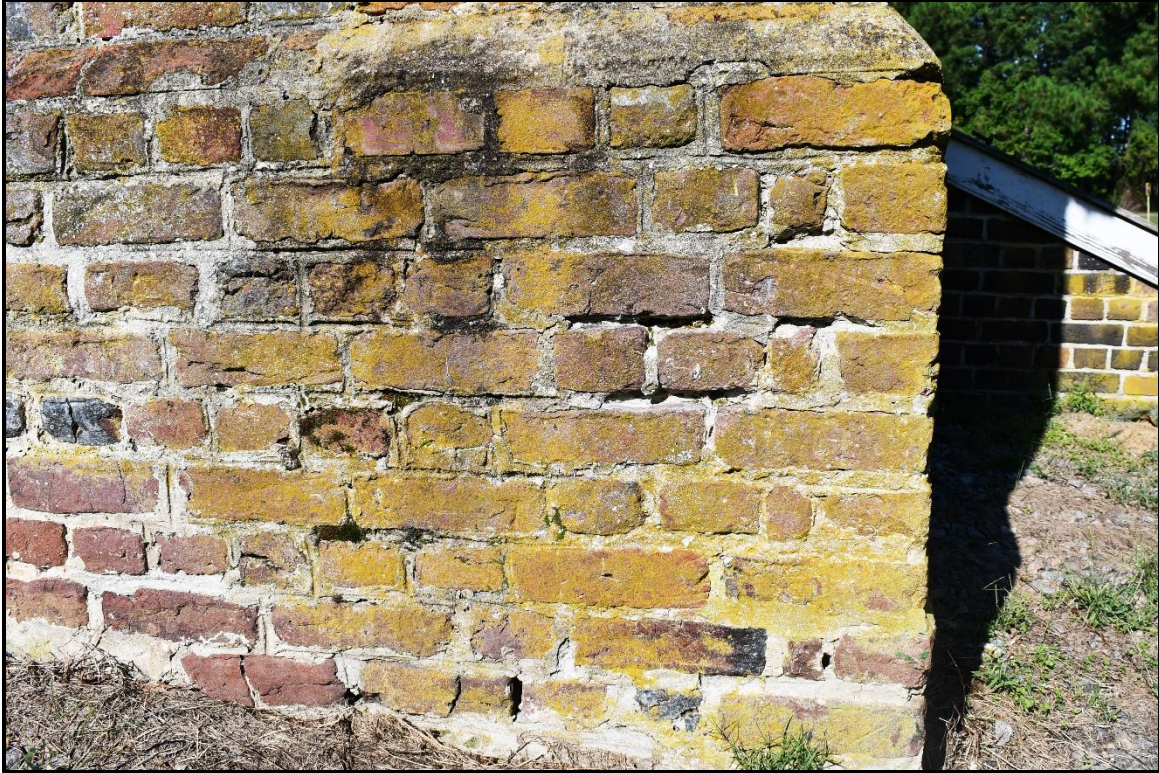
Photo 15: Deteriorated/open brick masonry mortar joints and significant presence of organic growth located at the northeast corner of the building.

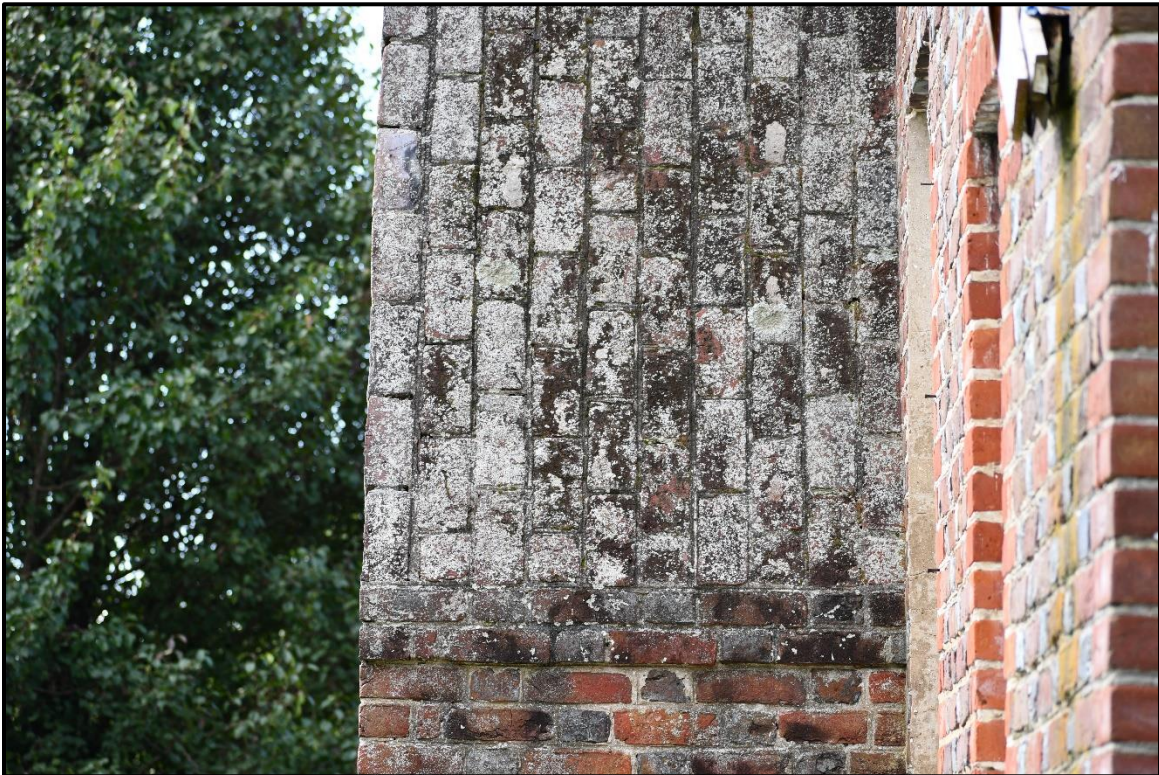
Photo 16: Significant presence of organic growth located at the sloped surface of the east elevation chimney.

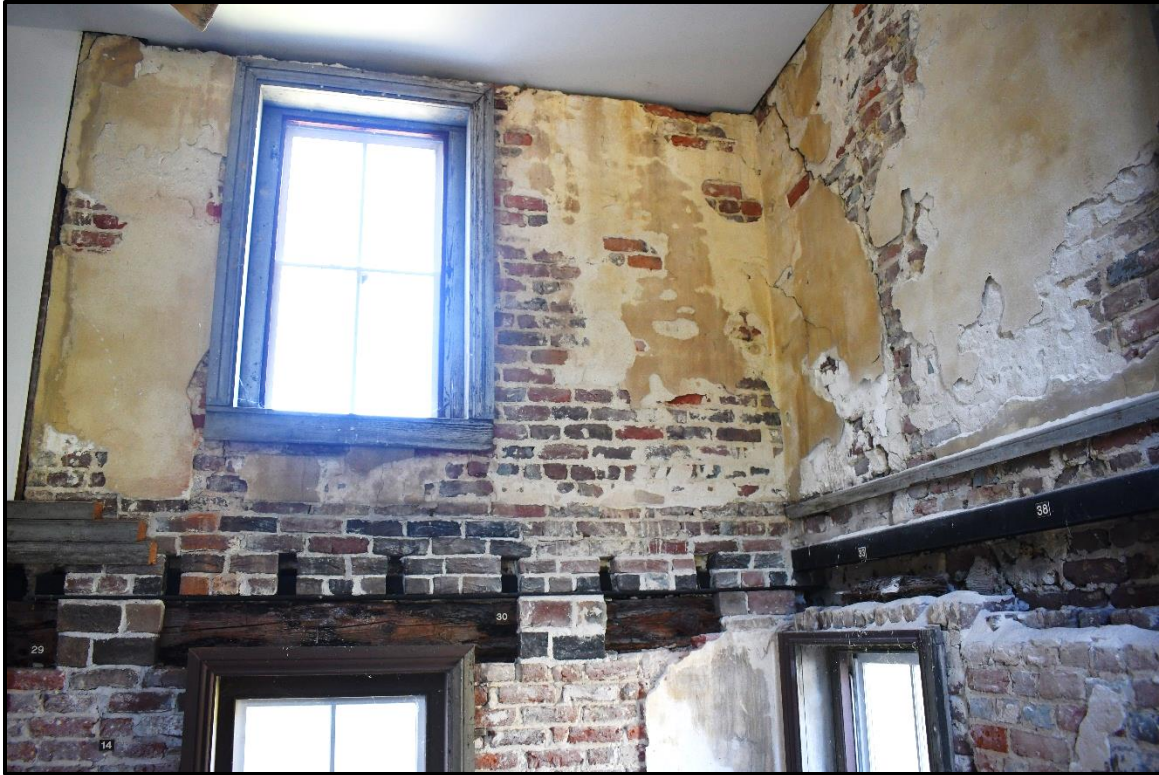
Photo 17: General condition of the existing plaster on the interior walls located at the southwest corner of the home.

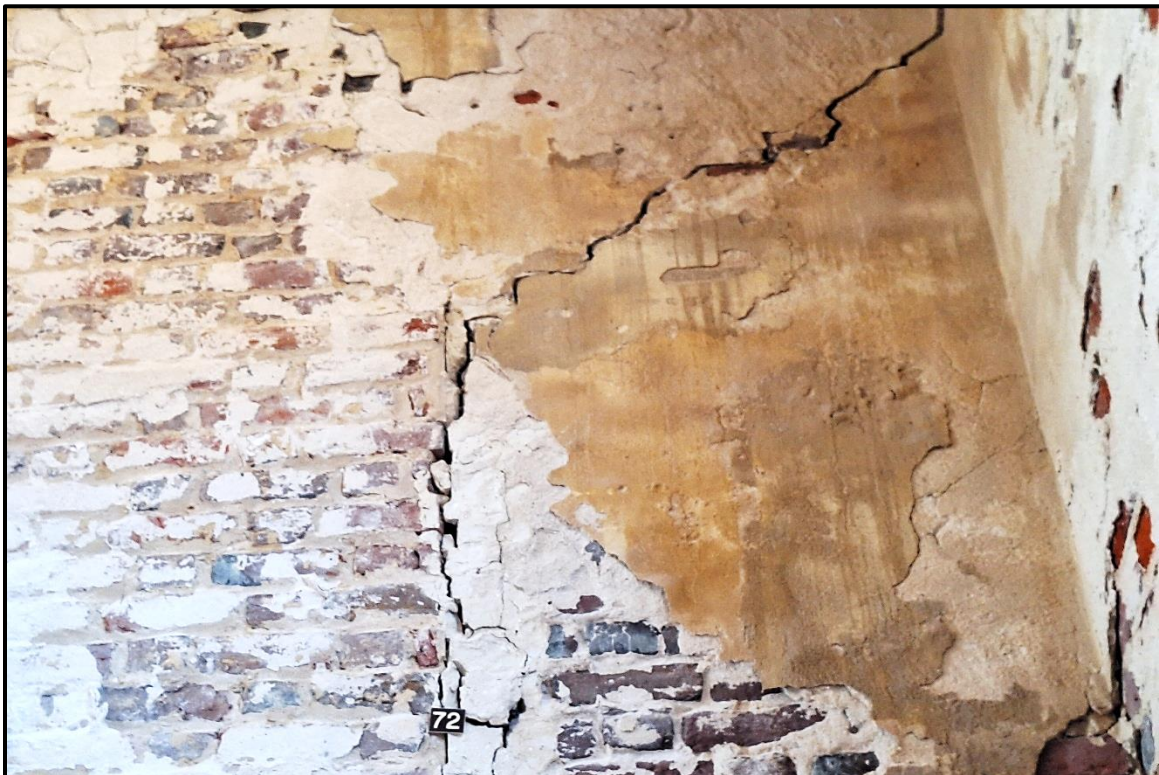
Photo 18: Step crack at the interior surface of the west gable end wall consistent with the location of the exterior crack exhibited in photograph #8 & #9.

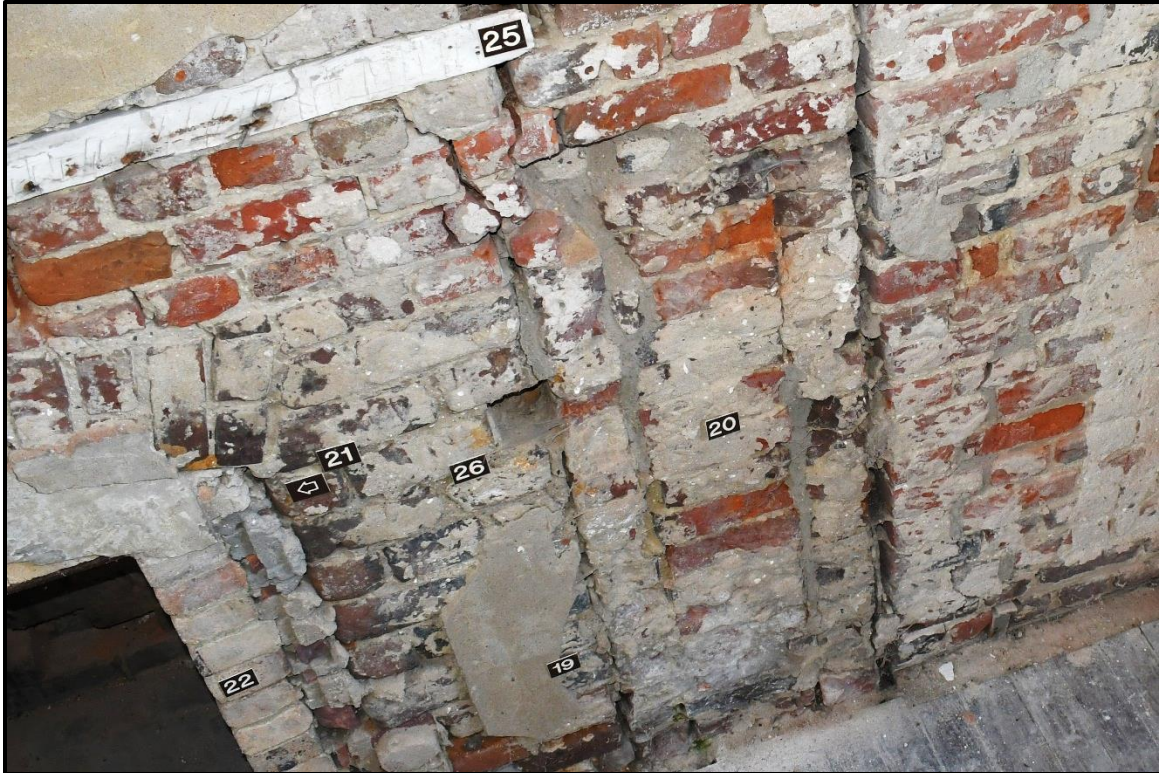
Photo 19: Typical condition of the masonry located on the interior surface of the west gable end wall. Note the joints between the varying wall segments.

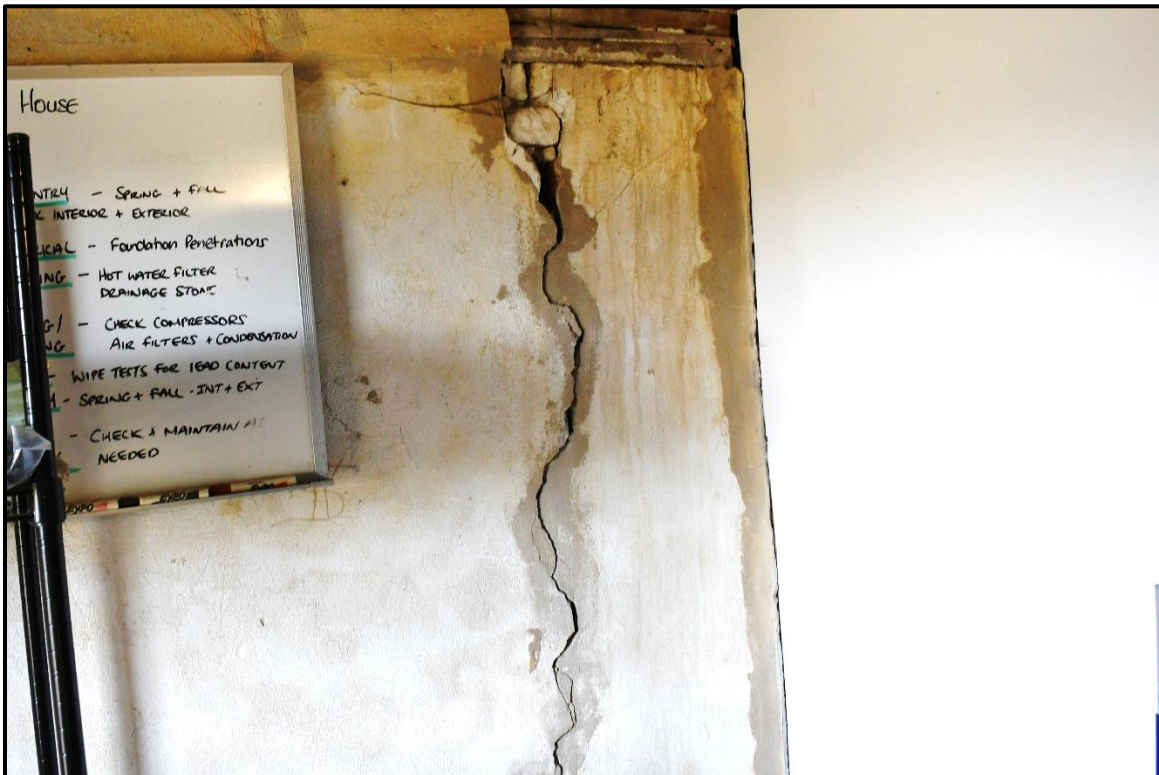
Photo 20: Vertical crack observed in the interior west wall located on the second floor of the main entry tower.

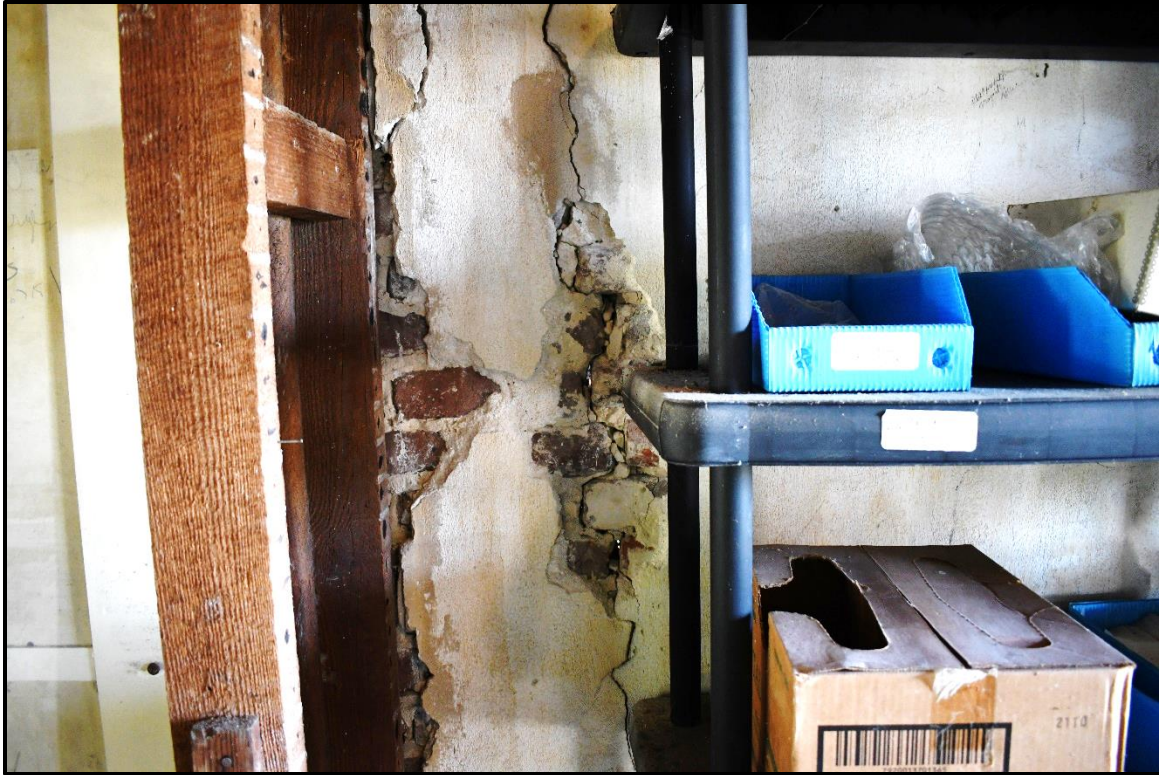
Photo 21: Vertical crack observed in the interior east wall located on the second floor of the entry tower. Note the daylight seen through the crack.
