Basis of Design

Repair and Preservation of Matthew Jones House

Project #: HERT 20-2645

100% Design Submission

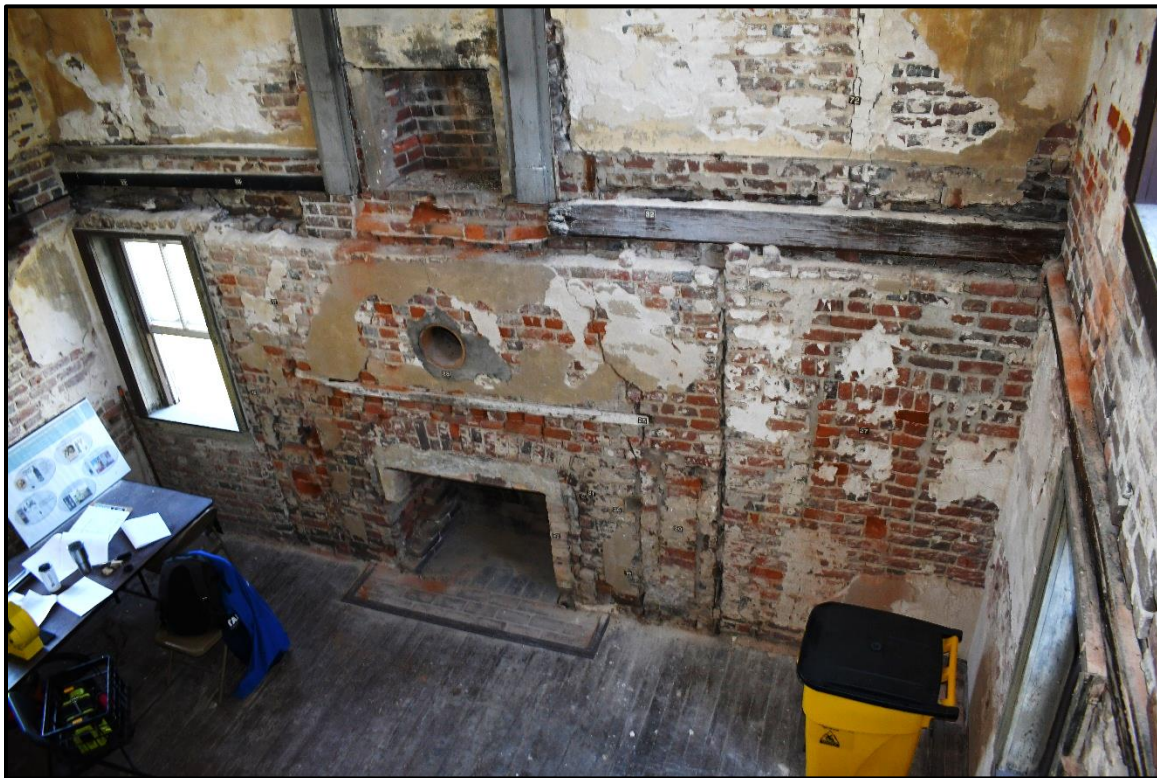
Photo 22: View of the west side of the home showing where the 2nd floor system had been removed.

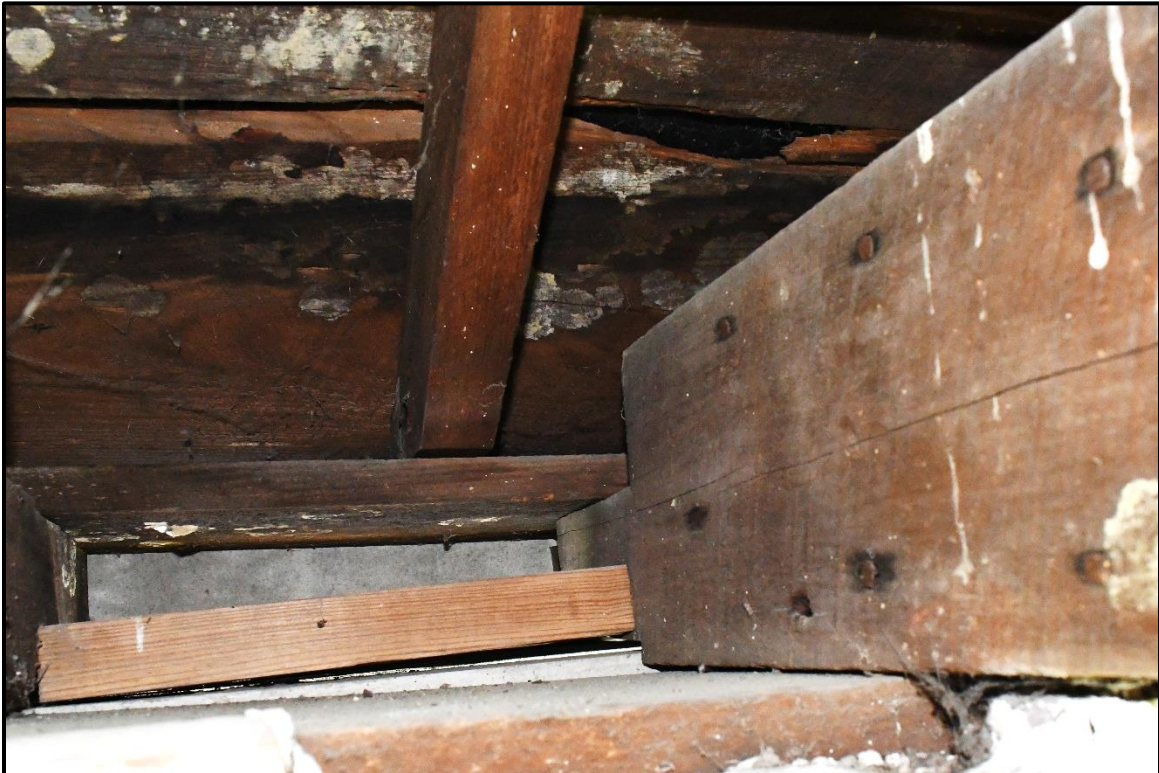
Photo 24: Main roof rafter and attic floor joist bearing condition located at the north wall of the home.

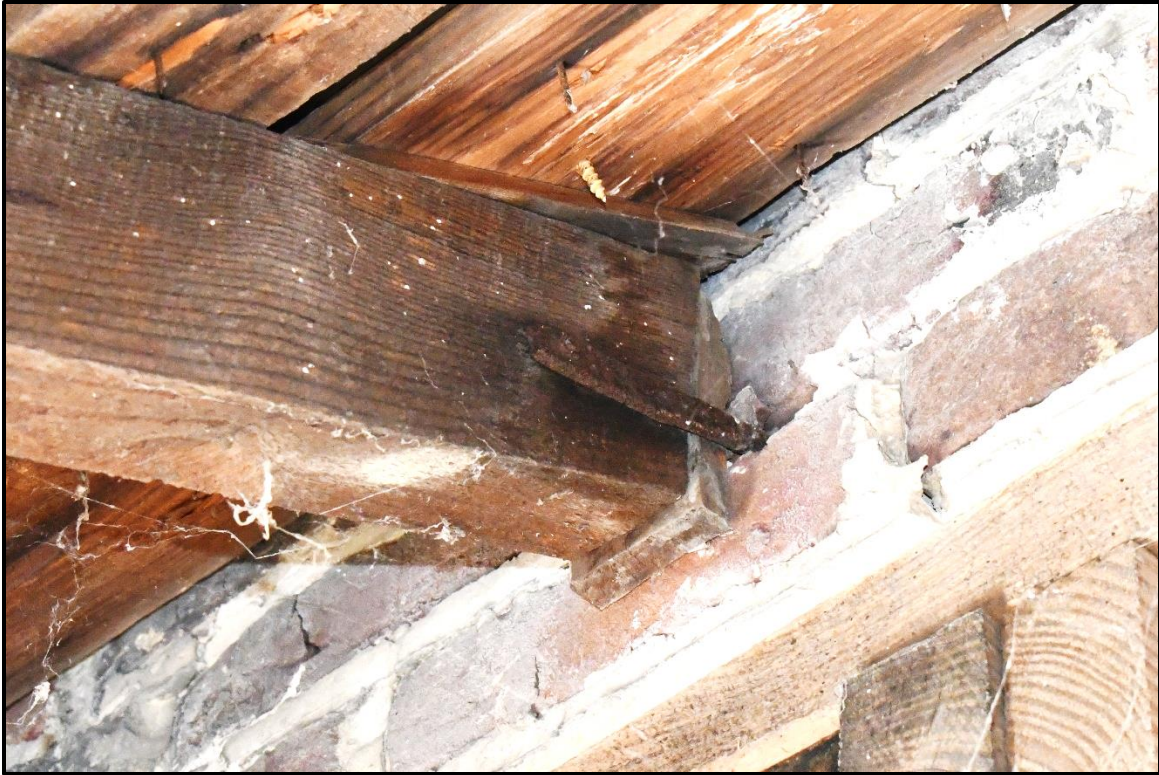
Photo 25: Upper connection of the rear shed roof rafter. Note the corrosion on the original framing hardware.

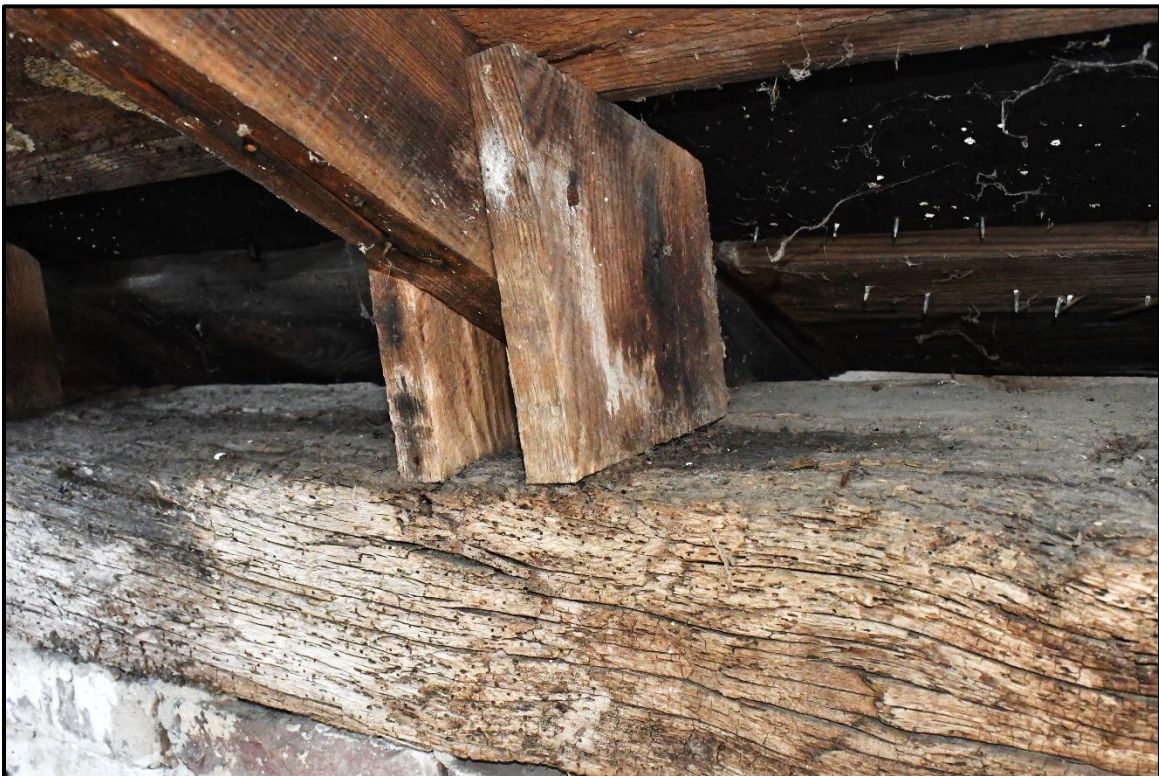
Photo 26: Lower connection of the rear shed roof rafter. Note the deteriorated condition of the timber plate.

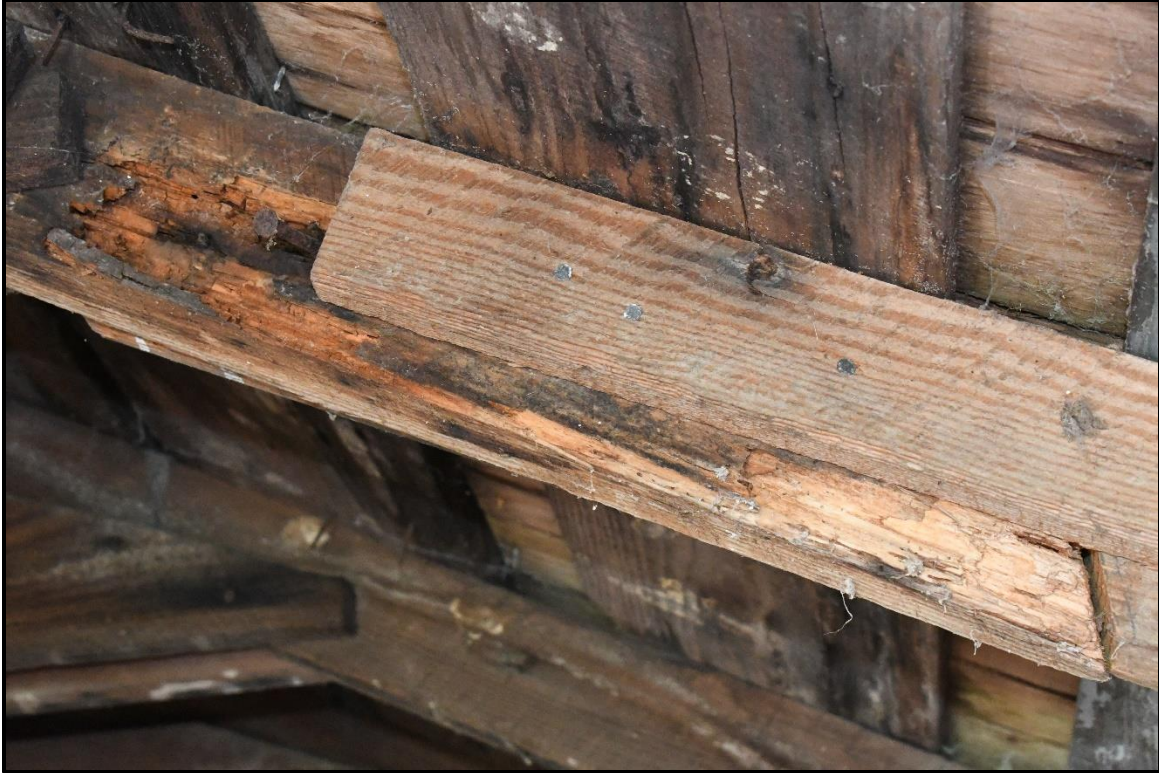
Photo 27: Wood rot or insect damage on a rafter located at the rear shed roof.

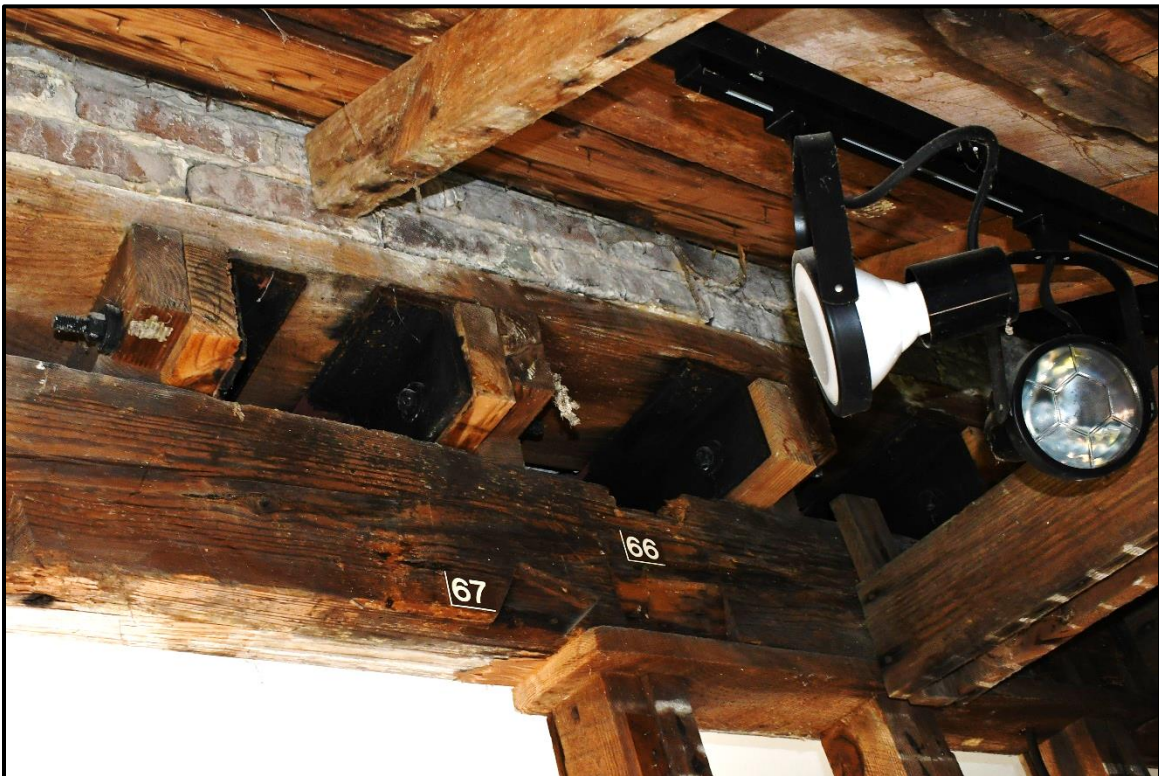
Photo 28: Portion of the second floor system visible from inside the rear shed. Note the supplemental steel angles adjacent to the floor joists.

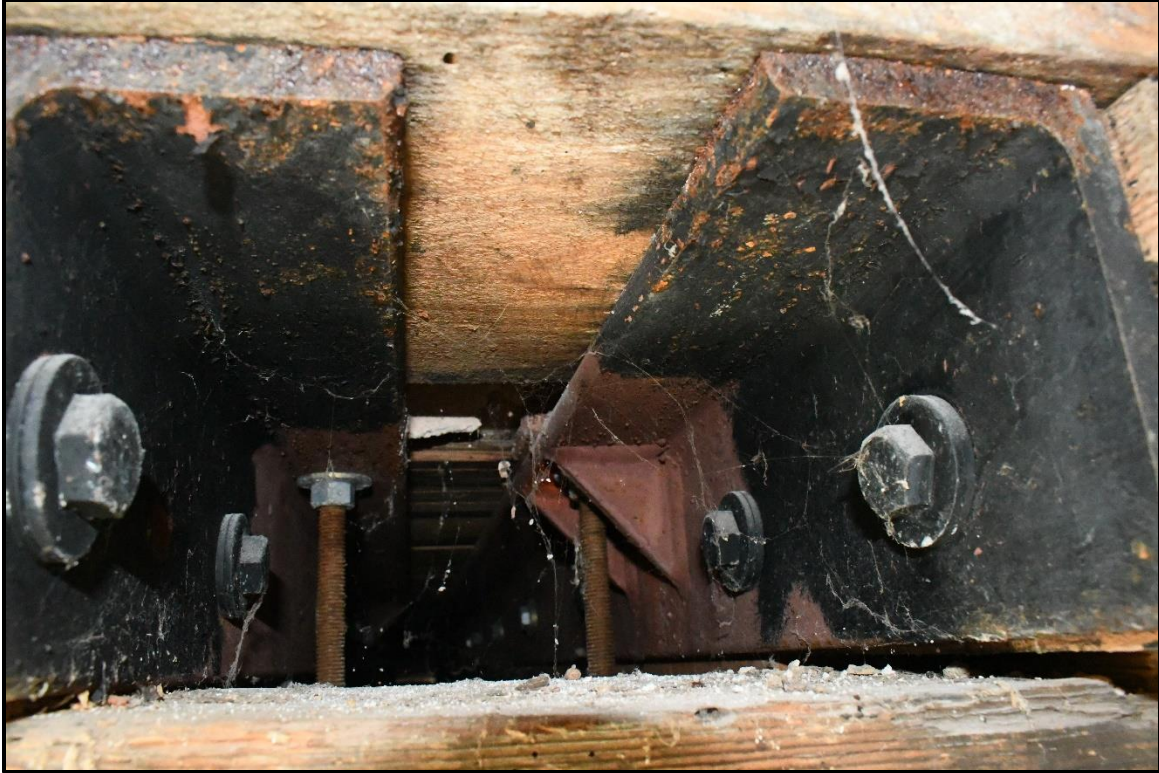
Photo 29: Steel angles installed adjacent to the second floor joists and hung from the steel beam located above the main roof attic joists.

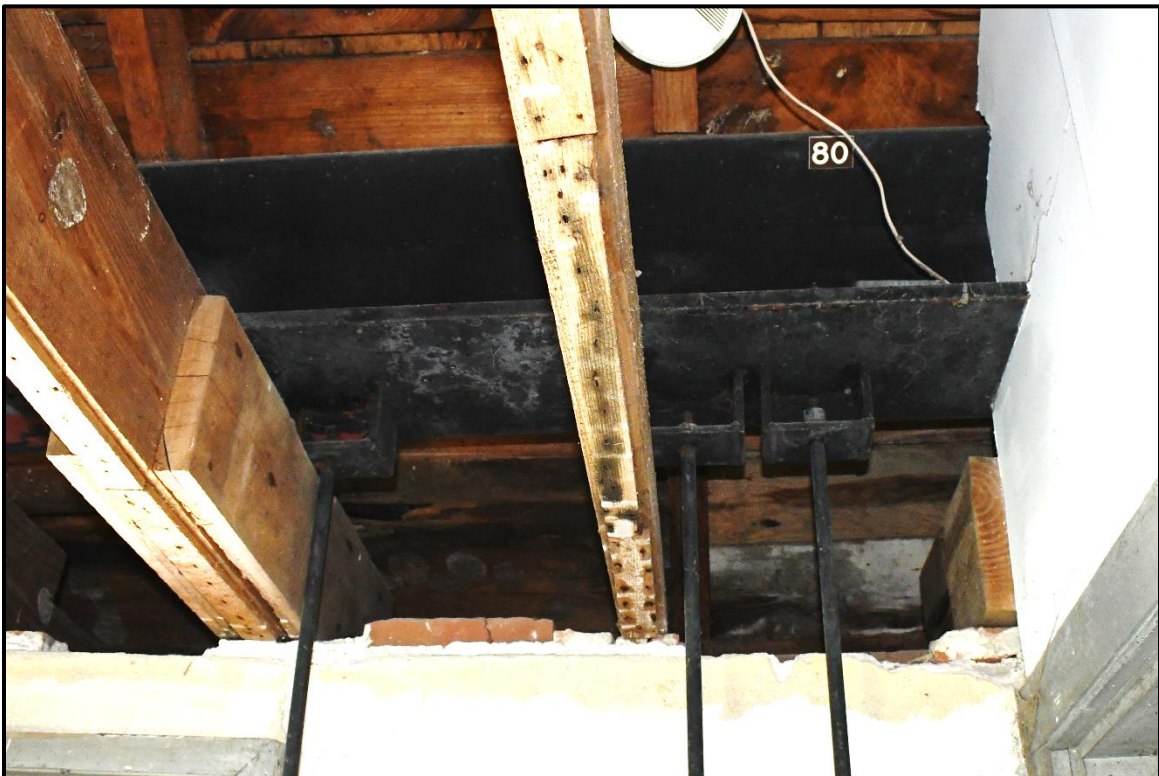
Photo 30: Steel beam located above the main roof attic floor joist located along the north wall of the home.
