TREADING WATER: A THREE PRONGED APPROACH FOR MITIGATING THE IMPACTS OF EROSION AND RISING SEA LEVELS ON FORT EUSTIS ARCHAEOLOGICAL SITES

Fort Eustis Cultural Resources, Fort Eustis, Virginia Center for the Environmental Management of Military Lands

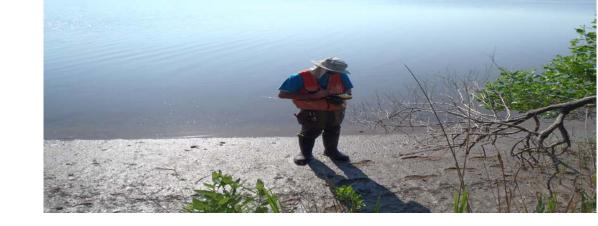
CSU monitoring director Patrick Barry taking GPS points of features uncovered by the low tide at 44NN14.

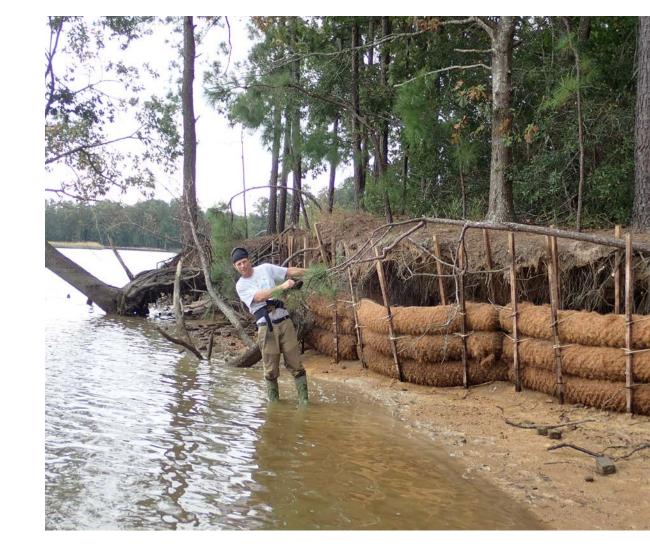
CSU monitoring director at the new coir log stabilization at 44NN14.

❖ JBLE CULTURAL RESOURCES BEGAN DEPLOYING TEMPORARY
SHORELINE STABILIZATION AT SITES 44NN107 AND 44NN14.

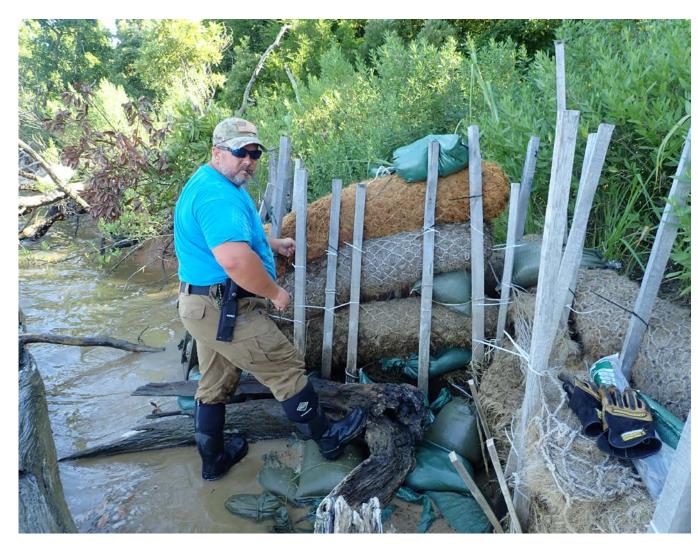
14. Environmental Tech Paul James assists with stabilization of site 44NN107.

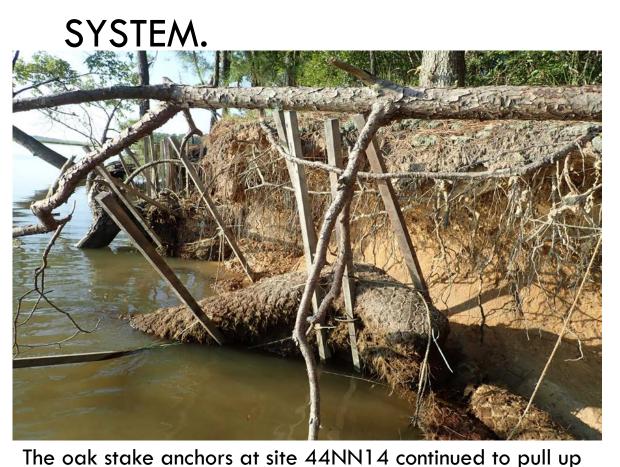
collapsing the stabilization.

o pull up

WE HAVE ADAPTED OUR SHORT TERM STABILIZATION TECHNIQUES FROM HEMP ROPE BINDING AND OAK STAKES AS ANCHORS, TO ZIP TIES AND PARACHUTE CORD AS BINDING AND METAL TENT STAKES AS THE ANCHOR

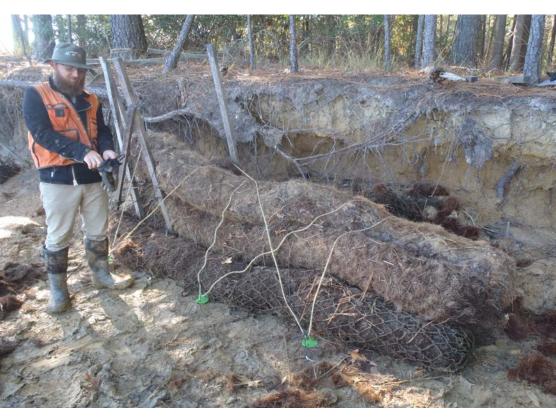
CSU employee William Feltz installs the new metal tent stake anchoring system at site 44NN14.

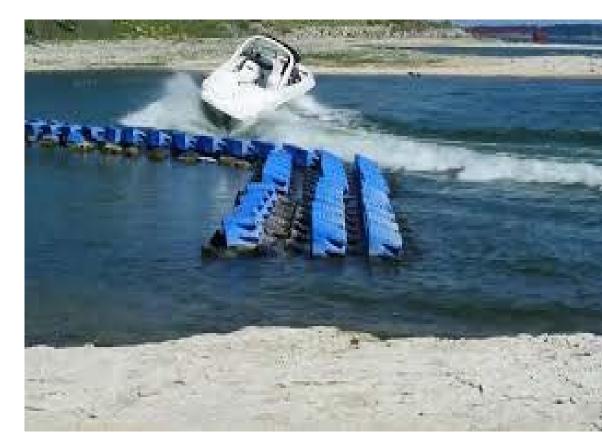
Floating breakwater technology for site stabilization is available at www.wavebrake.com

NETHODS AS WE TRANSITION TOWARD MORE LONG TERM SOLUTIONS

FOR OUR SITES SUCH AS FLOATING BREAKWATERS WITH OYSTER BAG SILLS.

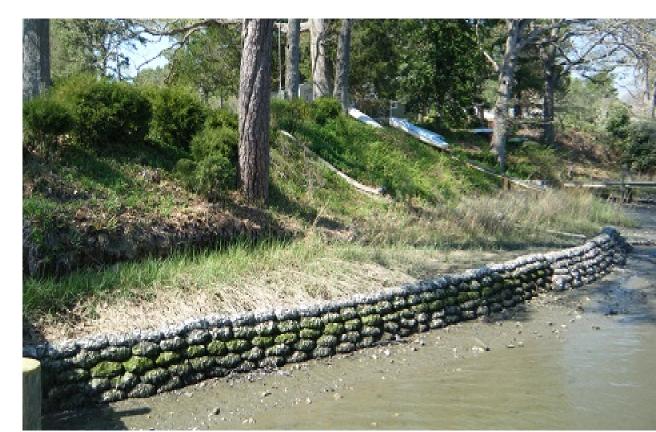
Oyster bag sills like this one illustrated by VIMS paired with floating stabilization and vegetation planting offer a more cost effective solution for long term site stabilization than traditional methods such as rip rap.
