A Window onto the Matthew Jones House

Courtney Birkett, RPA
Fort Eustis Cultural Resources, Fort Eustis, Virginia
Center for the Environmental Management of Military Lands

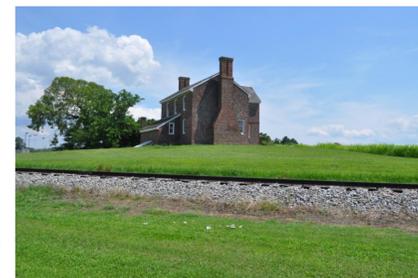
The western yard of the Matthew Jones House slopes down to the military railroad. Construction of the railroad caused great disturbance to the soils surrounding the house.

All the shovel tests except for the two closest to the Matthew Jones House were disturbed and consisted mostly of fill. This is almost certainly because of the modification of the surrounding landscape done by the military, especially the construction of a railroad approximately 23 m (75 ft.) west of the house and the associated grading of the surrounding soils. The two shovel tests immediately adjacent to the house contained intact soils and artifacts such as sherds of whiteware, window glass, colorless vessel glass, and nails. Interestingly, one also contained a Spanish real coin dating to 1692.
