Phase I Cultural Resource Survey of the Fort Eustis Tap/Line 34 Rebuild Project

LOCATION > City of Newport News, Virginia

DATE > October 2020

PREPARED BY >
Dutton + Associates, LLC

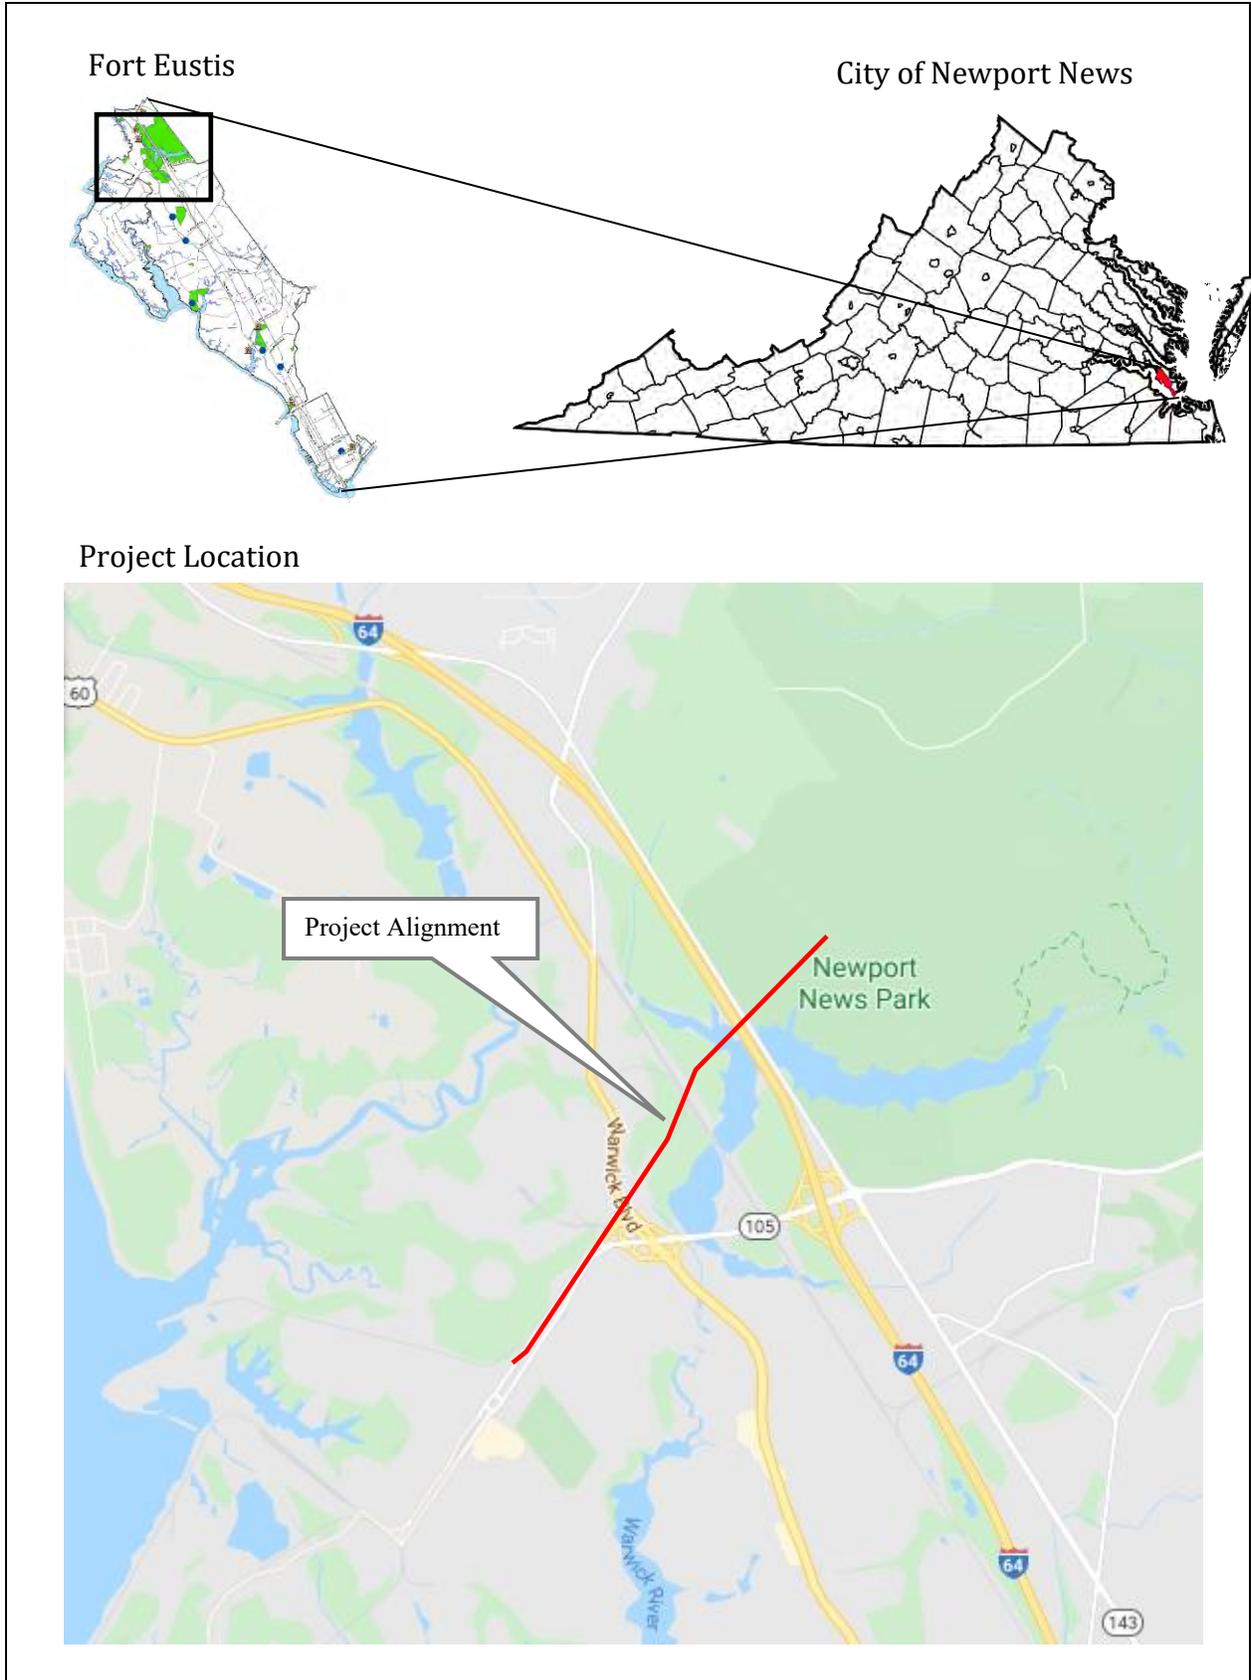
Figure 1-1: General location of the project alignment.

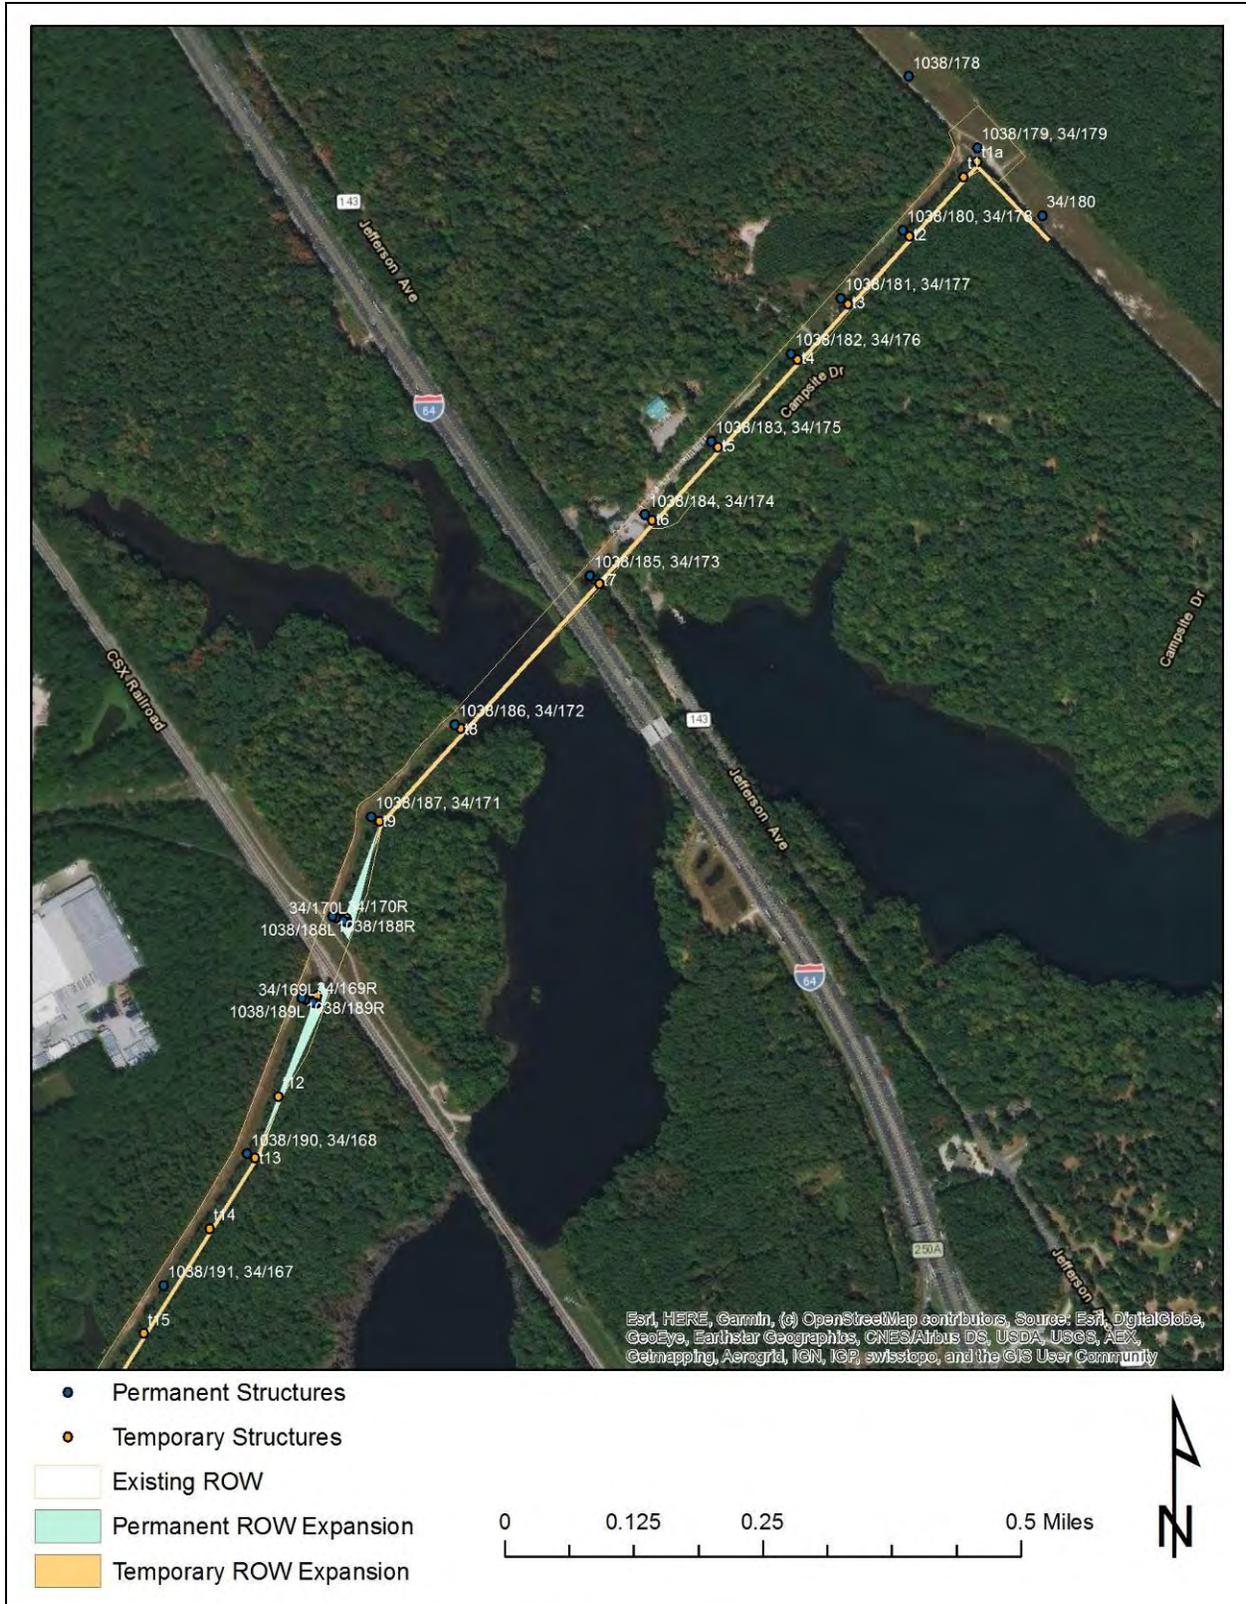
Figure 1-3: Detail of proposed permanent and temporary structure locations with ROW expansion (north half of alignment). Source: Dominion

A table of transmission line structures included in this effort, detailing existing and proposed heights may be found in Table 1-1. Maps of structure locations along with areas of temporary and permanent ROW expansion may be found in Figures 1-3 and 1-4. Schematics of representative proposed structures are provided in Figures 1-5 through 1-7 (Note: Proposed average heights depicted in graphics and the table are approximate and will vary slightly based upon final engineering).

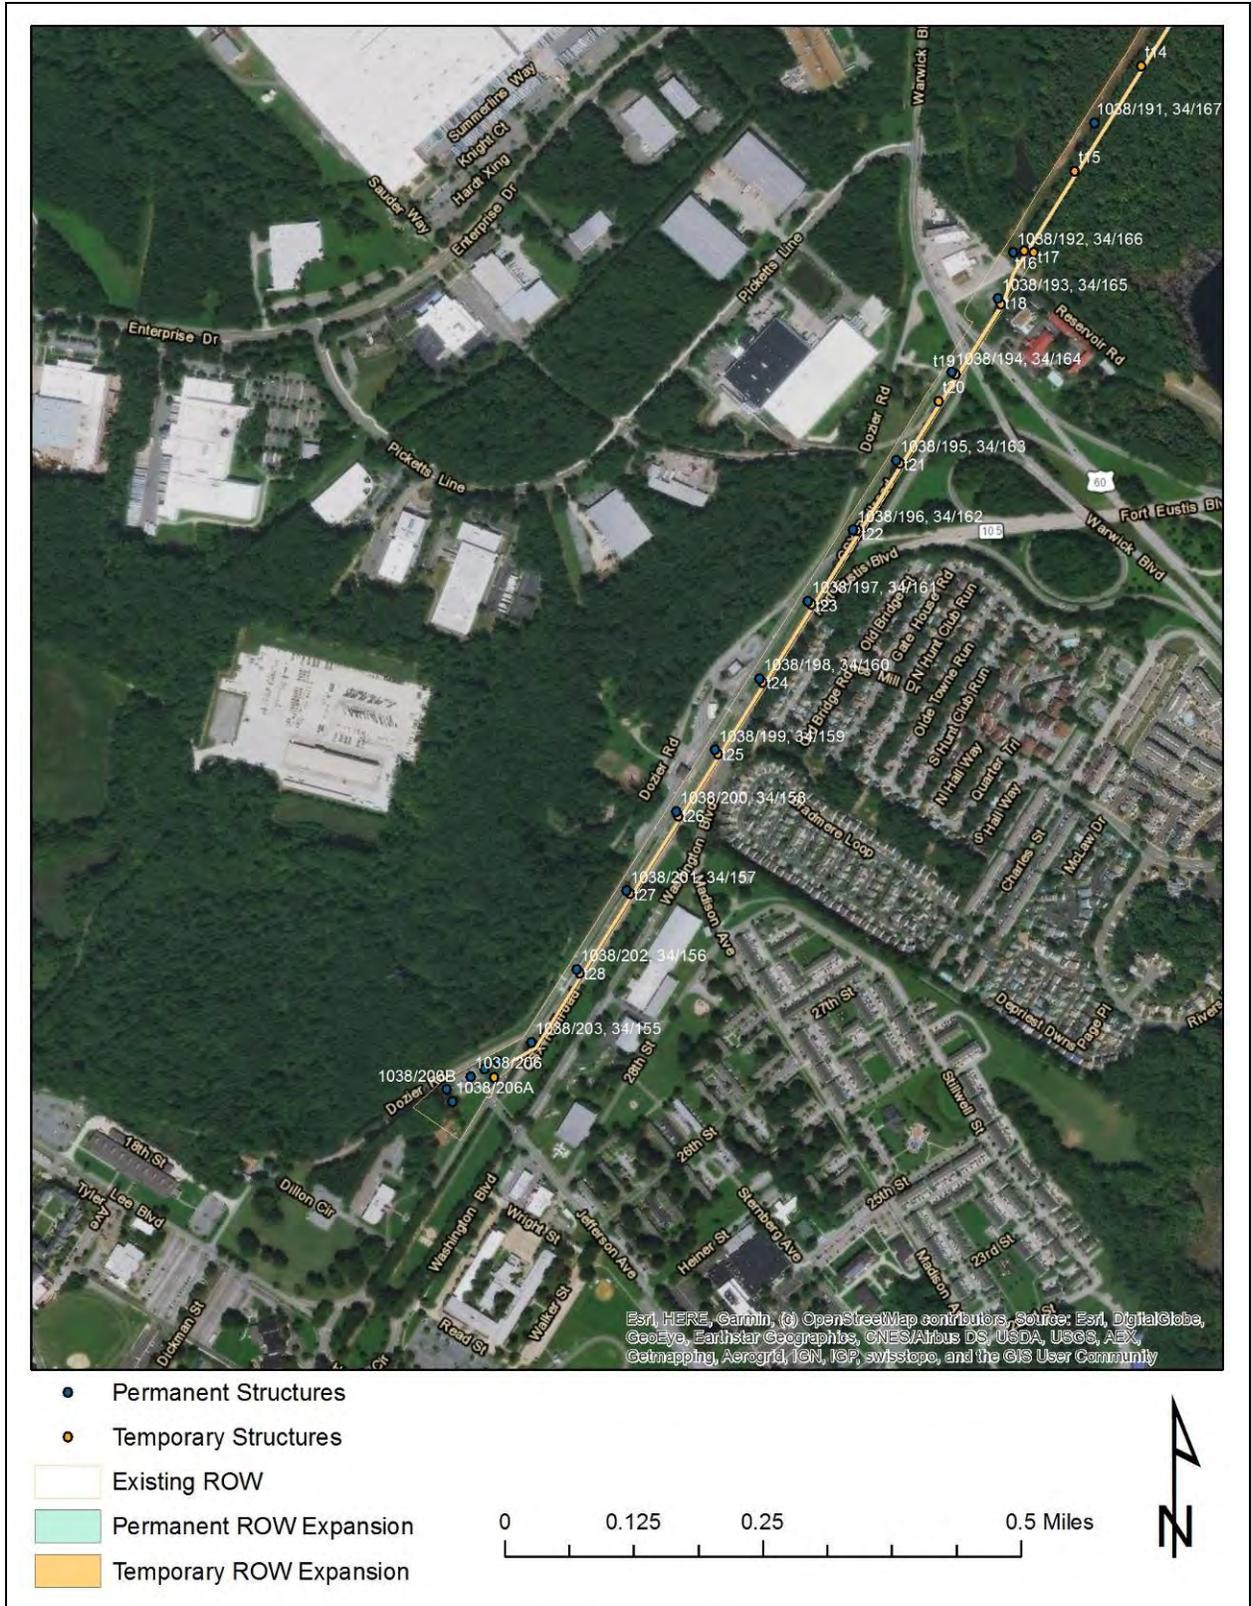
Figure 1-4: Detail of proposed permanent and temporary structure locations with ROW expansion (south half of alignment). Source: Dominion

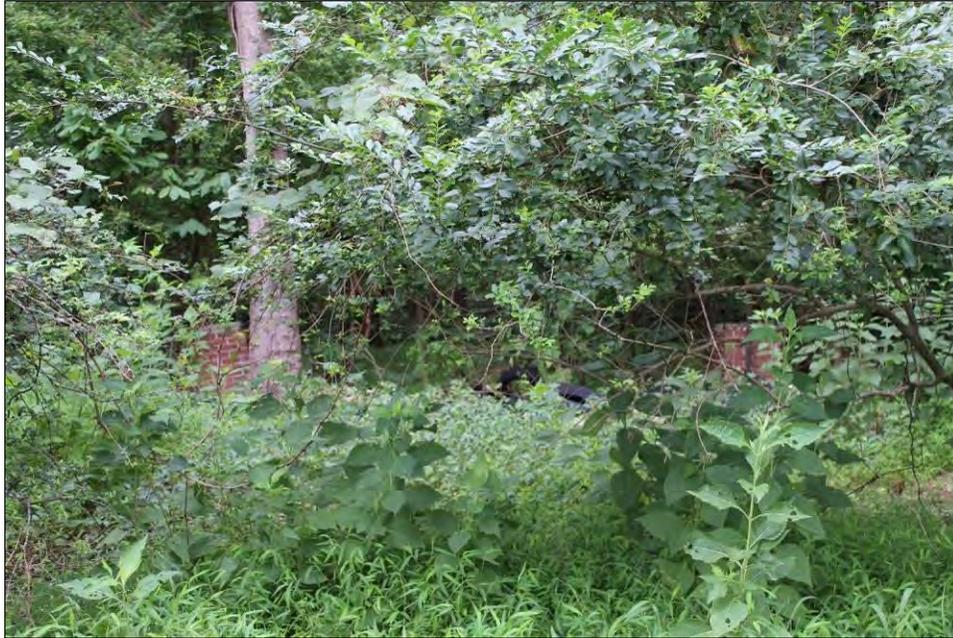
VDHR# 121-0010
Mulberry Island Church Site, Dozier Road

The Mulberry Island Church Site, also recorded as 44NN0176, is an archaeological site that represents the remains of a church site and cemetery believed to have been in existence since 1660. All that remains presently are a series of brick posts roughly bordering an area of burials. The site is heavily overgrown and could not be inspected, however, previous inspection noted that the earliest marked tombstone dates to 1870. The building is believed to have been abandoned and the last known use of the cemetery is believed to have occurred circa 1920 after the establishment of Fort Eustis immediately to the east.

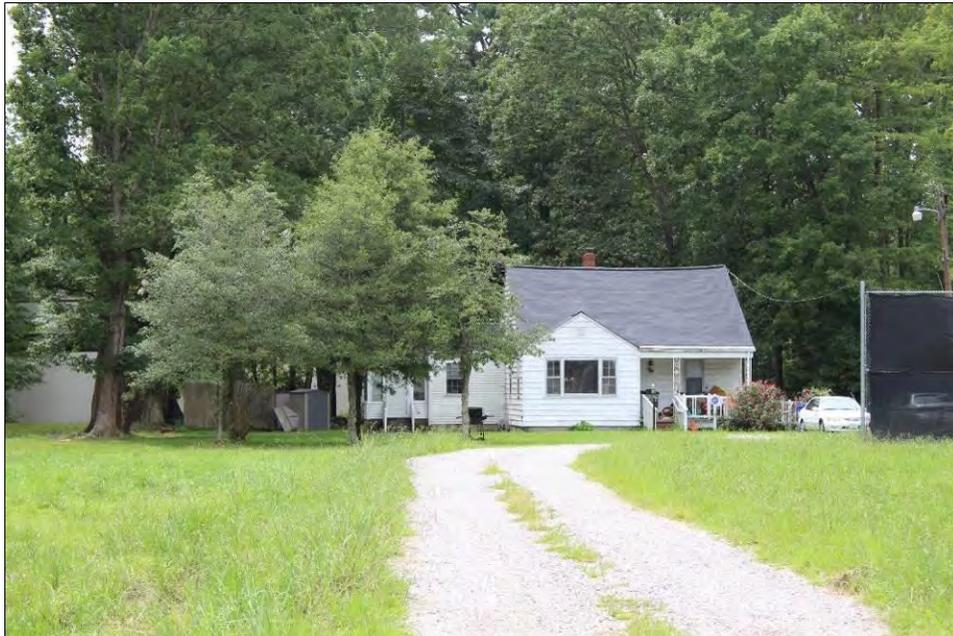
VDHR# 121-5043
House, 17249 Warwick Boulevard

This single dwelling was built circa 1950 according to site survey and exhibits a Minimal Traditional style. The building has a one-story rectangular main block with an offset projecting front bay and a small one-story side wing. The wood frame structural system is clad with vinyl siding and rests on a continuous concrete block foundation. It is topped by a side-gable roof with offset front cross gable covered with asphalt shingles that is pierced on the rear slope by a central interior brick chimney flue. The main entrance is set adjacent to the forward bay on the front and sheltered by a partial-width integral roof porch with cast metal supports. Fenestration consists of four-over-four double-hung sash windows as well as a single pane picture window on the forward bay. The building is simple and unembellished.

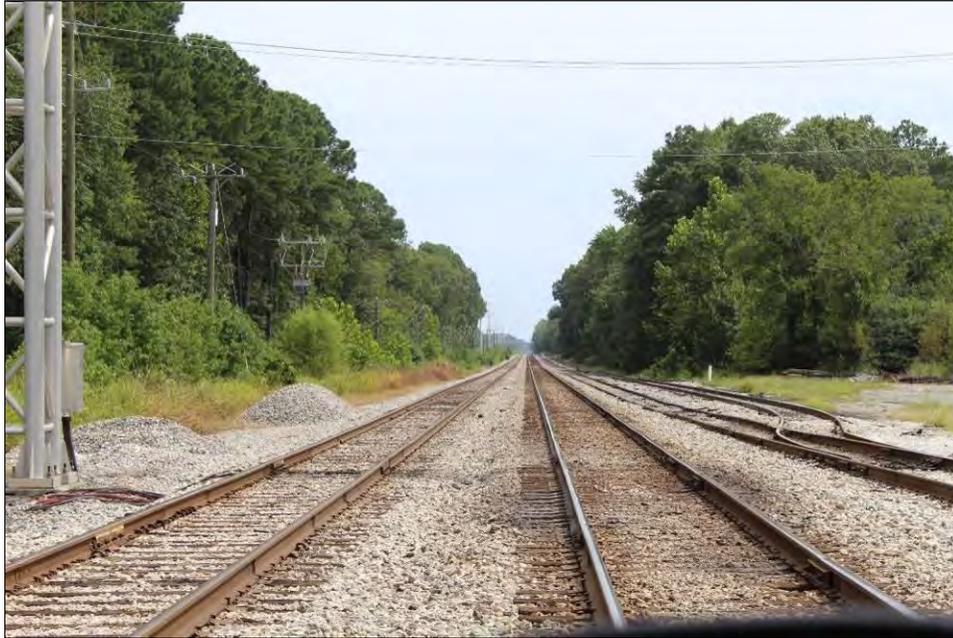
VDHR# 121-5134
Chesapeake & Ohio Railroad

A roughly one-mile segment of the former Chesapeake & Ohio (present-day CSX Railroad) corridor, extends through the project APE, running generally northwest-southeast. In this area, it generally parallels the other major transportation corridors through the Lower Peninsula including Route 60, I-64, and Jefferson Avenue. The portion of the corridor within the survey area is triple-tracked as it enters the survey area from the west near Lee Hall Depot, but transitions to a double-tracked configuration prior to crossing the Lee Hall Reservoir and continuing east towards Newport News.

The tracks are set upon a built-up gravel berm that extends through a ROW mostly bordered by woodland. There are no road crossings within the project APE, however, the corridor crosses over the Lee Hall Reservoir on an earthen bridge.

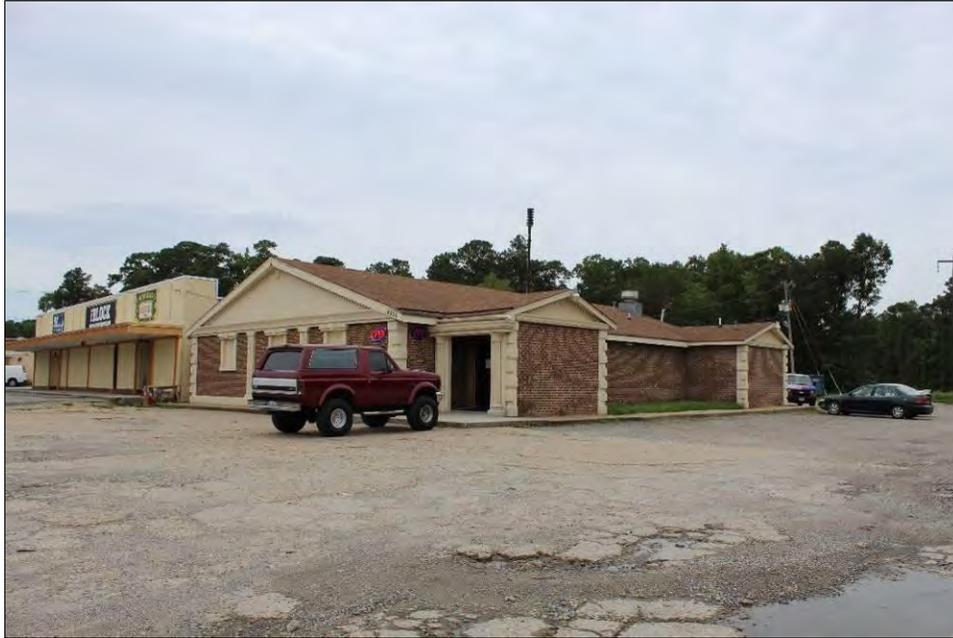
VDHR# 121-5457
Commercial Building, 16906 Warwick Boulevard

This commercial building was built in 1970 according to local records and exhibits a Nuevo-Neoclassical Revival style. The building has a one-story mostly rectangular main block with two small side wings. The masonry structural system is clad with brick veneer laid in a stretcher bond and rests on a continuous foundation. It is topped by a front-gable roof with two small cross gables to the side covered with asphalt shingles. The main entrance is set on the front of the forward side wing and is sheltered within an inset bay. There is no other windows or fenestration on the building. The building has a variety of neoclassical revival influences including a pedimented front gable, exaggerated quoins, false window lintels with keystones, and fluted pilasters supporting the front pediment and entry architrave.

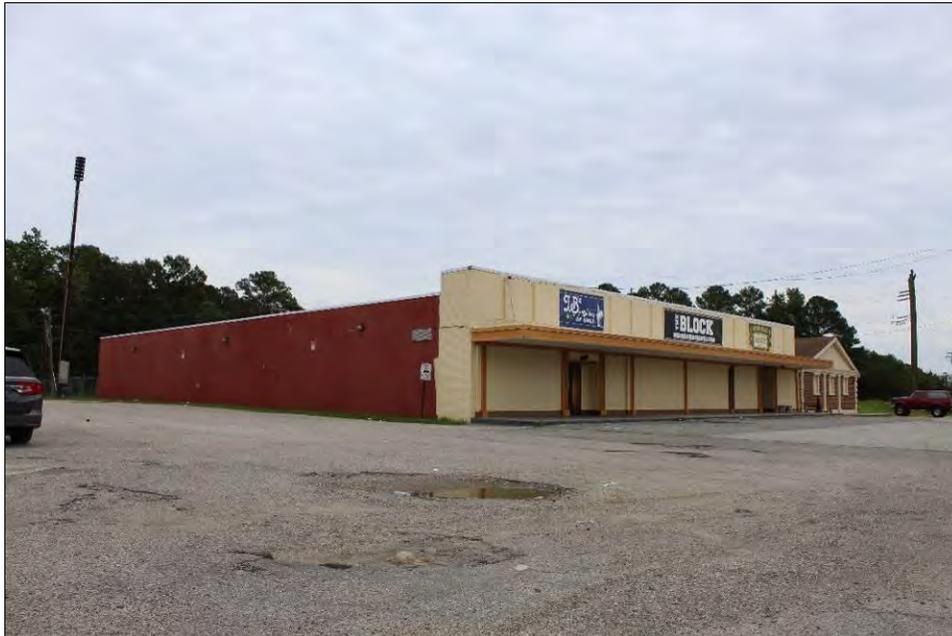
VDHR# 121-5458
Commercial Building, 16914 Warwick Boulevard

This commercial building was built in 1968 according to local records and exhibits no discernible style. The building has a one-story mostly rectangular main block with a small offset rear ell. The concrete block structural system is exposed on the sides and rear and clad with brick veneer laid in a stretcher bond on the front. It rests on a continuous foundation. It is topped by a flat roof with a raised flat parapet extending along the front. There are two separate storefront entries set at opposite ends of the front, both of which are sheltered by a full-width flat roof canopy. There are no other windows or fenestration on the building. The building is simple and embellished only by a series of vertical reliefs in the brickwork of the parapet.

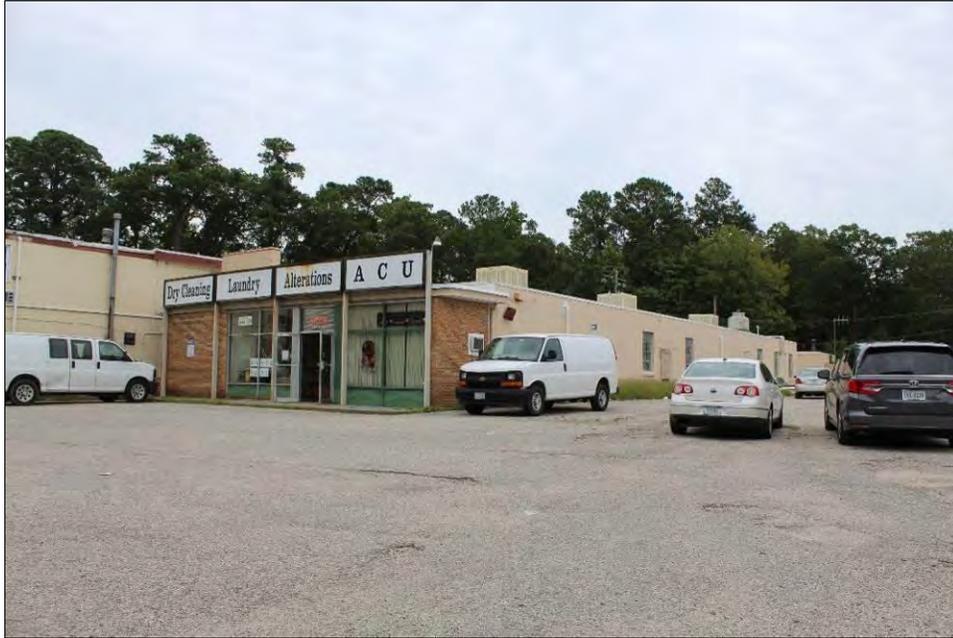
VDHR# 121-5459
Commercial Building, 16922 Warwick Boulevard

This commercial building was built in 1964 according to local records and exhibits no discernible style. The building has a one-story trapezoidal-shaped main block created by the rear angle of the property. The concrete block structural system is exposed on the sides and rear and clad with brick veneer laid in a stretcher bond on the front. It rests on a continuous foundation. The building is topped by a flat roof covered with unknown materials. The main entrance is set centrally on the front and is unsheltered. It is flanked by nearly full-height storefront windows with aluminum frames on both sides. Additional fenestration on the sides of the building consist of multi-light industrial-style windows. The front of the building is embellished by heavy roof overhangs, metal panels beneath the windows on the front, and a series of posts supporting a full-width parapet-styled sign over the front.

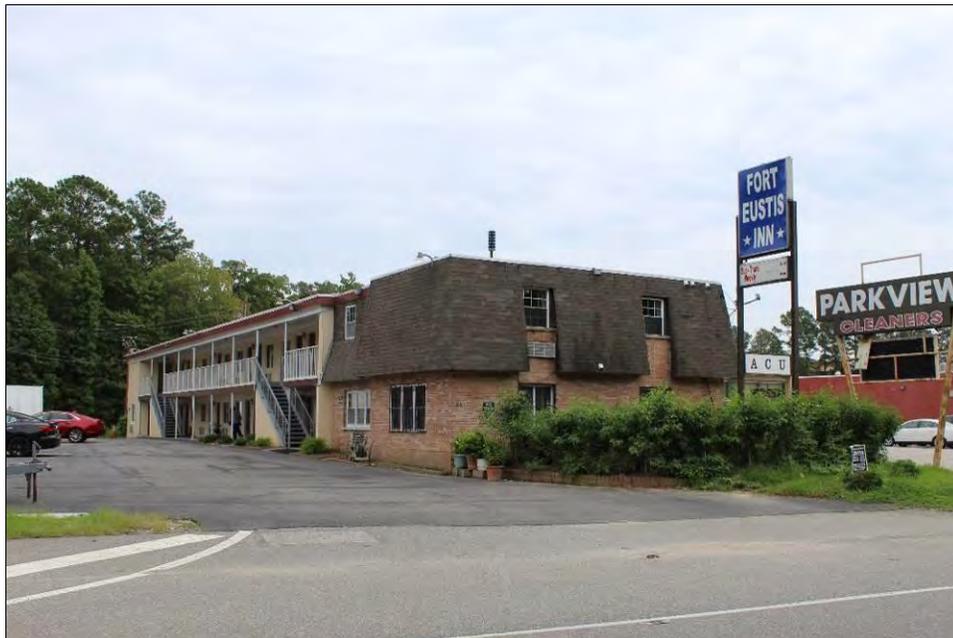
VDHR# 121-5460
Motel, 16924 Warwick Boulevard

This commercial building was built circa 1960 according to site survey and exhibits no discernible style. The building has a two-story rectangular form created by a front office block and a rear guestroom block. The front block has a masonry structural system clad with brick laid in a stretcher bond that rests on a continuous foundation. It is topped by a pent roof with a flat top. The rear block has an exposed concrete block structural system that rests on a continuous foundation and is topped by a flat roof. The entrance to the front block is through an interior corridor within the first bay of the guestroom block. Guestroom entries are from the exterior and set along the side, sheltered by an integral roof overhang. Two stairwells provide access to the second floor balcony. Fenestration consists of six-over-six double-hung sash windows on the front block and single-pane fixed windows on the rear block. The building is simple and embellished only with a heavy pent roof on the front that is pierced by upper story window openings.

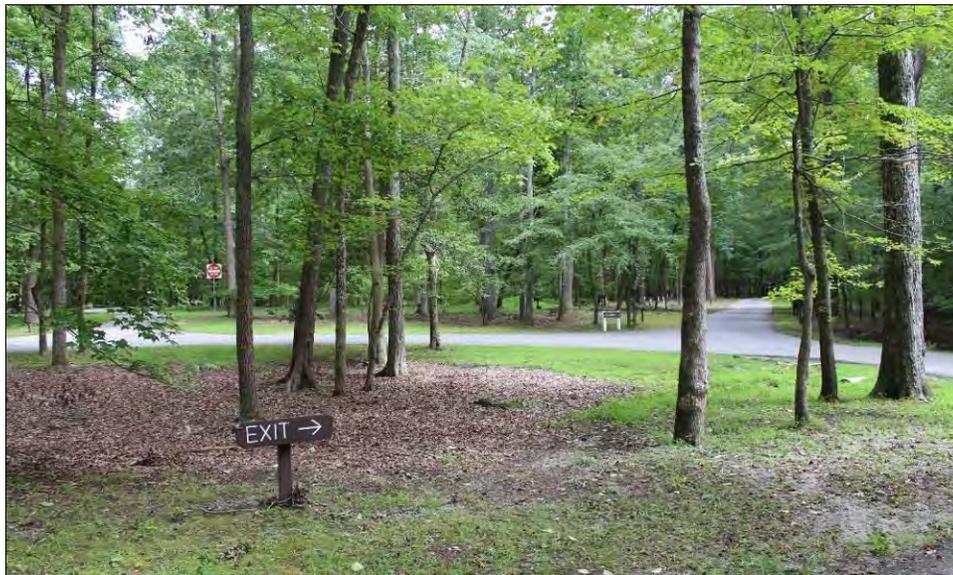
VDHR# 121-5461
Newport News Park Campground, Campsite Drive

This campground was opened circa 1966 along with the creation of Newport News Park according to written data. It consists of several clusters of campsites for primitive and RV camping. The primary building is a modern visitor center located at the front of the complex. This building was constructed circa 2015 according to map review and exhibits a rustic revival style. The one-story building has a mostly square form. The wood frame structural system is clad with a combination of cedar siding and stone veneer and rests on a continuous foundation. It is topped by a hipped roof covered with standing seam metal. There are entries on all sides of the building, each sheltered within a gabled portico with stone columns supports. The building is embellished with a variety of “rustic” influences.

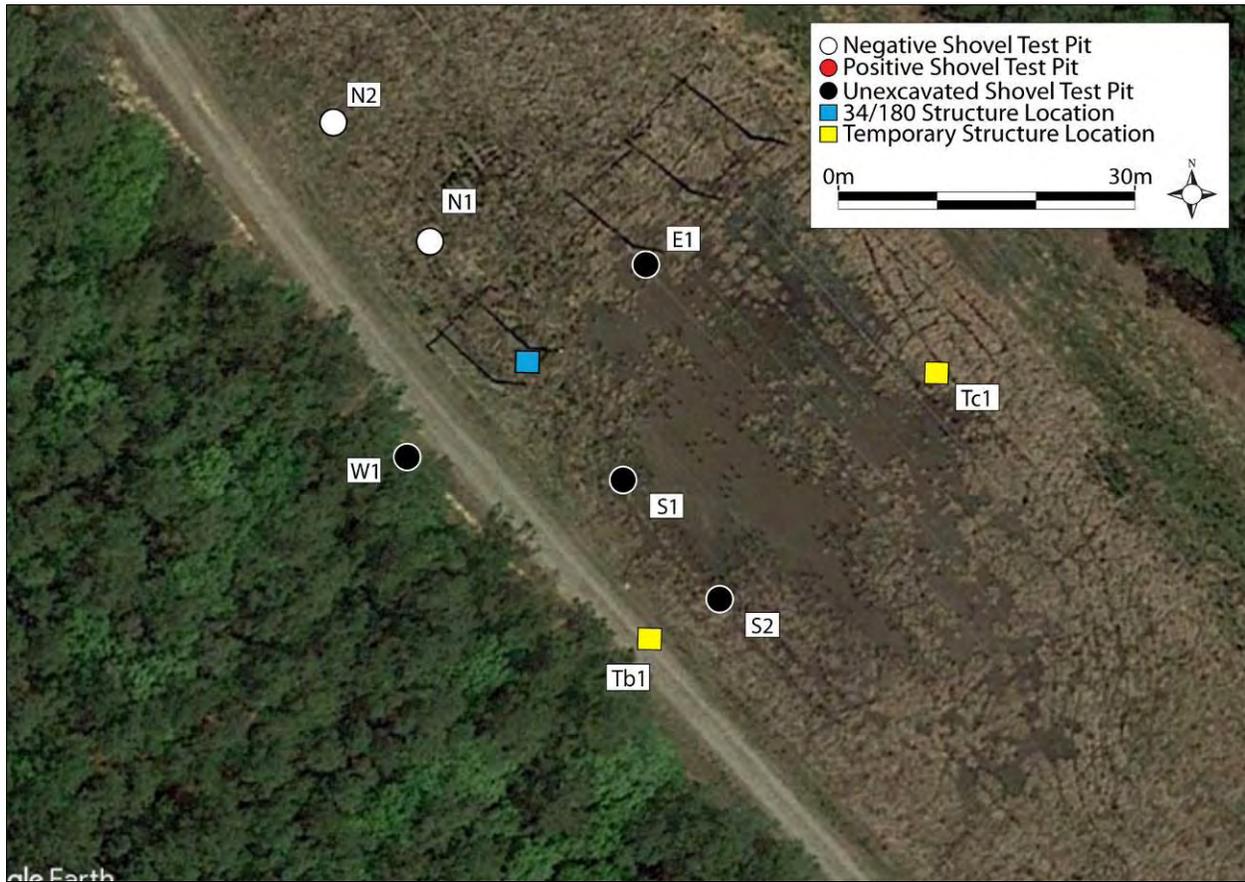
Figure 8-4: Aerial view of Structures 34/180 Tb1 and Tc1.

(Figures 8-4 through 8-6). No evidence of subsurface or surface features was observed during survey in this location.

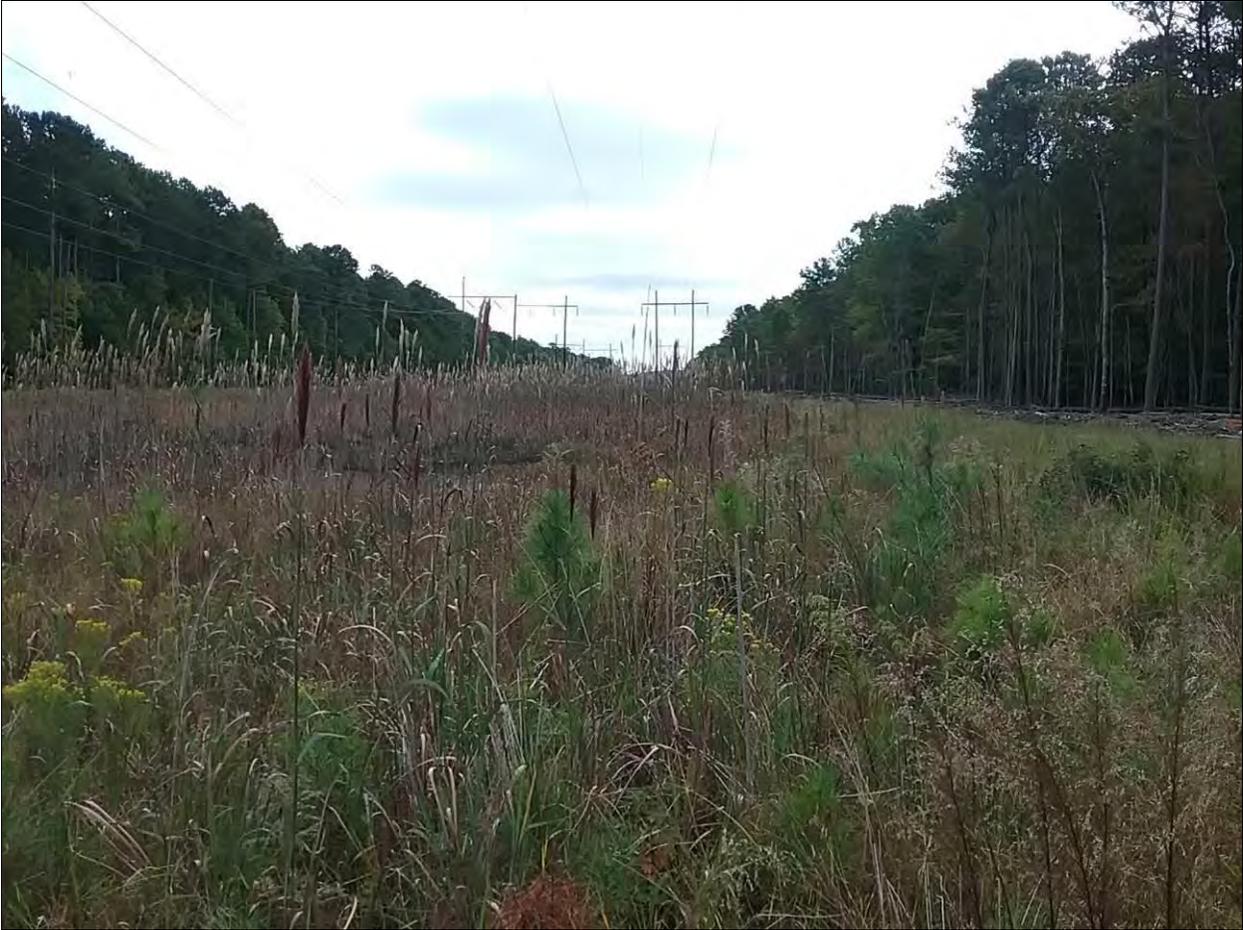
Figure 8-5: View of 34/180, Tb1, and Tc1 setting and vegetation looking south, showing wetland.

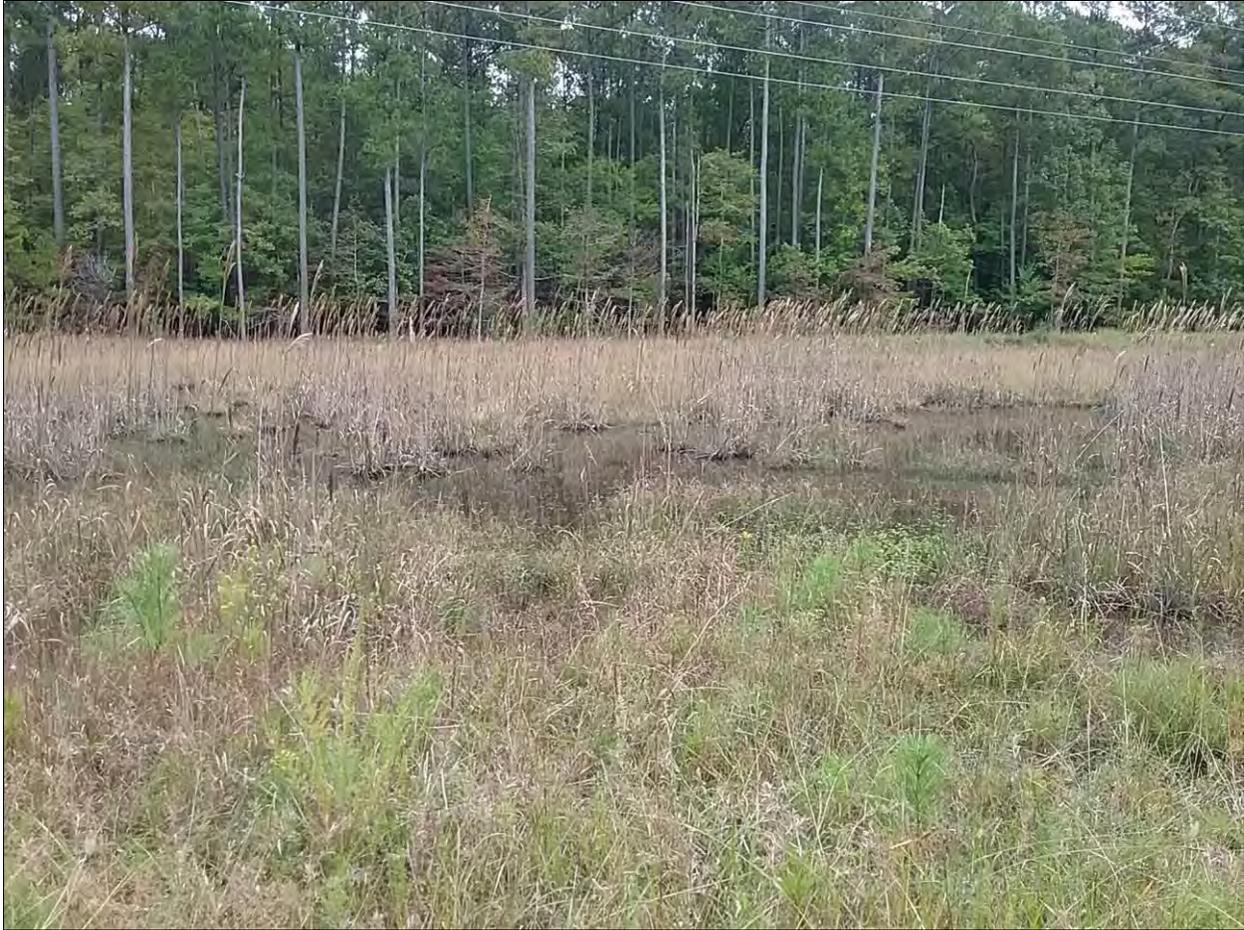
Figure 8-6: Standing water at the projected location of Tc1 looking east.

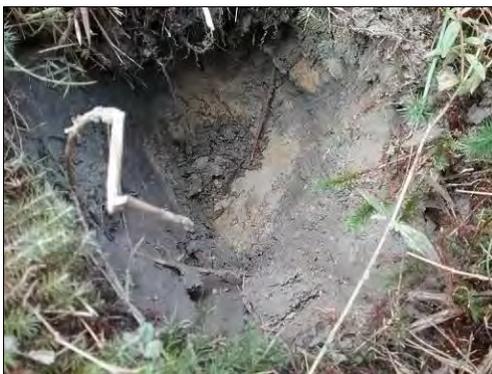
Soils from the excavated shovel tests at Structure 34/180 consisted of about 27 cm of 10YR 4/4 brown sandy loam over a hydric subsoil consisting of 10YR 6/8 brownish yellow clay mottled with 2.5Y 6/1 gray clay (Figure 8-7).

Figure 8-7: Soil profile of shovel test N1 at 34/180.

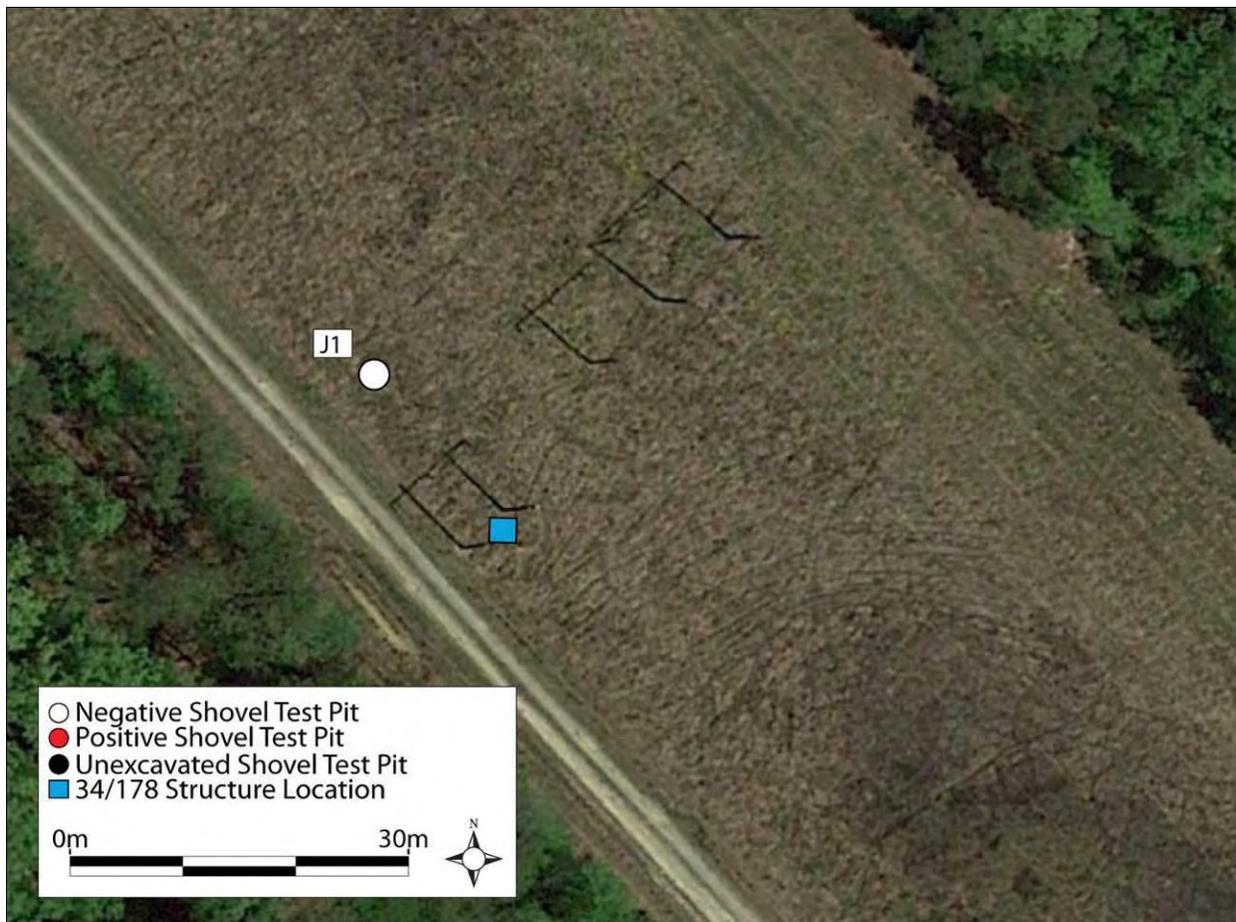
Figure 8-8: Aerial view of Structure 1038/178.

Structure 1038/178 is located in Newport News Park at the intersection of the Fort Eustis Tap and TL-34. The terrain in the area of the structure is slightly elevated fill with wetland vegetation and wetland soils surrounding the structure. Due to the fact that there was standing water surrounding the structure, only one shovel tests were excavated in this location, Judgmental shovel test pit 1 (J1), which was negative for cultural material (Figures 8-8 through 8-10). J1 was placed in the driest location within the proximity to the structure. No evidence of subsurface or surface features was observed during survey in this location.

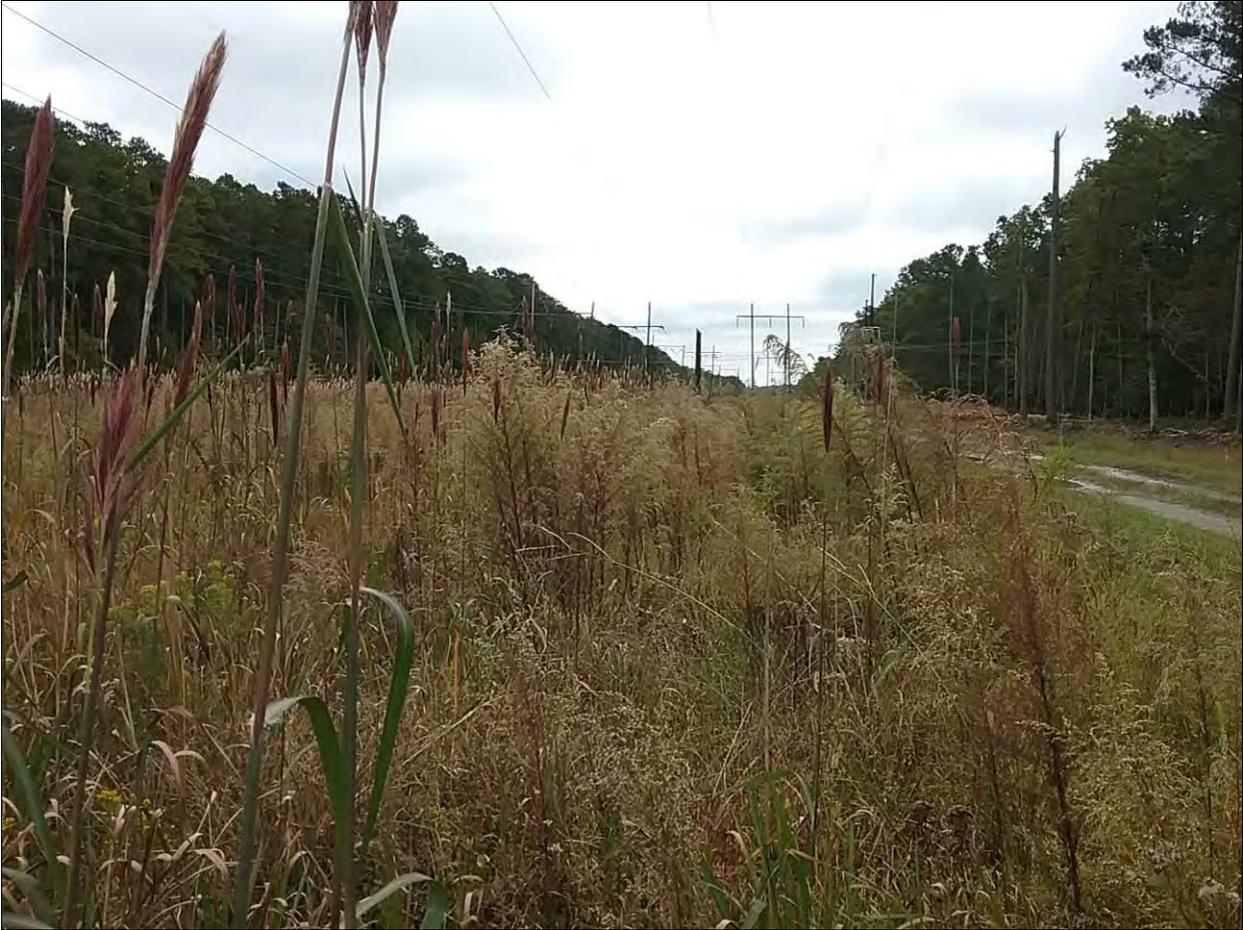
Figure 8-9: View of 34/178 showing wetland vegetation looking north.

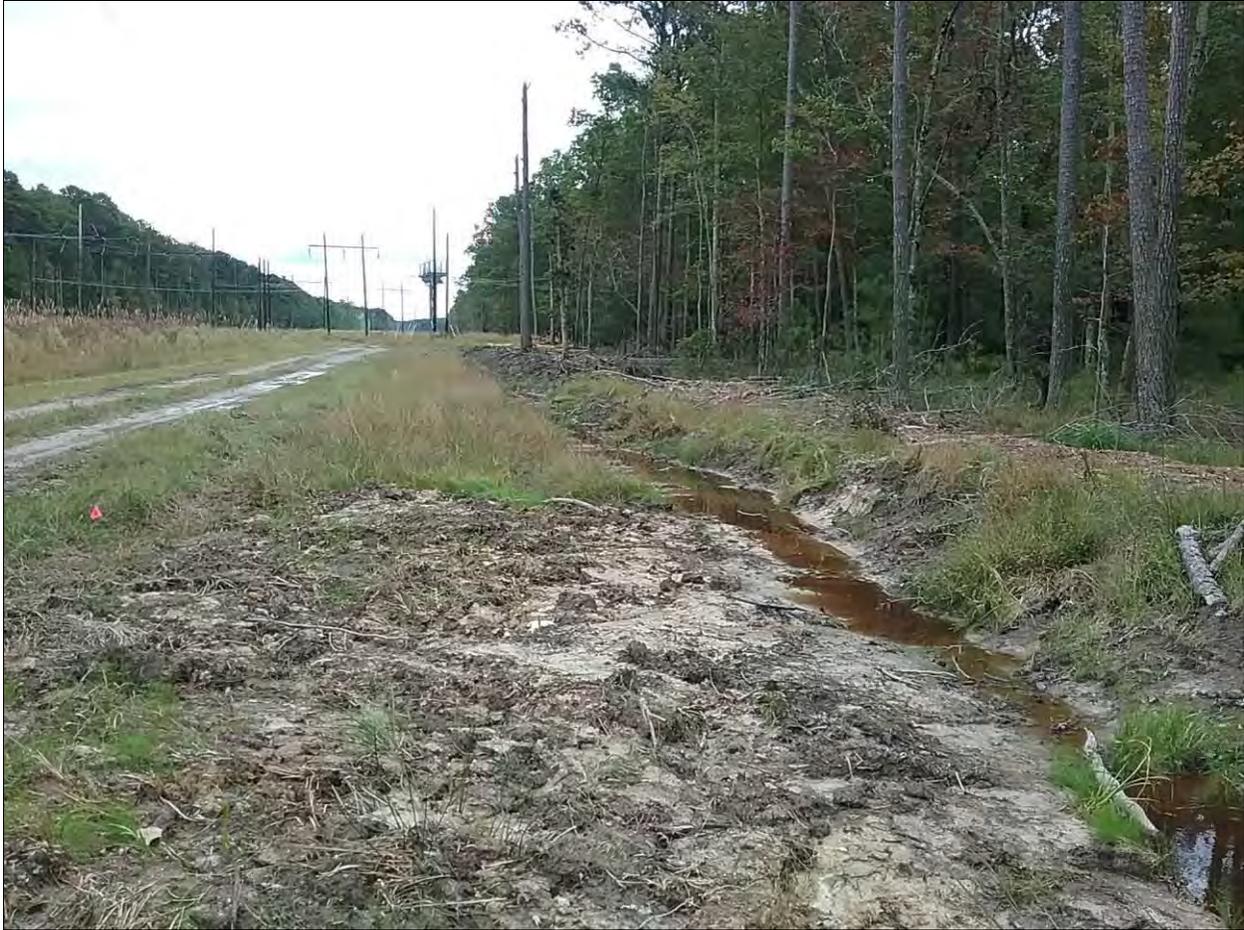
Figure 8-10: Standing water in the vicinity of the structure looking south.

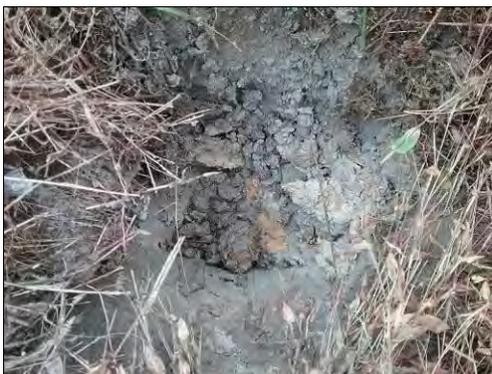
Soils from the excavated shovel test at Structure 34/178 consisted of about 19 cm of 10YR 4/4 brown sandy loam mottled with 2.5Y 6/1 gray clay which came down to 2.5Y gray clay. The shovel test was hydric (Figure 8-11).

Figure 8-11: Soil profile of shovel test J1 at Structure 1038/178.

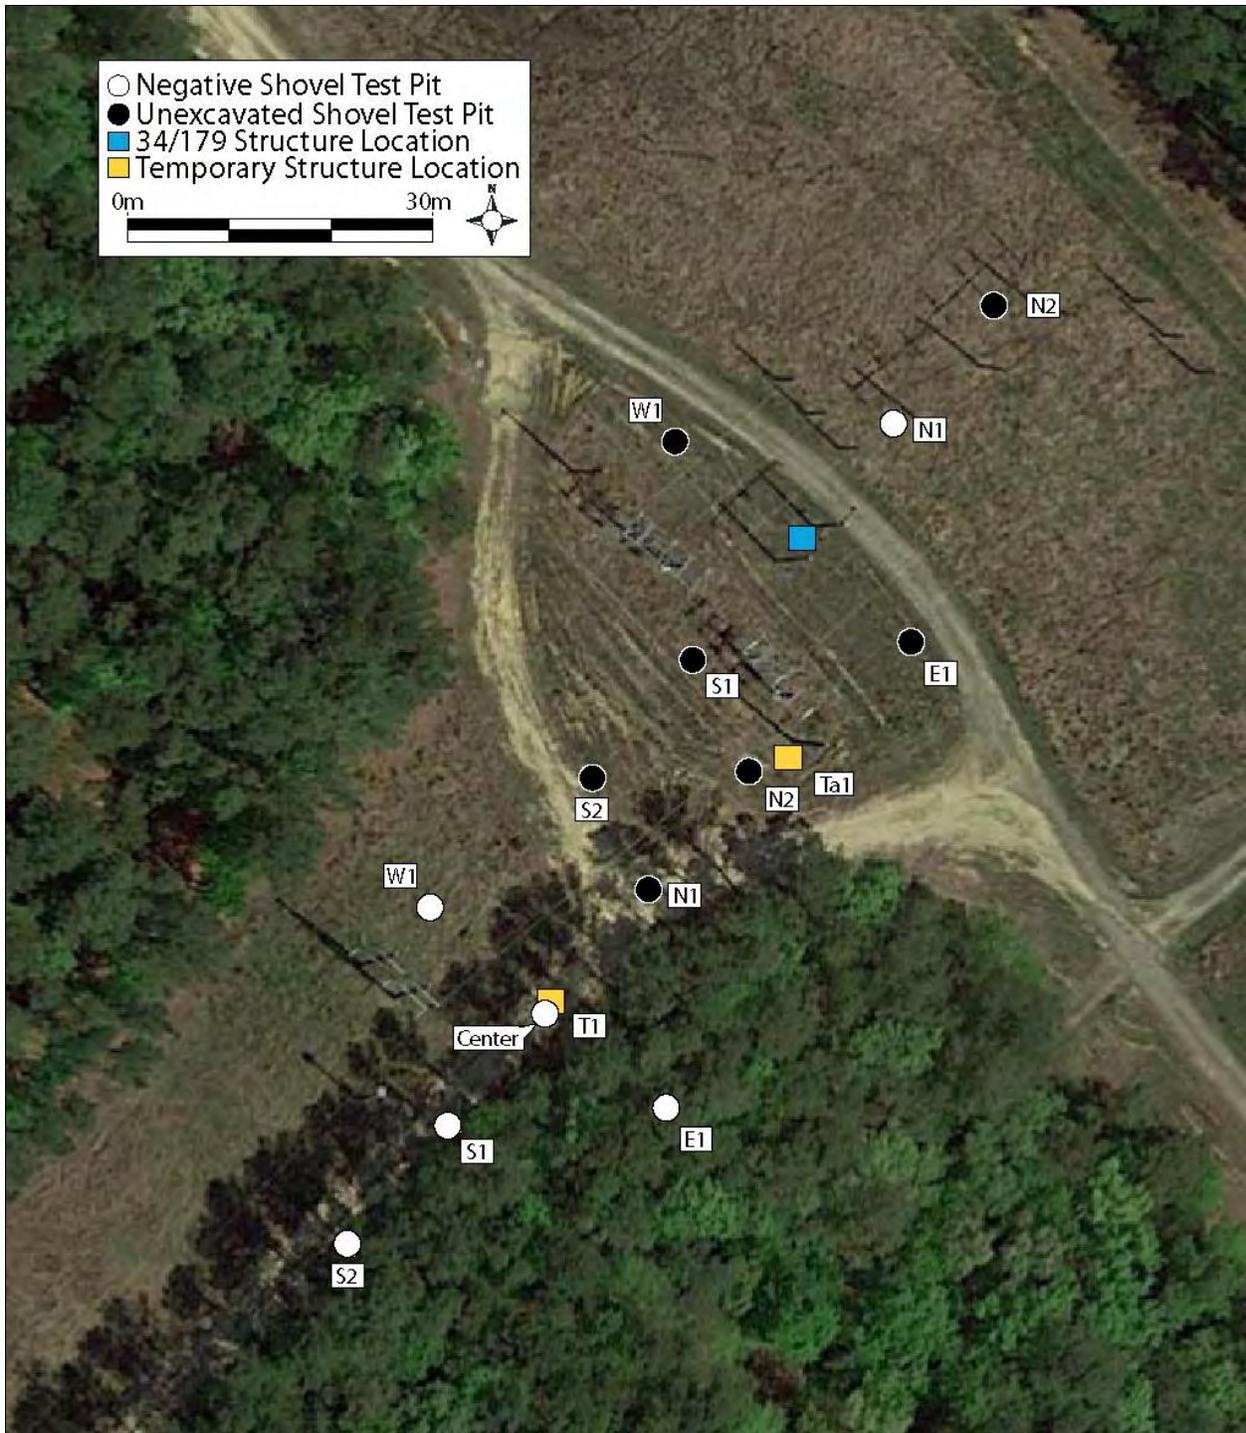
Figure 8-12: Aerial view of Structures 34/179, Ta1, and T1.

Structure 34/179 and temporary structure Ta1 are located in Newport News Park at the intersection of the Fort Eustis Tap and TL-34. The terrain in the area of the structure is slightly elevated fill with wetland vegetation and wetland soils surrounding the structure. Additional transmission structures are located in the immediate vicinity of the proposed replacement structure. Ta1 is located just south of Structure 34/179 and is immediately adjacent to existing transmission line infrastructure. Due to the location of existing transmission line infrastructure and wetland vegetation, only a single shovel test was excavated in this location, which was negative for cultural material (Figures 8-12 and 8-13). No evidence of subsurface or surface features was observed during survey in this location.
