Phase I Cultural Resource Survey of the Fort Eustis Tap/Line 34 Rebuild Project

LOCATION > City of Newport News, Virginia

DATE > October 2020

PREPARED BY >
Dutton + Associates, LLC

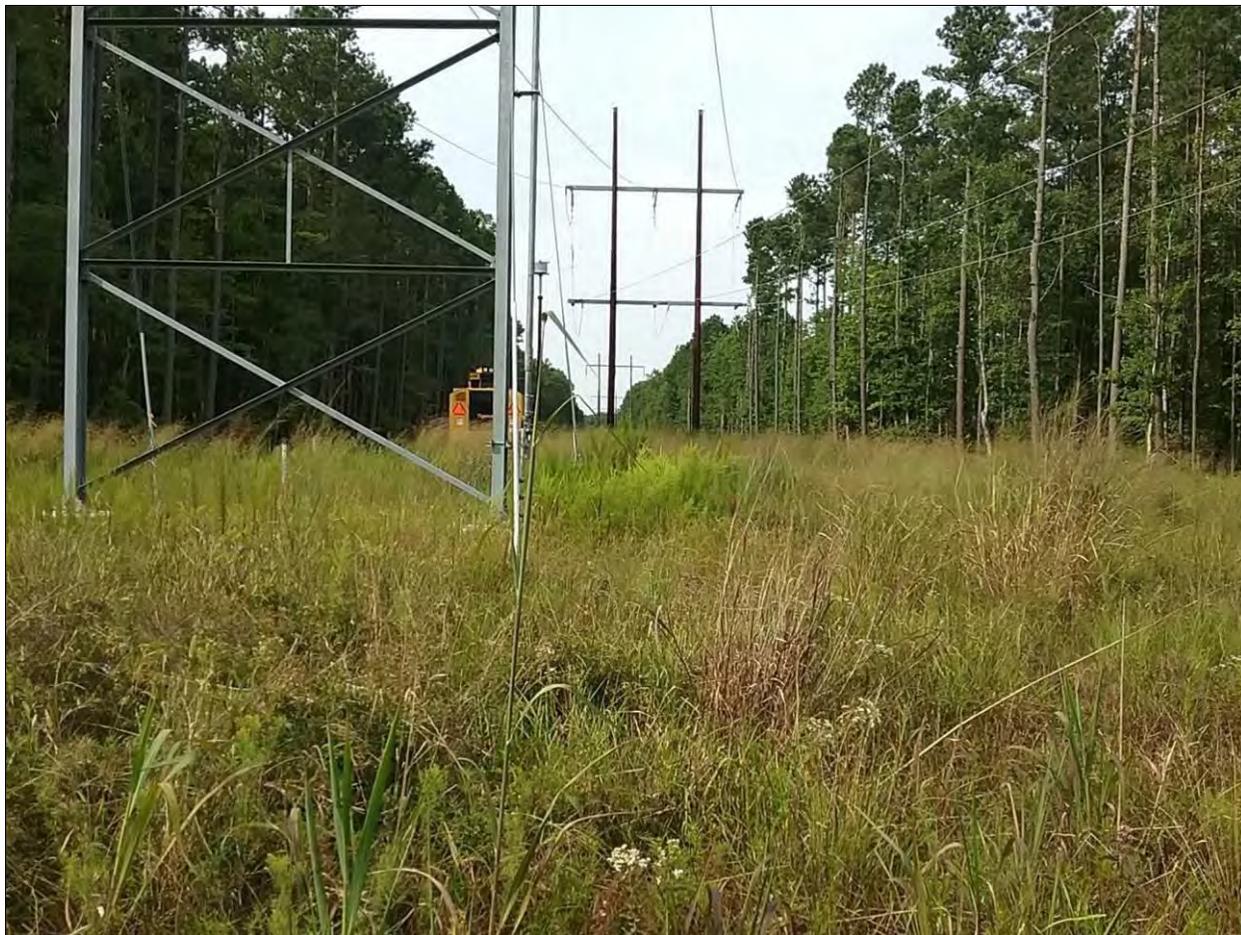
Figure 8-13: View of 34/179 and Ta1 setting and vegetation looking south.

Structure 34/179 and temporary structure Ta1 are located in Newport News Park at the intersection of the Fort Eustis Tap and TL-34. The terrain in the area of the structure is slightly elevated fill with wetland vegetation and wetland soils surrounding the structure. Additional transmission structures are located in the immediate vicinity of the proposed replacement structure. Ta1 is located just south of Structure 34/179 and is immediately adjacent to existing transmission line infrastructure. Due to the location of existing transmission line infrastructure and wetland vegetation, only a single shovel test was excavated in this location, which was negative for cultural material (Figures 8-12 and 8-13). No evidence of subsurface or surface features was observed during survey in this location.

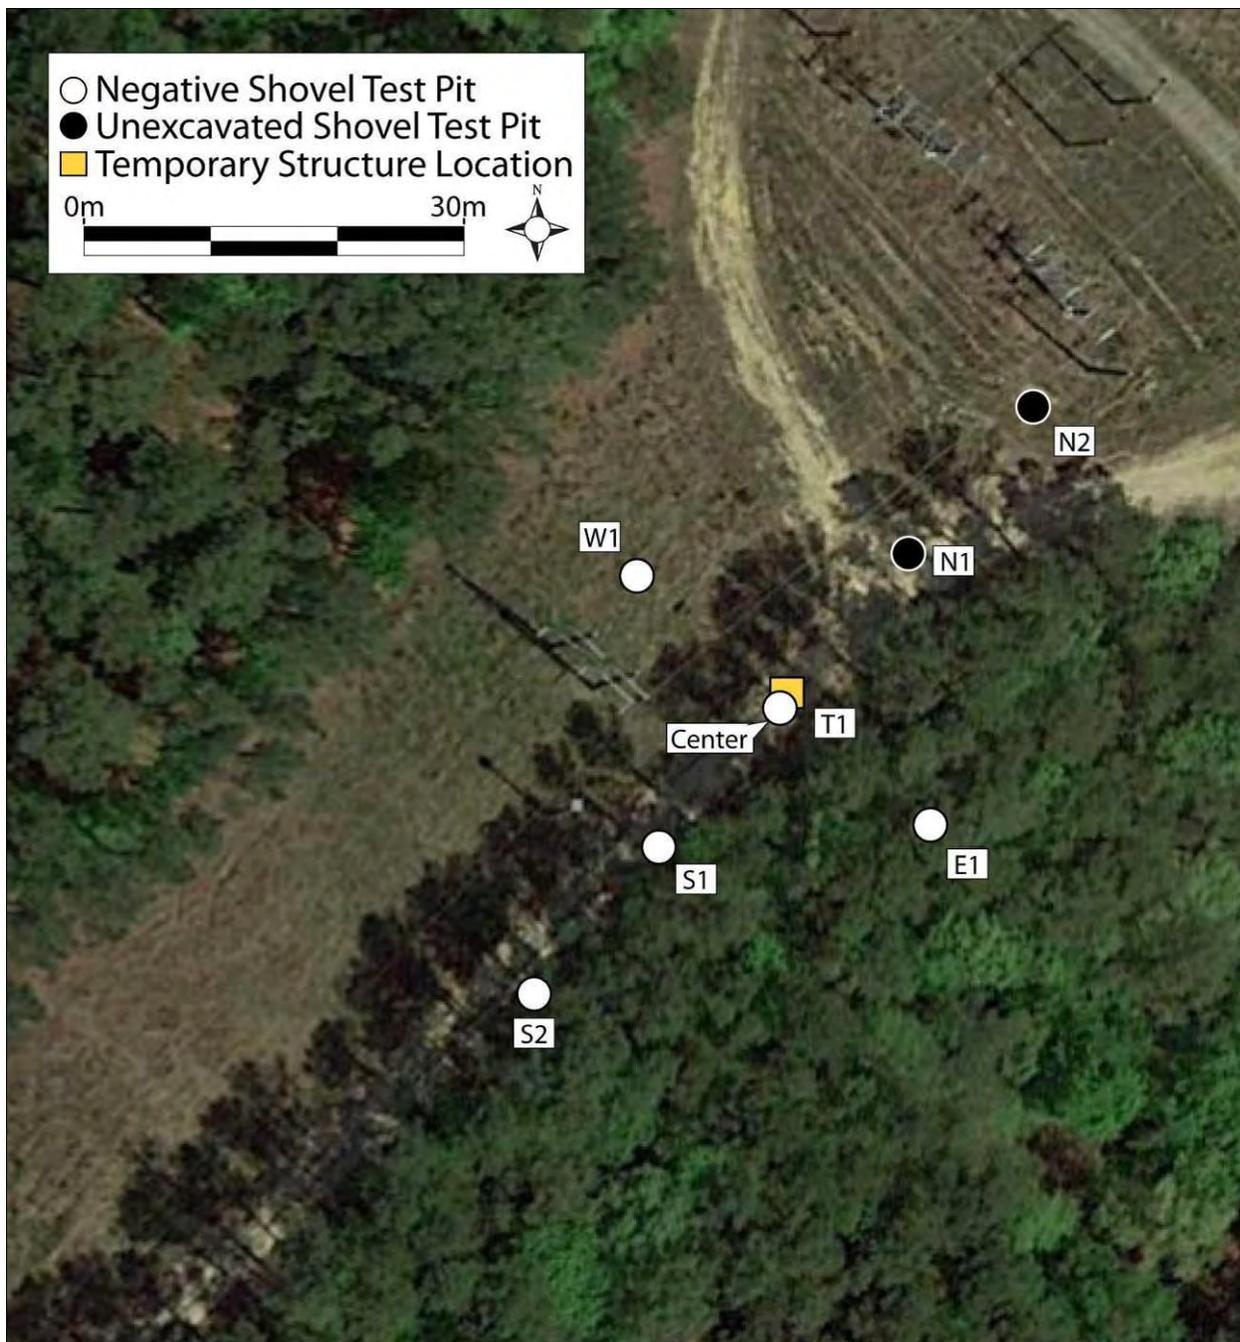
Figure 8-15: Aerial view of Structure T1.

Temporary Structure T1 is located in Newport News Park along the southeastern edge of the ROW adjacent to wetlands and pine forest in the pathway of the gravel access road. Vegetation consisted of grasses and wetland vegetation. The terrain was level, and four (4) of the six (6) shovel tests were excavated around this temporary structure location (Figures 8-15 and 8-16). All four (4) excavated shovel tests were negative for cultural material. No evidence of subsurface or surface cultural features was observed.

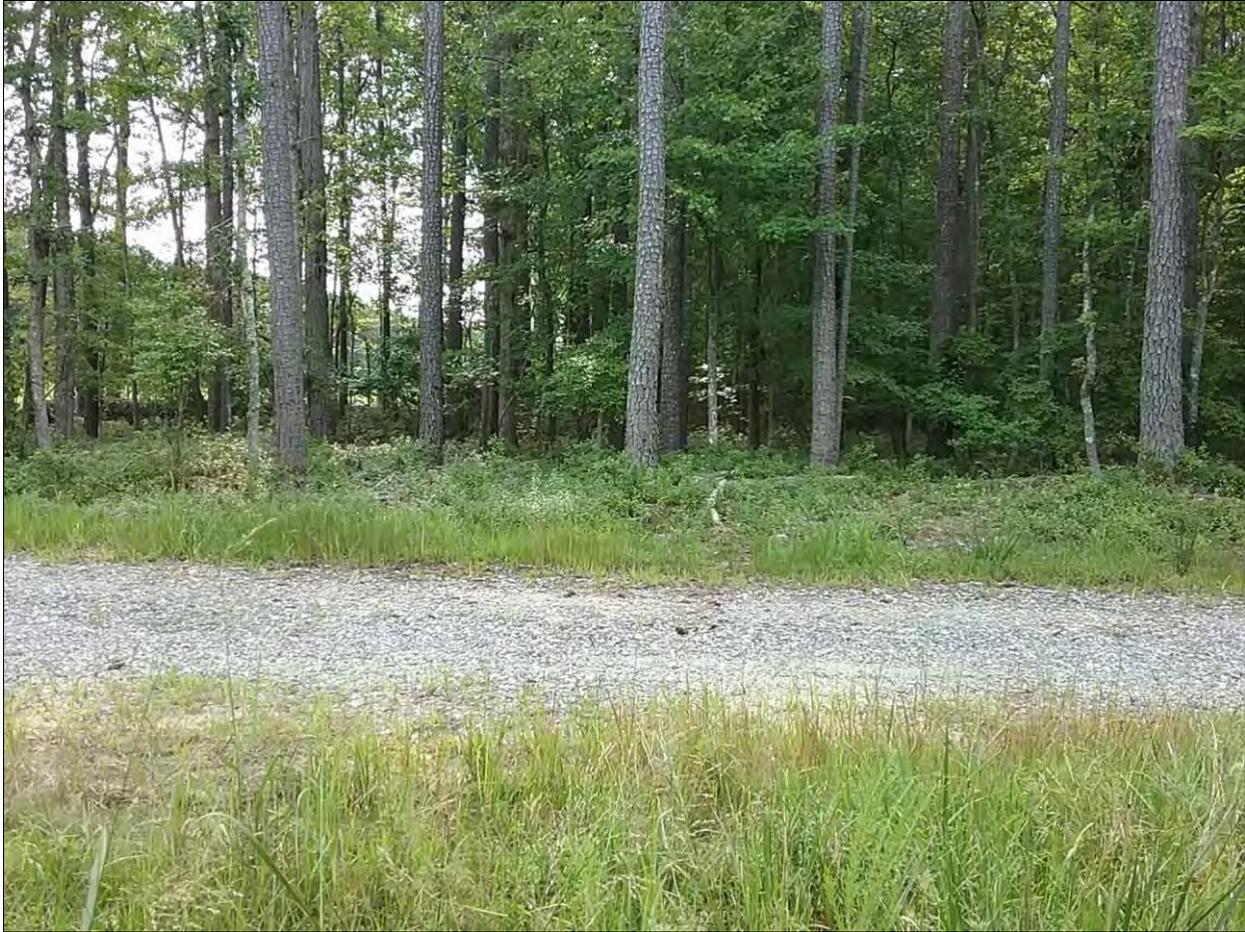
Figure 8-16: Looking east towards Temporary Structure T1

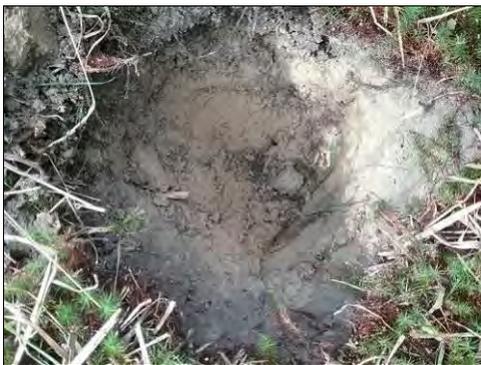
Soils consisted of about 15 cm of 10YR 4/6 dark yellow brown silty loam over 10YR 6/4 light yellow brown sandy clay subsoil (Figure 8-17).

10YR 4/6 silty loam
0-15 cm

10YR 6/4 sandy clay subsoil
15-27 cm

Figure 8-17: Soil profile of shovel test W1 at T1.

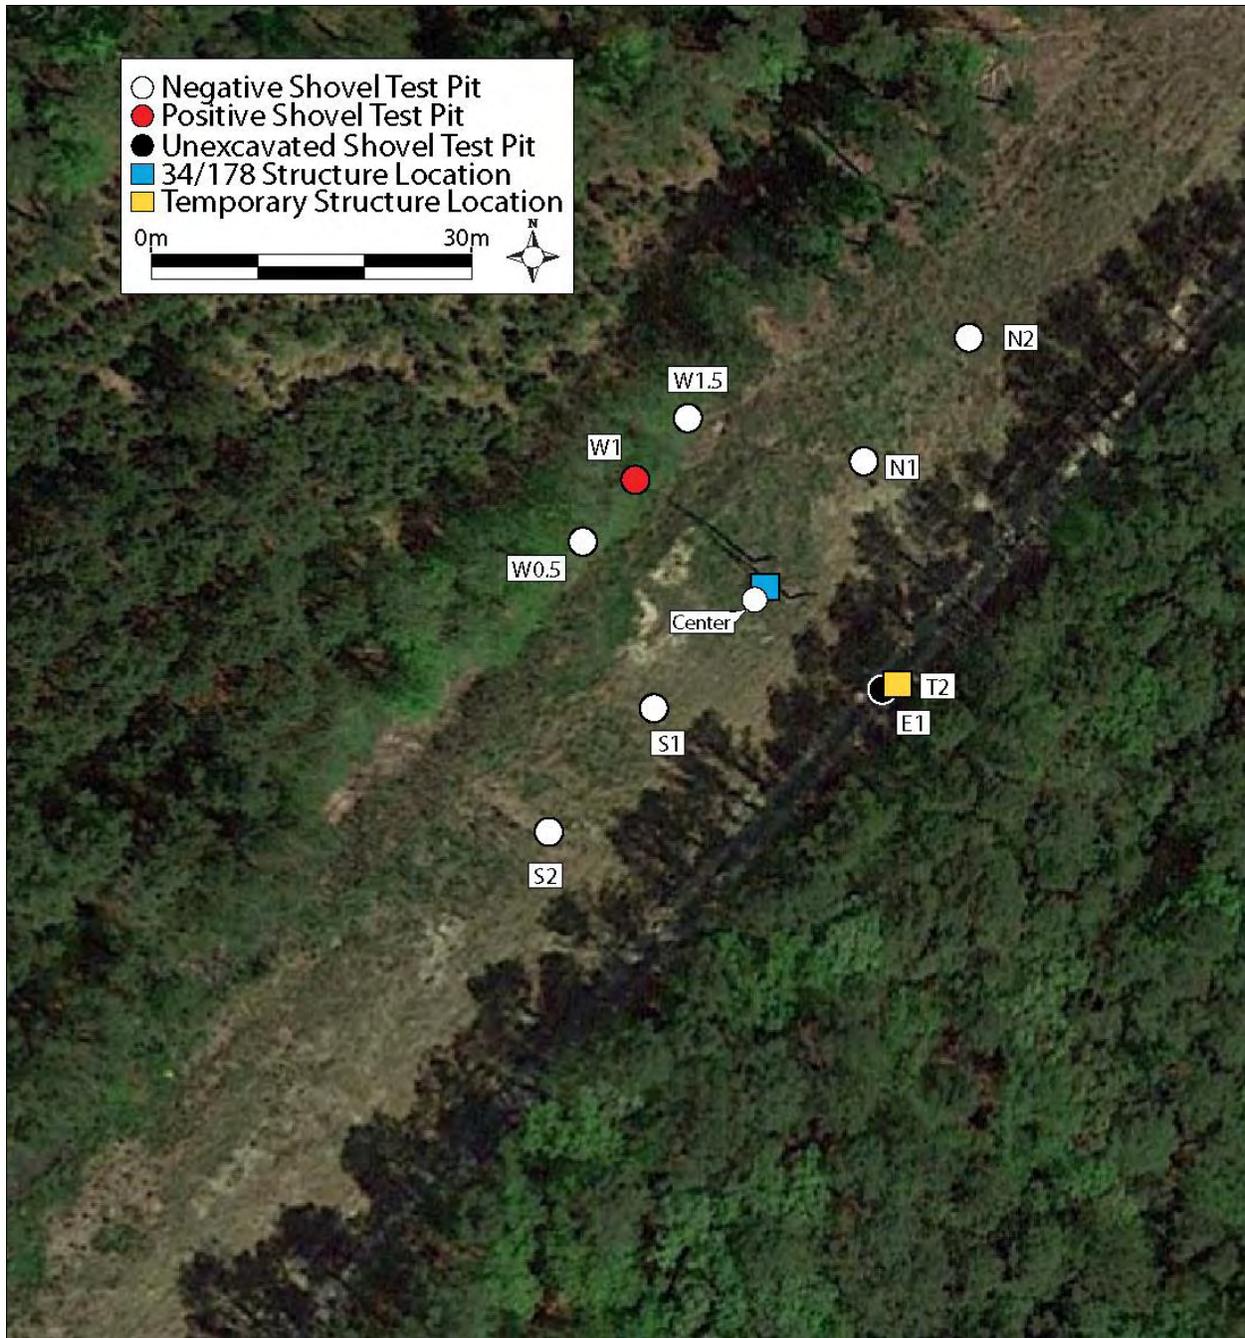
Figure 8-18: Aerial view of shovel tests at Structures 34/178 and T2.

Structures 34/178 and T2 are located in Newport News Park within the existing ROW. The area is covered with wild grasses and the existing graveled access road runs along the eastern edge of the ROW. A ditch runs along the western edge of the ROW. Six (6) shovel tests were excavated around these structure locations and one (1) shovel test was not excavated due to observed disturbance (Figures 8-18 and 8-19). One (1) shovel test, W1 was positive for cultural material, which consisted of a partially burned brick fragment and a single shard of colorless vessel glass. Due to the limited amount of material recovered and negative radial shovel tests, the find is classified as an isolated find (IF-1) with limited to no data potential. No evidence of subsurface or surface cultural features was observed.

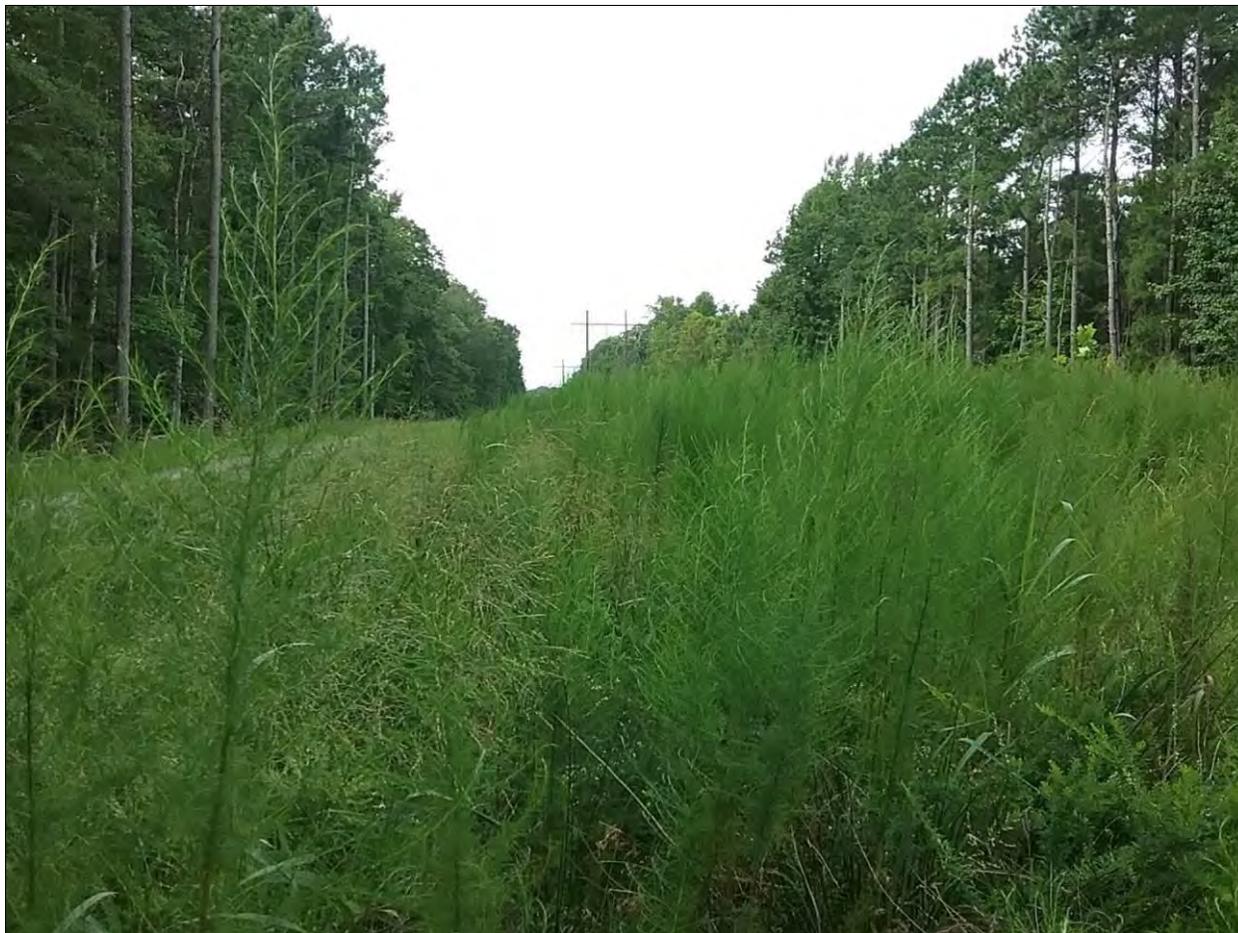
Figure 8-19: Terrain and vegetation around Structures 34/178 and T2, facing south.

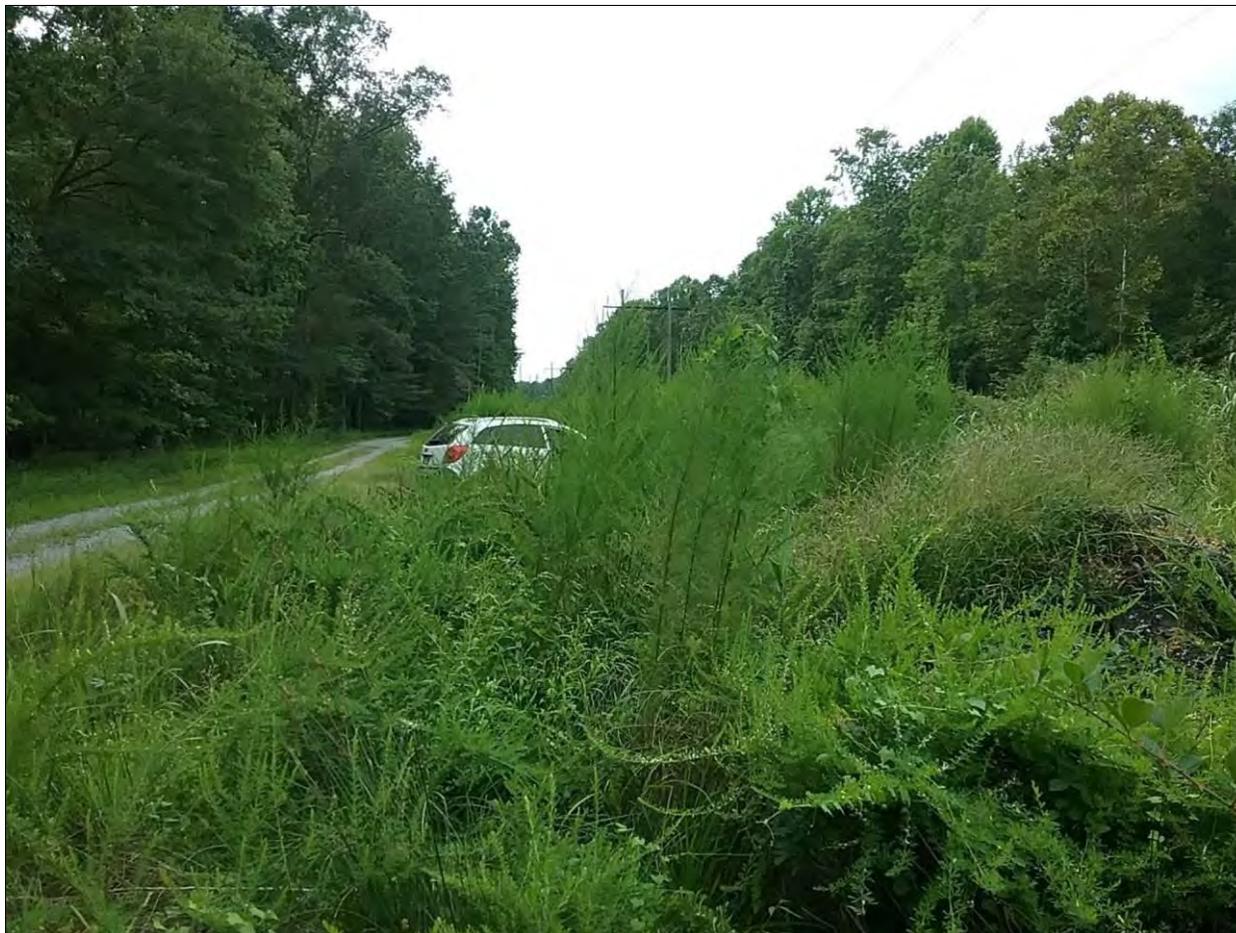
Figure 8-22: Terrain and vegetation around Structures 34/177 and T3, facing south.

Structures 34/177 and T3 are located in Newport News Park within the existing ROW. The area is covered with wild grasses and briars and a gravel pad with spoil piles containing asphalt are present. Three (3) shovel tests were excavated around these structure locations none of which were positive for cultural material. All other shovel tests in this location were not excavated due to observed soil disturbances (Figures 8-21 and 8-22). No evidence of subsurface or surface cultural features was observed.

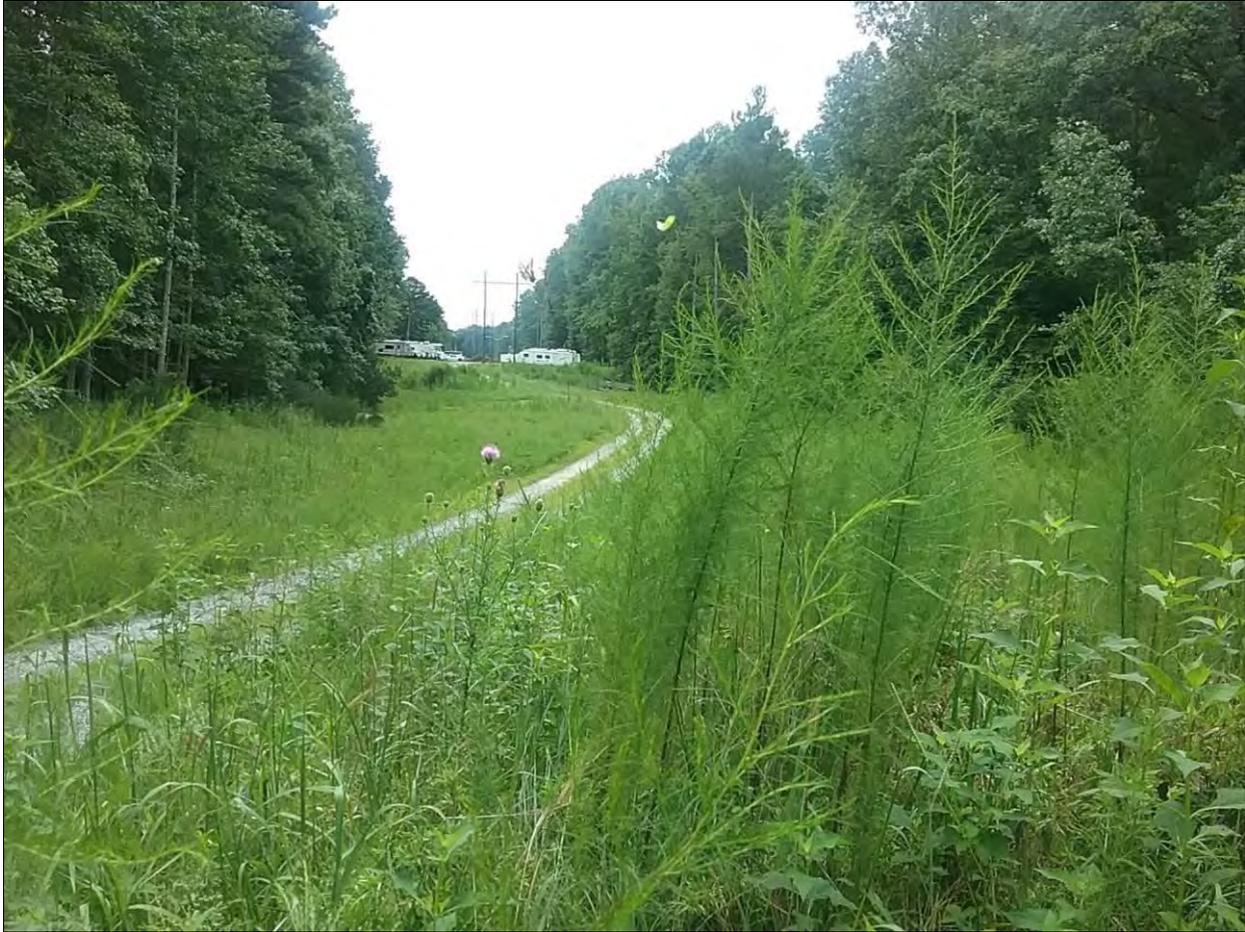
Figure 8-25: Terrain and vegetation around Structures 34/176 and T4, facing south.

Structures 34/176 and T4 are located in Newport News Park within the existing ROW south of the Newport News Park Bikeway, which crosses the ROW. The area is covered with wild grasses and the existing structure is located in the edge of a slight bowl-shaped area, which leads down southward to a small drainage that runs between the next structure to the south. A drainage ditch runs along the western edge of the ROW. Five (5) shovel tests were excavated around these structure locations none of which were positive for cultural material. Two (2) shovel tests were not excavated due to slope (Figures 8-24 and 8-25). No evidence of subsurface or surface cultural features was observed.

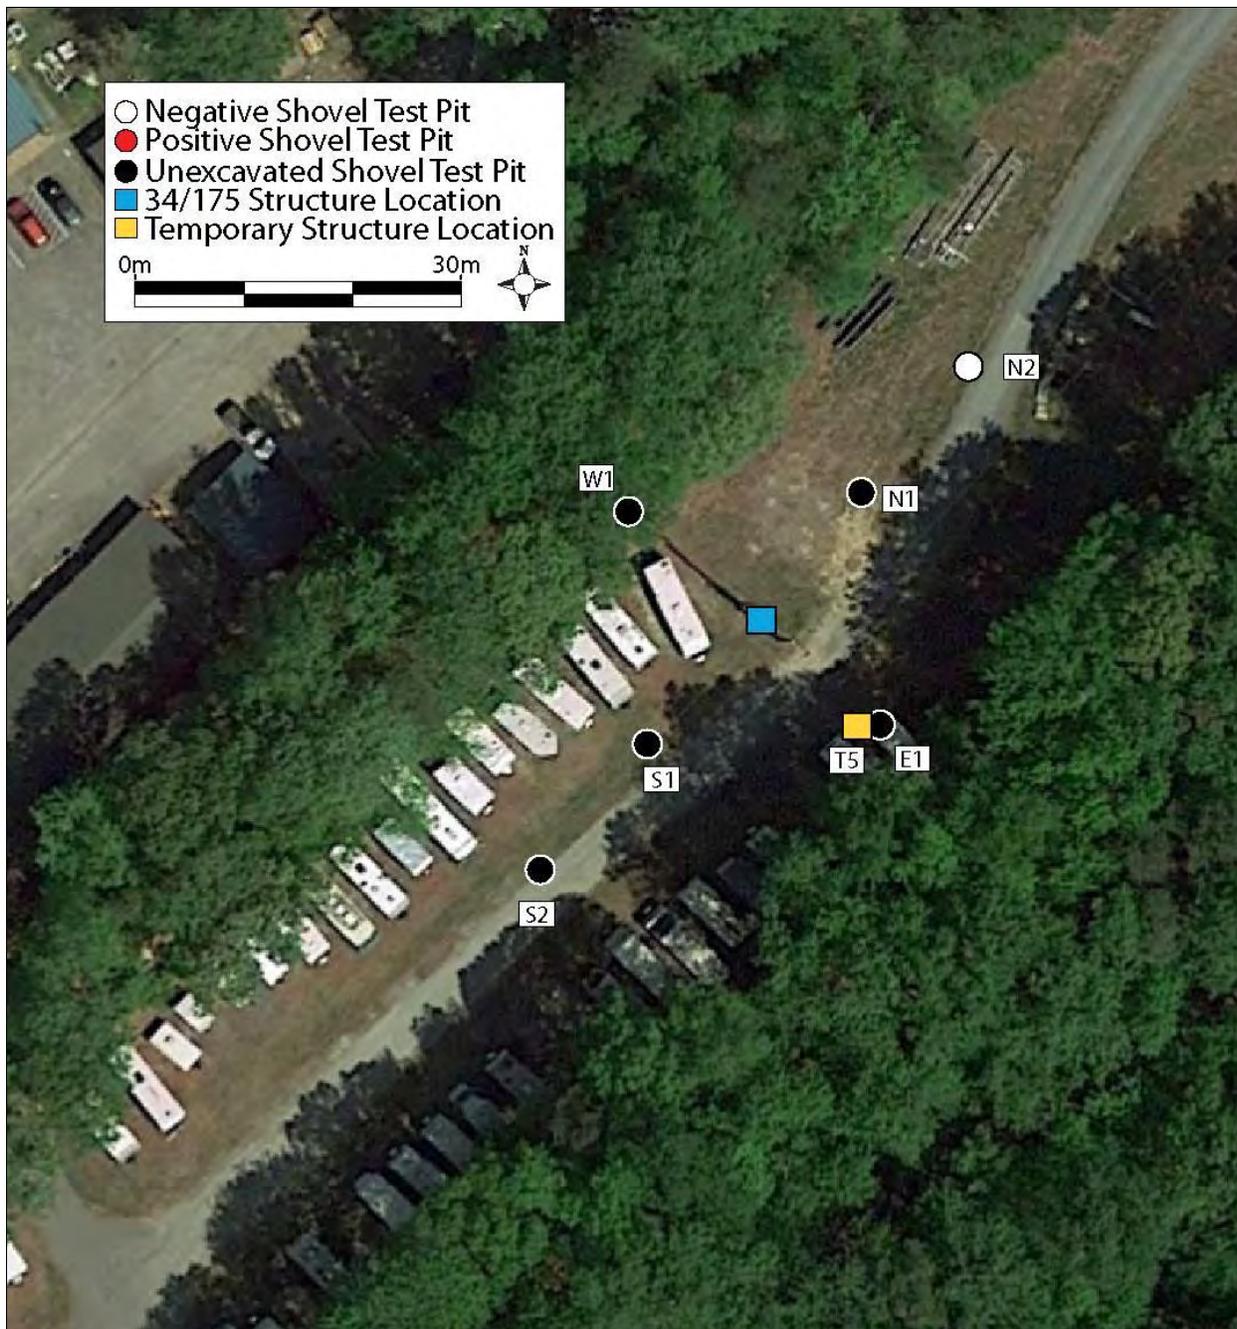
Figure 8-27: Aerial view of shovel tests at Structures 34/175 and T5.

Structures 34/175 and 34/174 and Temporary Structures T5 and T6 are located in Newport News Park within the existing ROW at either end of an area that has been repurposed by the park for temporary parking and storage of recreational campers. The area is covered with mown grasses that are mixed with gravels. One shovel test was excavated at Structure 34/175 and was negative for cultural material. No additional shovel tests were excavated around these two sets of structures due to observed ground disturbances and existing uses (Figures 8-27 through 8-30). No evidence of subsurface or surface cultural features was observed.

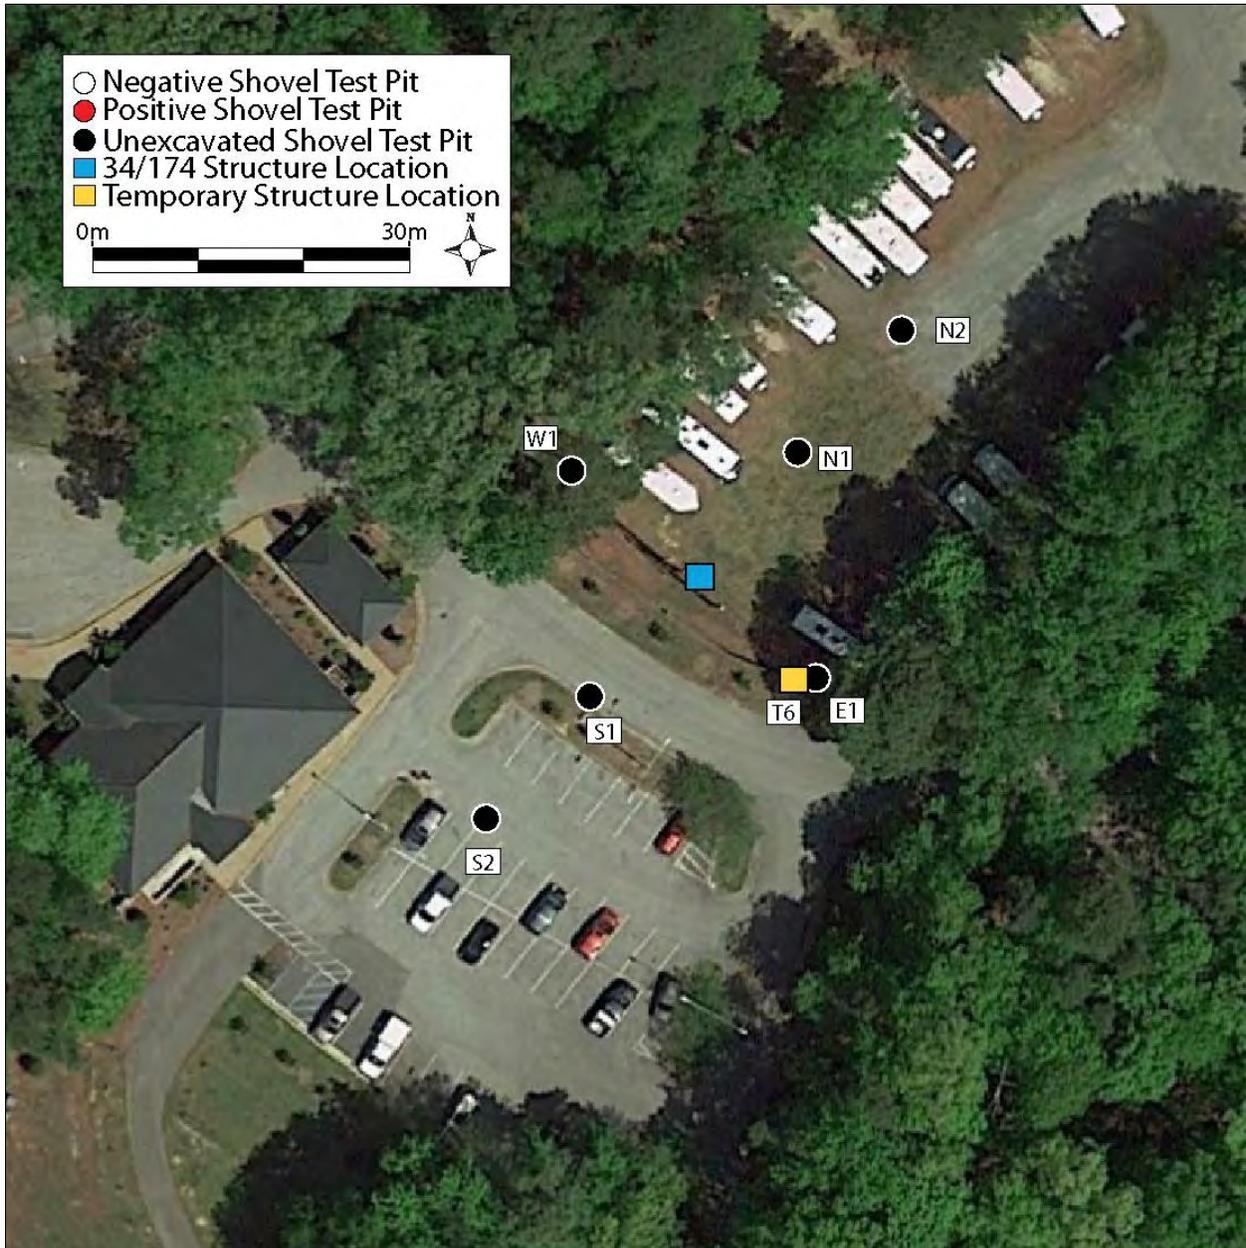
Figure 8-28: Aerial view of shovel tests at Structures 34/174 and T6.

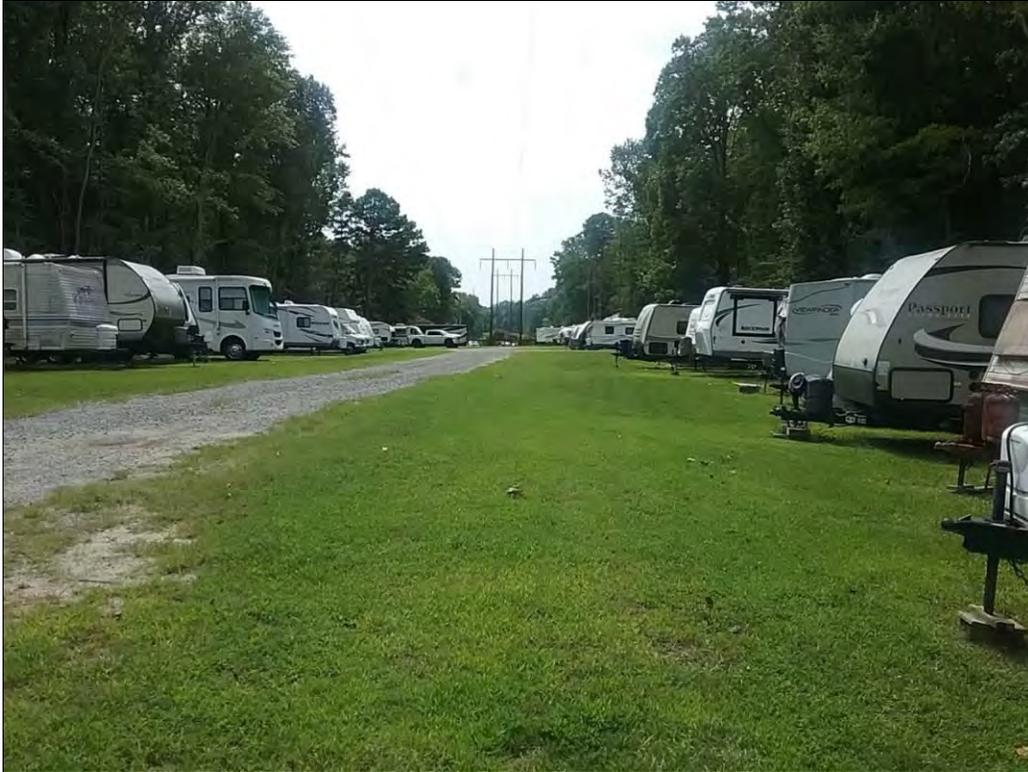
Figure 8-29: Terrain and existing conditions from Structures 34/175 and T5, facing south.

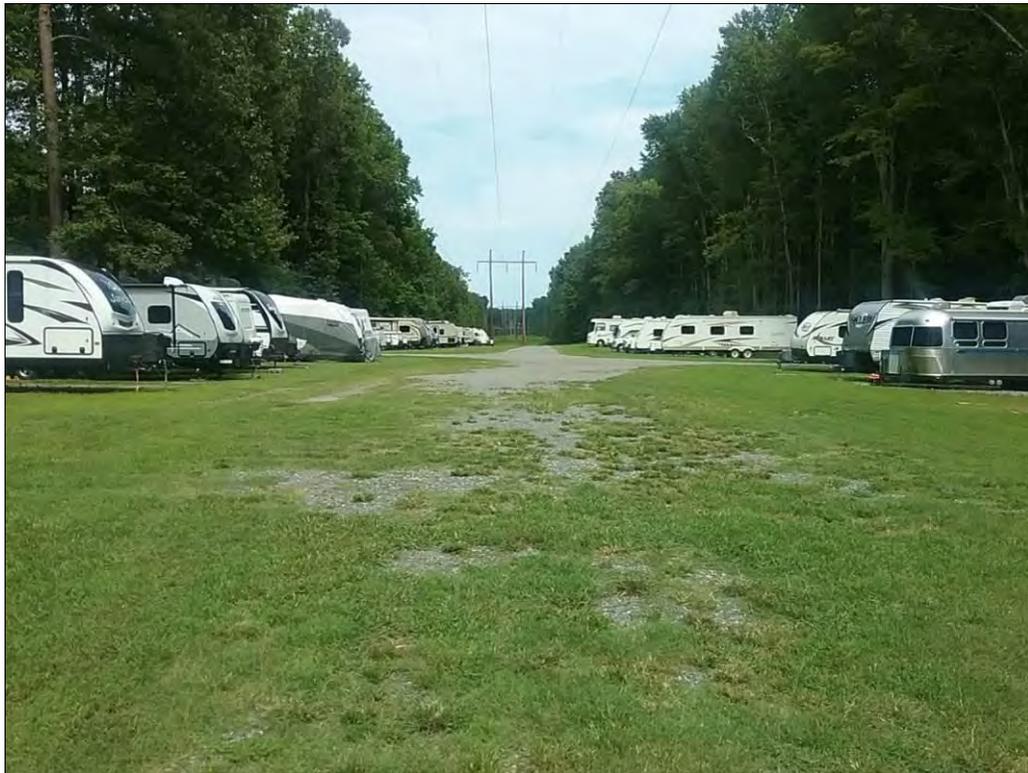
Figure 8-30: Terrain and existing conditions from Structures 34/174 and T6, facing north.

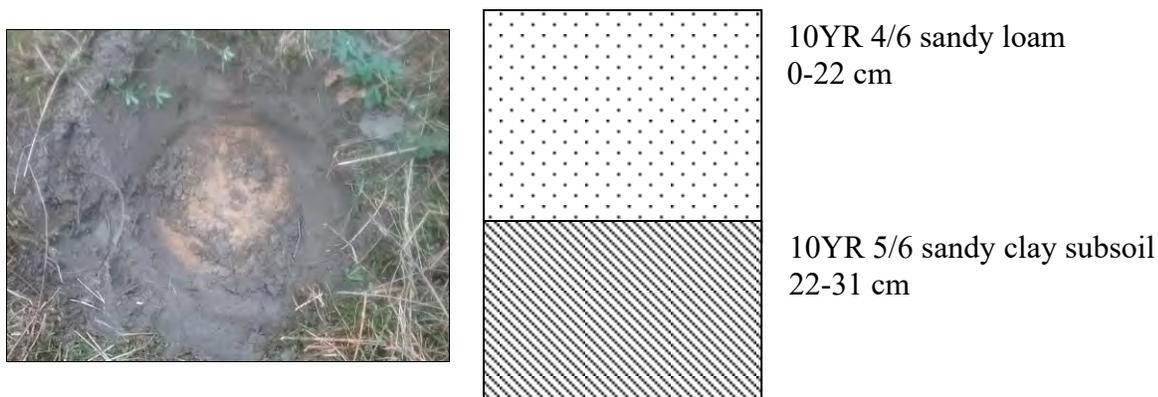
Figure 8-31: Soil profile for shovel test N1 at Structures 34/175 and T5.

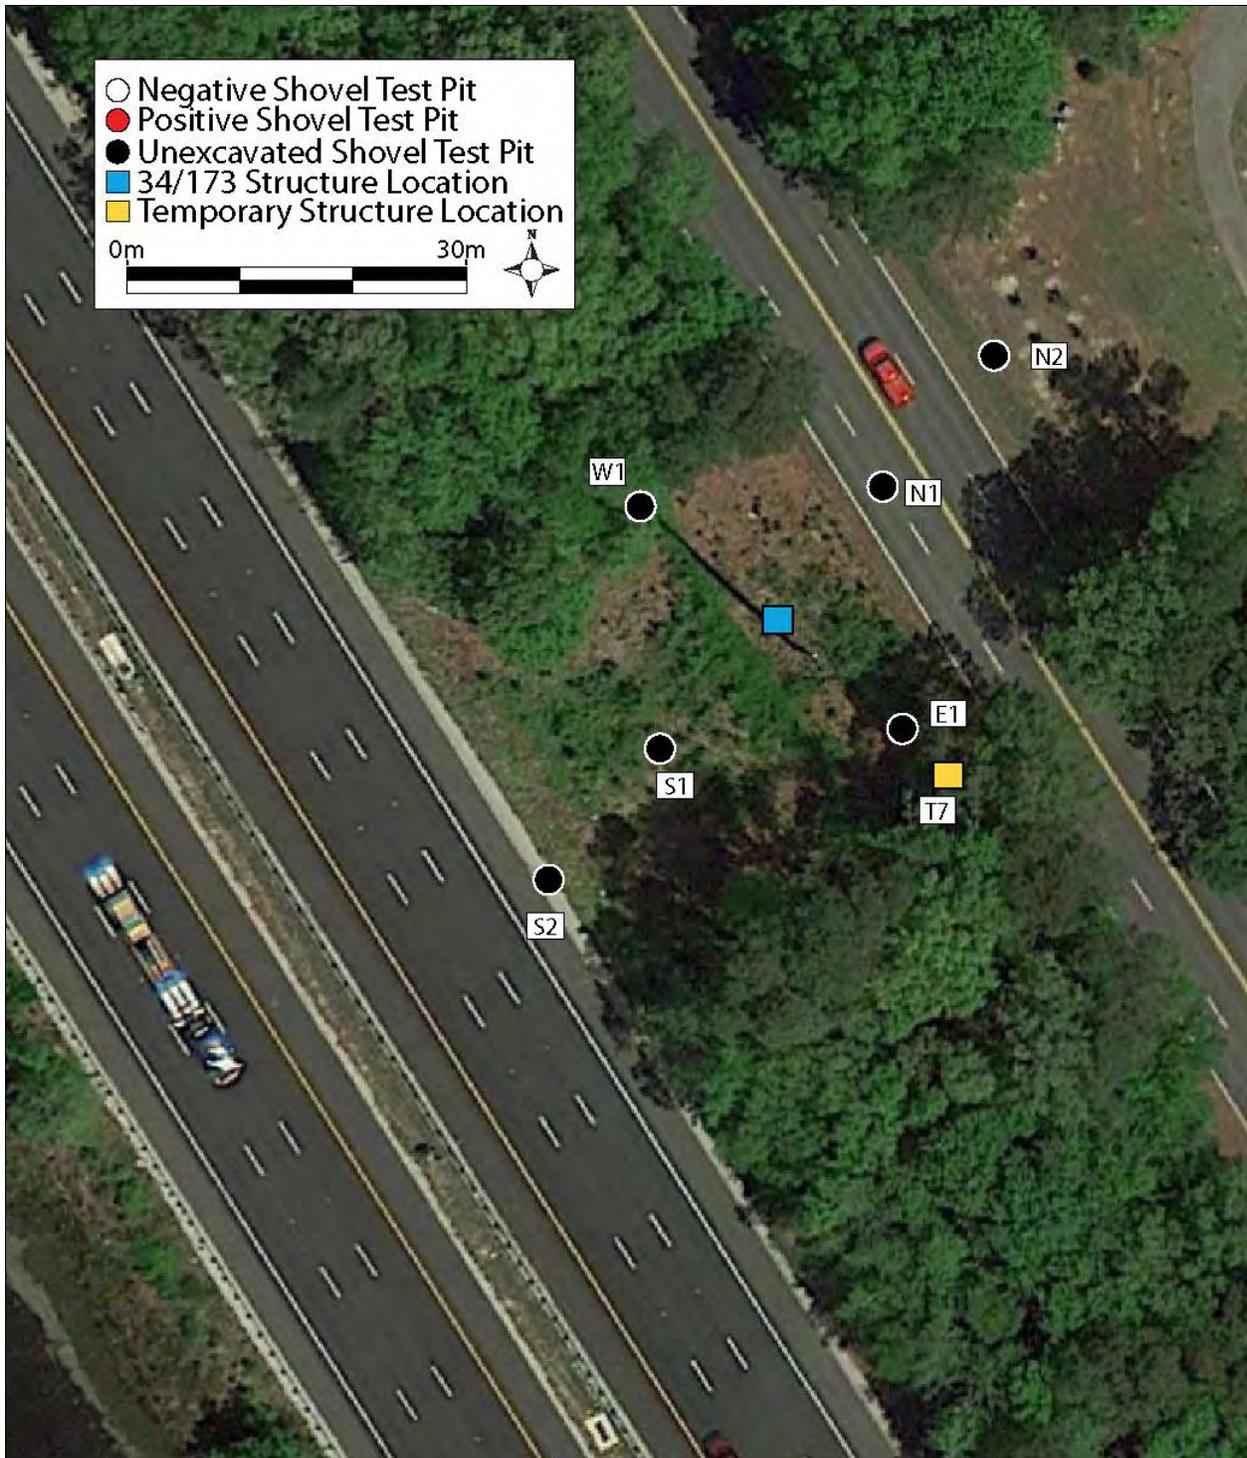
Figure 8-32: Aerial view of shovel tests at Structures 34/173 and T7.

Structures 34/173 and T7 are located within the existing ROW in the median between Jefferson Avenue (Rt. 143) and Interstate 64. The area is covered with wild grasses and brambles and was previously surveyed at the Phase I level for cultural resources in 2012 as part of the Virginia Department of Transportation's Interstate 64 widening and improvement project. As such, no additional shovel testing was conducted in this area (Figures 8-32 and 8-33). No evidence of subsurface or surface cultural features was observed.

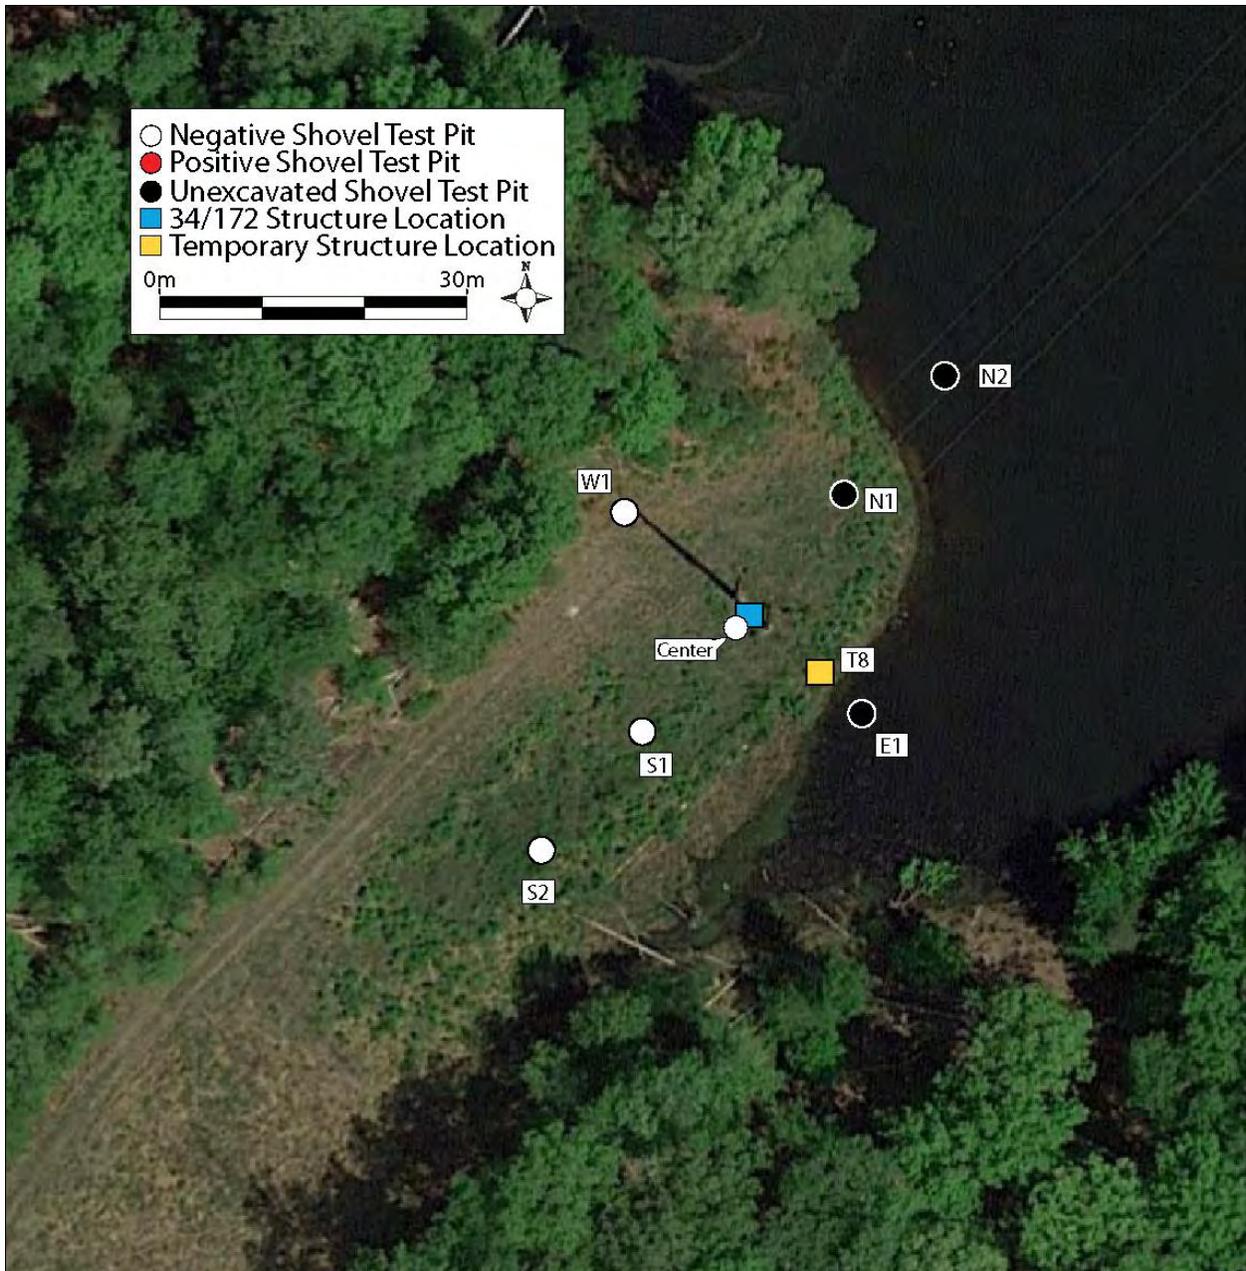
Figure 8-34: Aerial view of shovel tests at Structures 34/172 and T8.

Structures 34/172 and T8 are located in the existing ROW on fill soils just north of and adjacent to City Reservoir. Vegetation in the area consists of a mix of mowed grasses with gravel and tall grasses with saplings located immediately under the ROW. Four (4) shovel tests were excavated around these structure locations none of which were positive for cultural material. Three (3) shovel tests were not excavated due to wetlands (Figure 8-34 and 8-35). No evidence of subsurface or surface cultural features was observed.

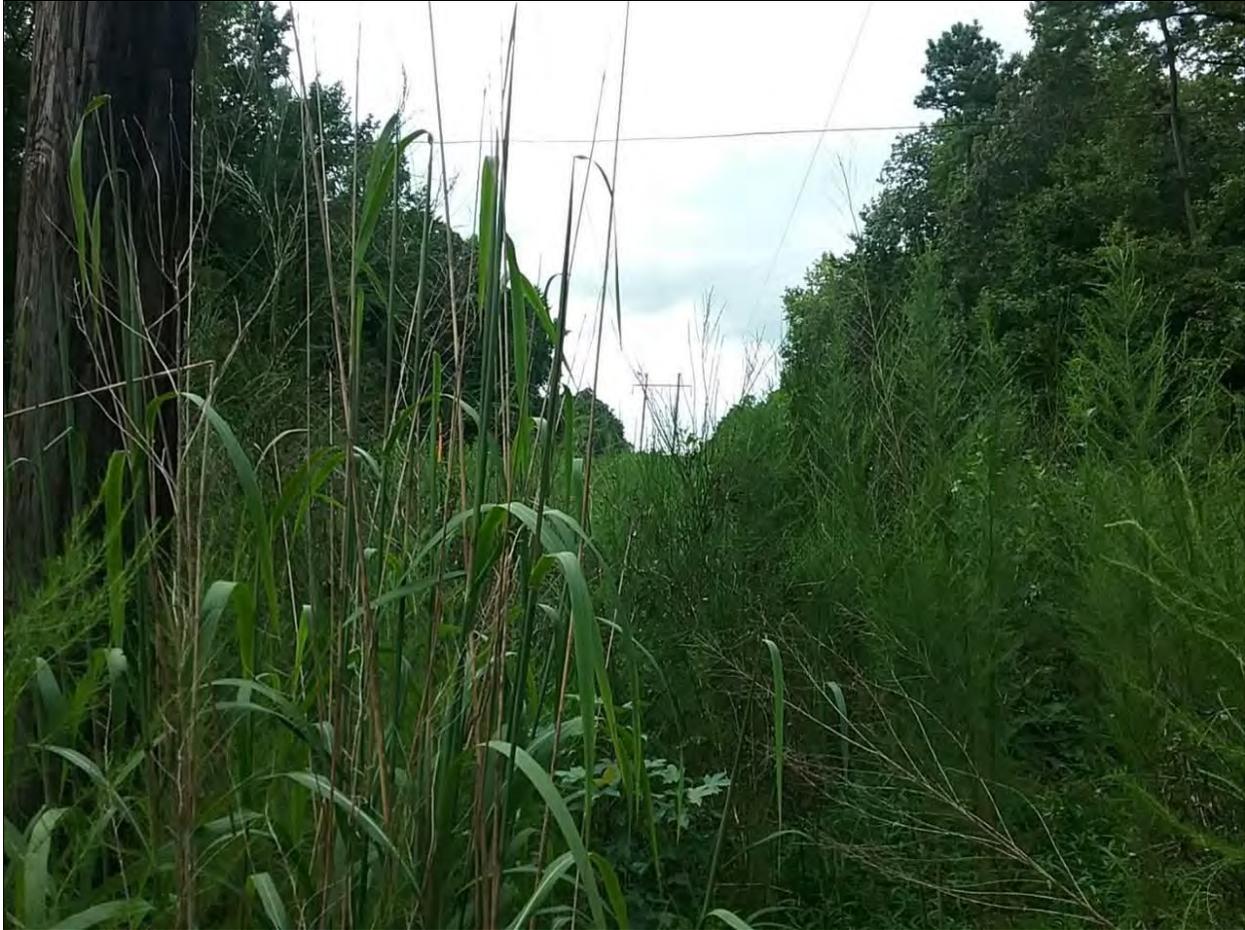
Figure 8-39: Terrain and vegetation around Structures 34/171 and T9, facing south.

Structures 34/171 and T9 are located in the existing ROW at a slight angle in the line. The terrain is slightly sloped with a wetland located to the east and vegetation in the area consists of tall grasses. Five (5) shovel tests were excavated around these structure locations one of which was positive for cultural material; four (4) brick fragments and one (1) sherd of refined undecorated whiteware. Given the small amount of material recovered and their limited information potential, the positive shovel tests were not classified as an archaeological site and recorded as an archaeological location (L-1), which is likely the result of casual loss or discard. Three (3) shovel tests were not excavated due to wetlands (Figures 8-38 and 8-39). No evidence of subsurface or surface cultural features was observed.

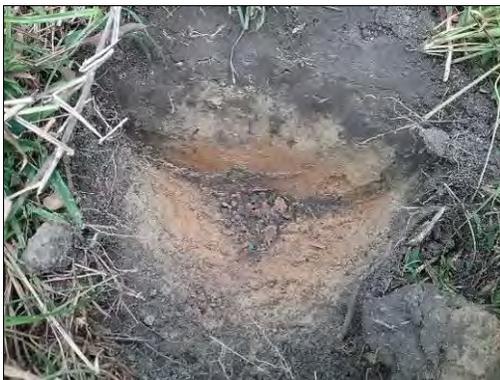
Soils around Structures 34/171 and T9 consisted of about 13 cm of 10YR 4/3 brown silty loam over 17 cm 10YR 5/4 yellow brown sandy loam over 7.5YR 5/8 strong brown sandy clay subsoil (Figure 8-40).

10YR 4/3 silty loam
0-17 cm

10YR 5/4 sandy loam
13-17 cm

Figure 8-40: Soil profile for shovel test N1 at Structures 34/171 and T9.

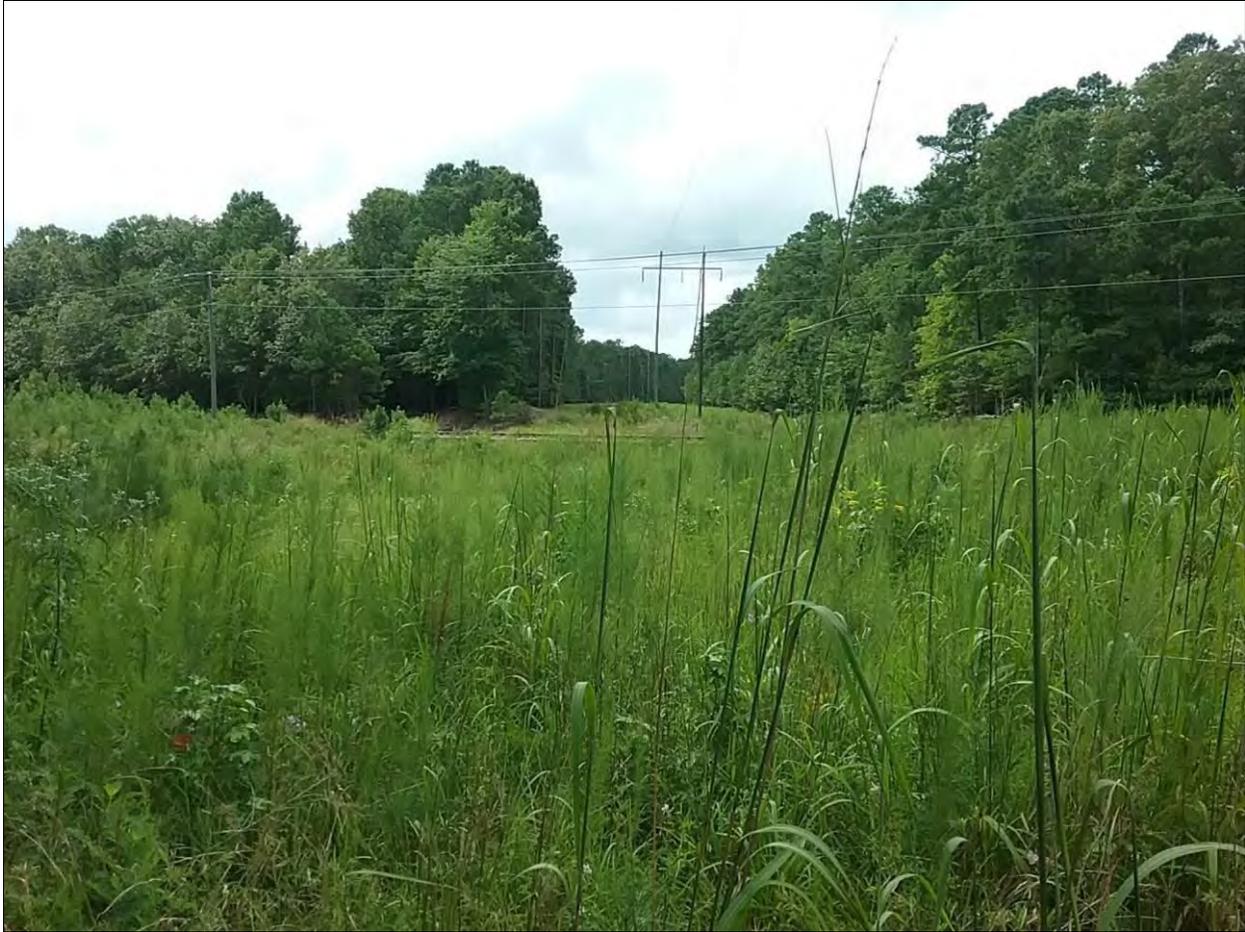
Figure 8-42: Terrain and vegetation around Structures 34/170 and T10, facing south.

Structures 34/170 and T10 are located in the existing ROW just north of the existing rail line. A gravel access road, drainage ditch, and existing transmission line, which parallel the rail line cross the ROW. The terrain is generally flat and vegetation in the area consists of tall grasses. Seven (7) shovel tests were excavated around these structure locations none of which were positive for cultural material. Three (3) shovel tests were not excavated due to observed disturbances associated with the road and drainage ditch (Figures 8-41 and 8-42). No evidence of subsurface or surface cultural features was observed.

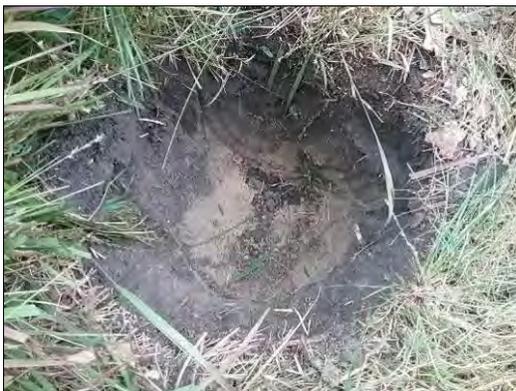
Soils around Structures 34/170 and T10 consisted of about 20 cm of 10YR 3/2 very dark gray brown sandy loam over 10YR 5/6 very brown clay loam subsoil (Figure 8-43).

10YR 3/2 sandy loam
0-20 cm

10YR 5/6 clay loam subsoil
20-34 cm

Figure 8-43: Soil profile for shovel test N2 at Structures 34/170 and T10.
