Phase I Cultural Resource Survey of the Fort Eustis Tap/Line 34 Rebuild Project

LOCATION > City of Newport News, Virginia

DATE > October 2020

PREPARED BY >
Dutton + Associates, LLC

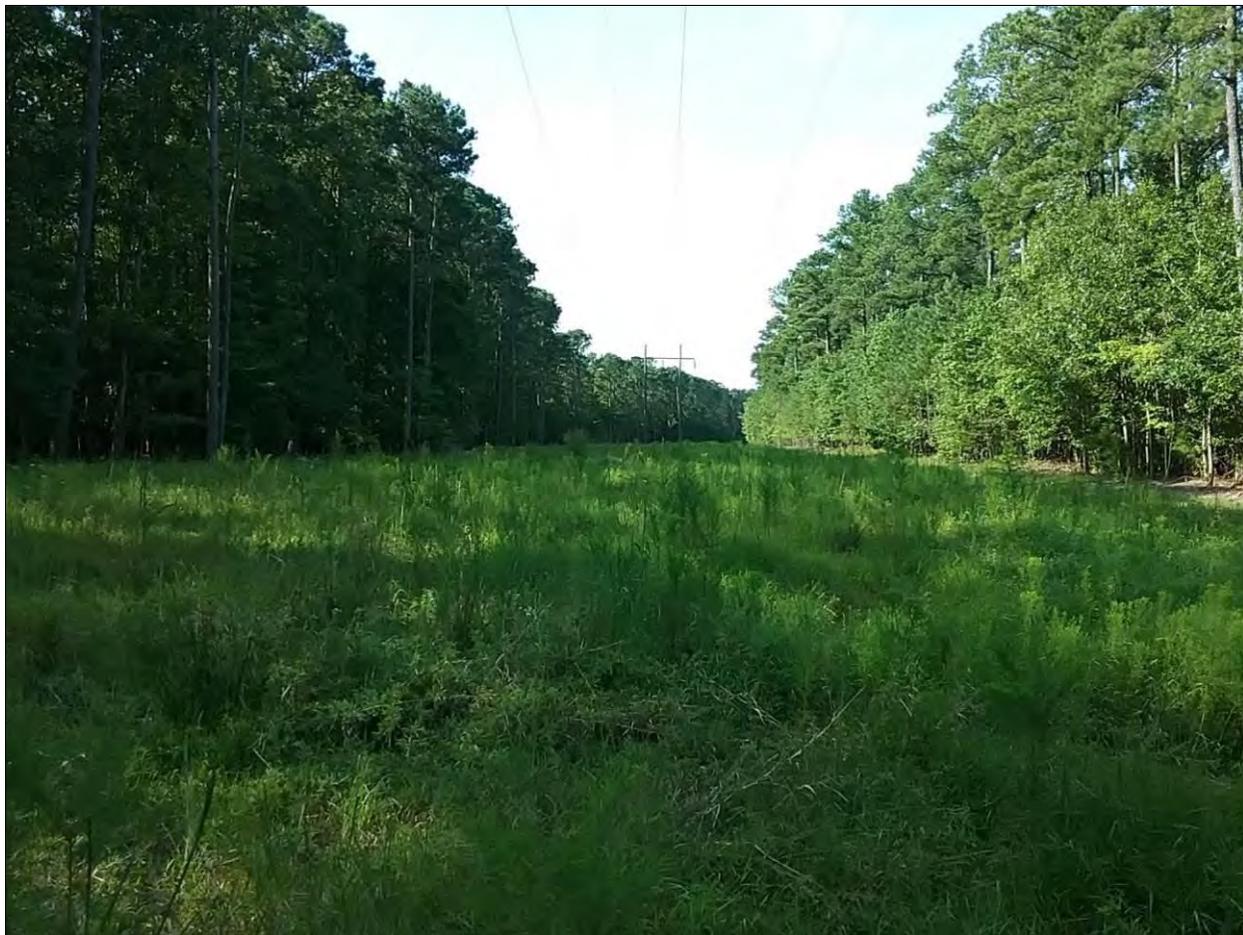
Figure 8-45: Terrain and vegetation around Structures 34/169 and T11, facing south.

Structures 34/169 and T11 are located in the existing ROW, which runs west of and parallel to a spur of the rail line, which runs southwest to Joint Base Langley-Eustis. The terrain is generally flat and vegetation in the area consists of tall grasses with areas of seasonally wet soils visible. Nine (9) shovel tests were excavated around these structure locations none of which were positive for cultural material (Figures 8-44 and 8-45). No evidence of subsurface or surface cultural features was observed.

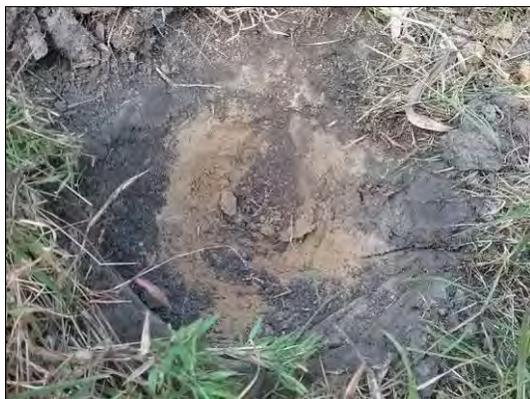
Soils around Structures 34/169 and T11 consisted of about 16 cm of 10YR 3/2 dark brown sandy loam over 5YR 5/8 yellow red sandy clay subsoil mottled with 7.5YR 6/2 pale gray sandy clay (Figure 8-46).

10YR 3/2 sandy loam
0-16 cm

5YR 5/8 sandy clay mottled
w/ 7.5YR 6/2 sandy clay
16-26 cm

Figure 8-46: Soil profile for shovel test S2 at Structures 34/169 and T11.

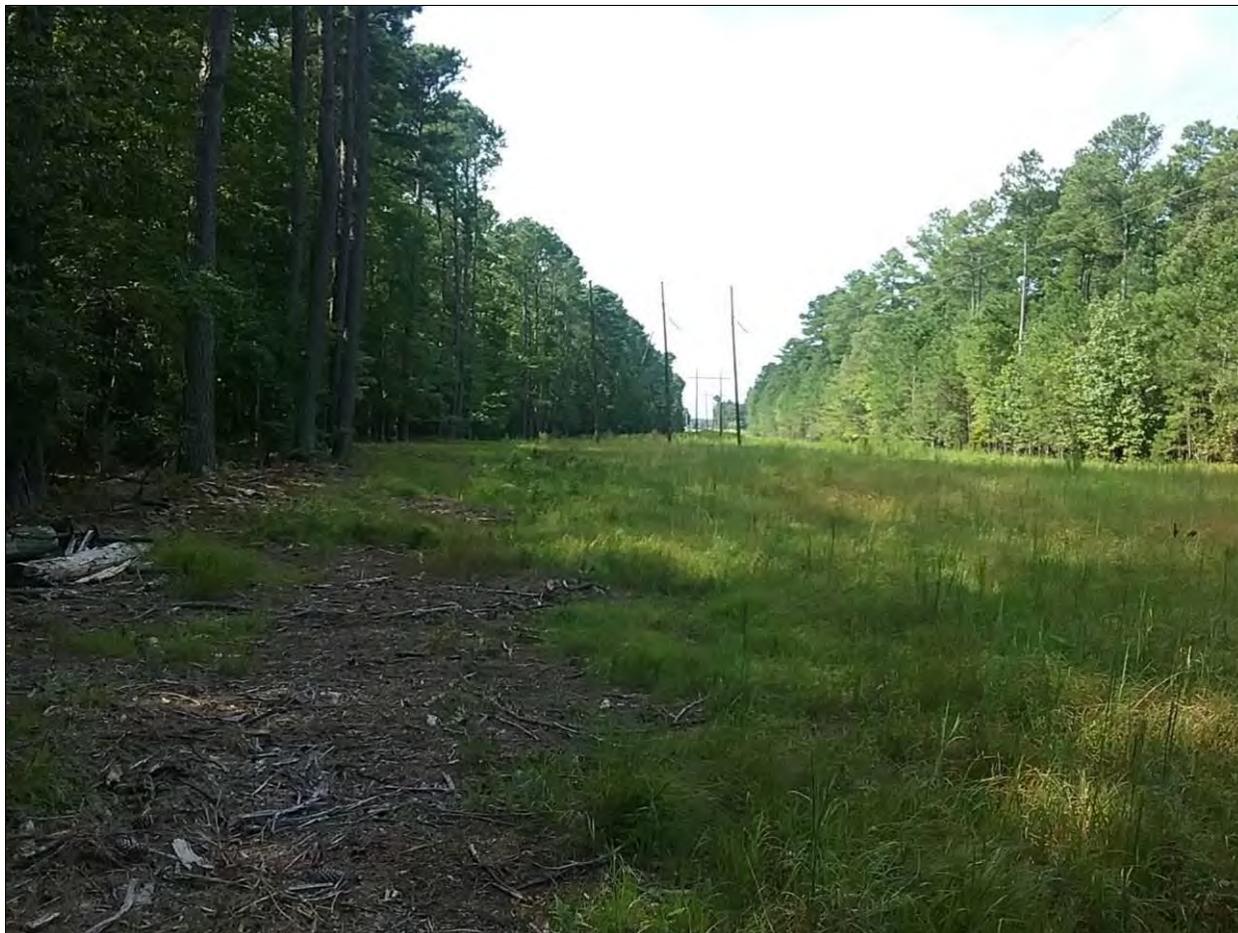
Figure 8-48: Terrain and vegetation around Temporary Structure T12, facing south.

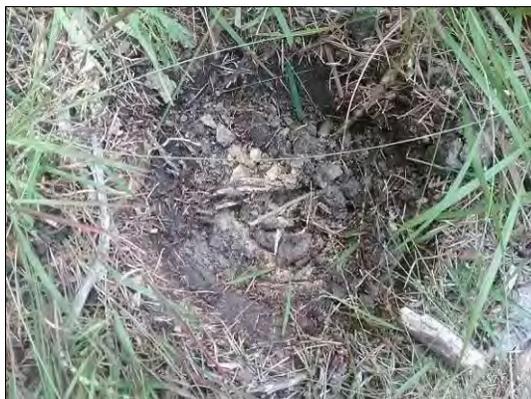
Soils around Temporary Structure T12 consisted of about 11 cm of 10YR 3/2 dark brown sandy loam over 5YR 5/8 yellow red sandy clay subsoil mottled with 7.5YR 6/2 pale gray sandy clay (Figure 8-49).

10YR 3/2 sandy loam
0-11 cm

5YR 5/8 sandy clay mottled
w/ 7.5YR 6/2 sandy clay
11-17 cm

Figure 8-49: Soil profile for shovel test C at Temporary Structure T12.

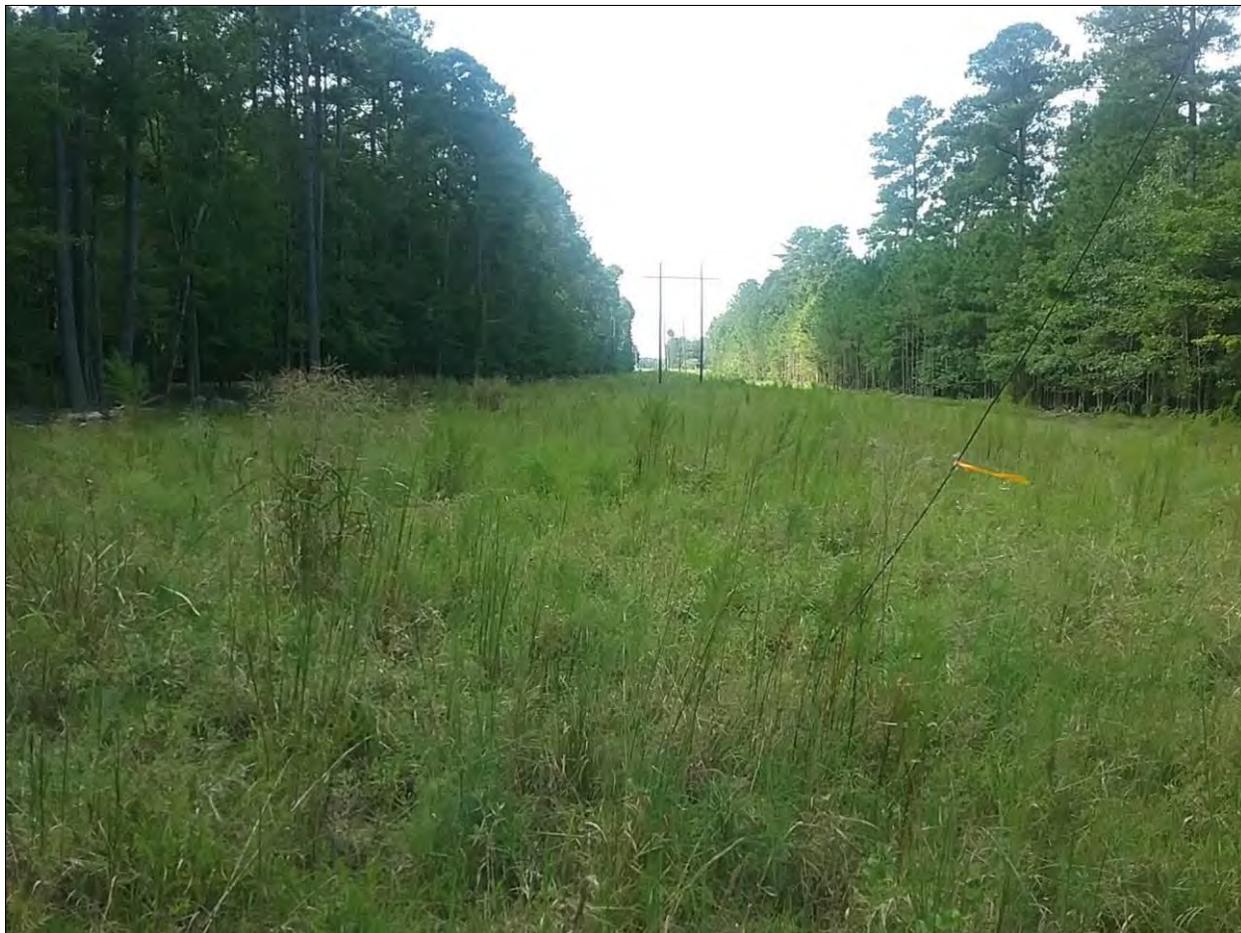
Figure 8-51: Terrain and vegetation around Structures 34/168 and T13, facing south.

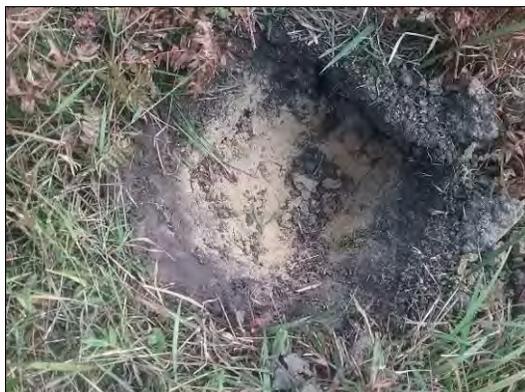
Soils around Structures 34/168 and T13 consisted of about 13 cm of 10YR 3/2 dark brown sandy loam over 5YR 5/8 yellow red sandy clay subsoil mottled with 7.5YR 6/2 pale gray sandy clay (Figure 8-52).

10YR 3/2 sandy loam
0-13 cm

5YR 5/8 sandy clay mottled
w/ 7.5YR 6/2 sandy clay
13-28 cm

Figure 8-52: Soil profile for shovel test N2 at Structures 34/168 and T13.

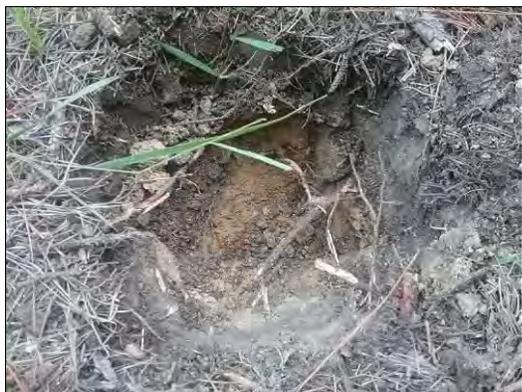
Soils around Temporary Structure T14 consisted of about 22 cm of 10YR 3/2 dark brown sandy loam over 5YR 5/8 yellow red sandy clay subsoil mottled with 7.5YR 6/2 pale gray sandy clay (Figure 8-55).

10YR 3/2 sandy loam
0-22 cm

5YR 5/8 sandy clay mottled
w/ 7.5YR 6/2 sandy clay
22-30 cm

Figure 8-55: Soil profile for shovel test C at Temporary Structure T14.

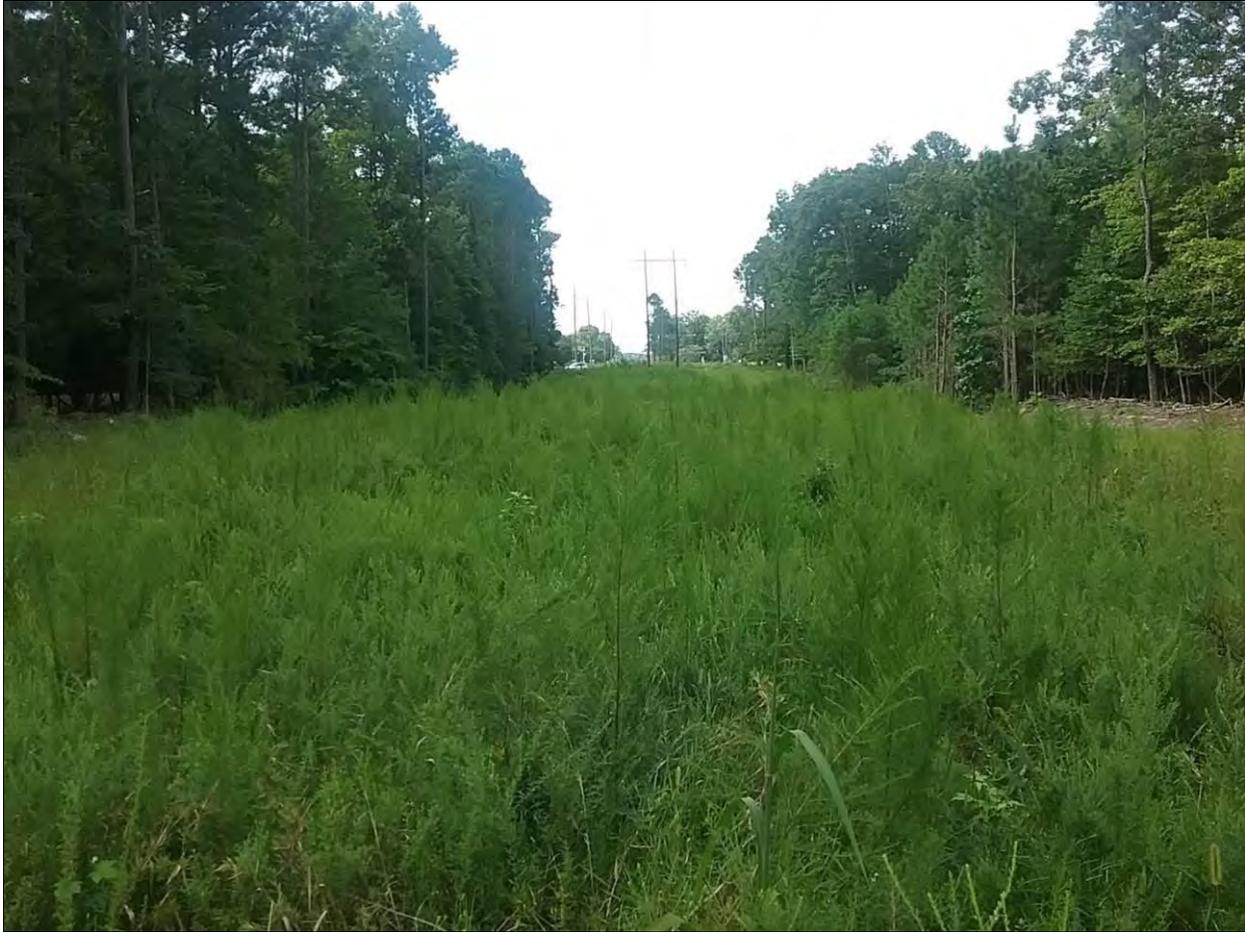
Figure 8-57: Terrain and vegetation around Structures 34/167, facing south.

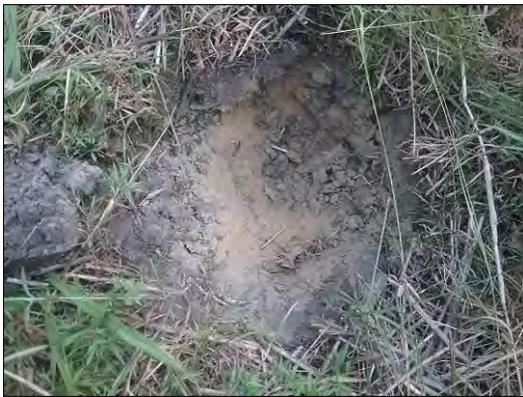
Soils around Structure 34/167 consisted of about 11 cm of 10YR 3/2 dark brown sandy loam over 5YR 5/8 yellow red sandy clay subsoil mottled with 7.5YR 6/2 pale gray sandy clay (Figure 8-58).

10YR 3/2 sandy loam
0-11 cm

5YR 5/8 sandy clay mottled
w/ 7.5YR 6/2 sandy clay
11-20 cm

Figure 8-58: Soil profile for shovel test N2 at Structure 34/167.

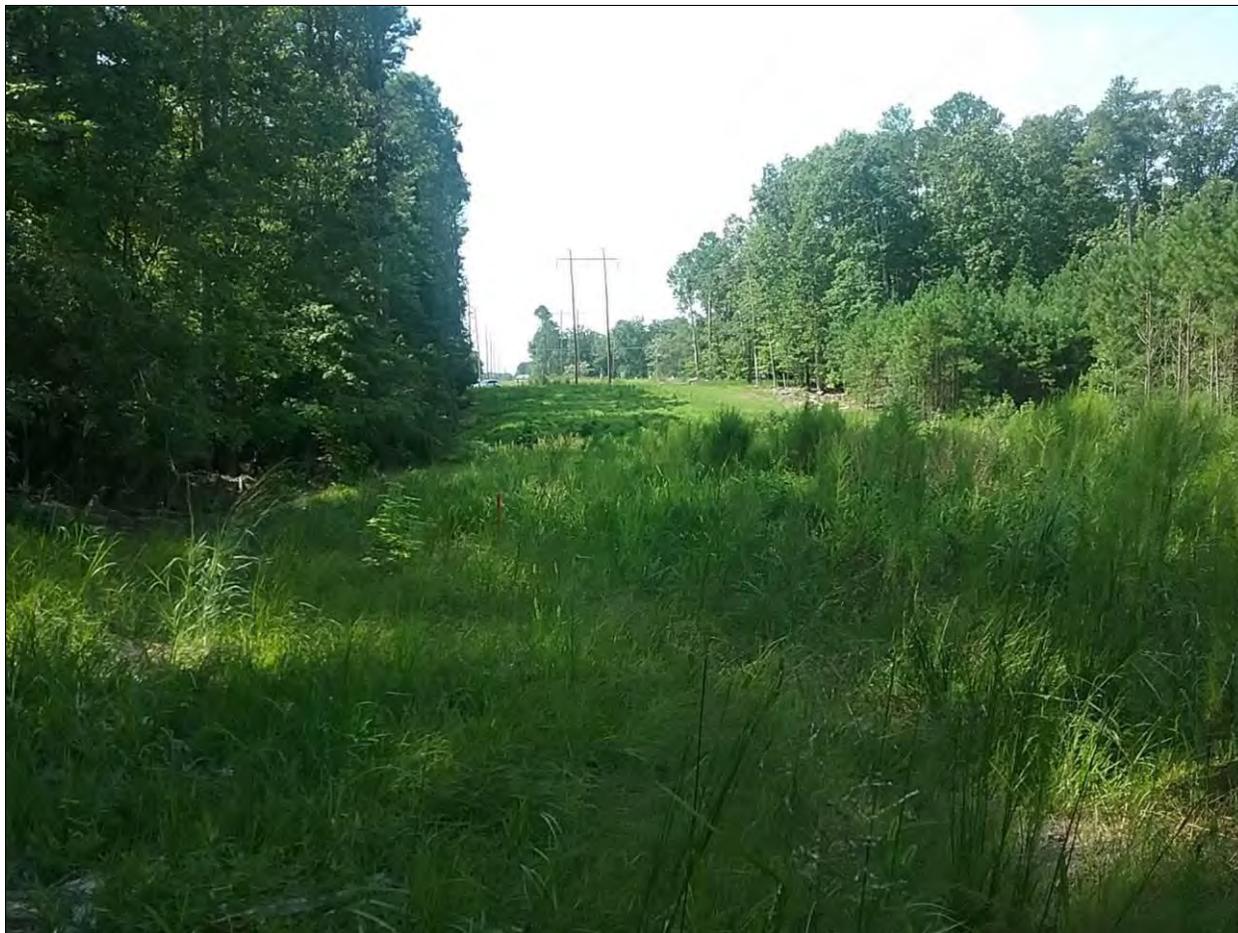
Figure 8-60: Terrain and vegetation around Temporary Structure T15, facing south.

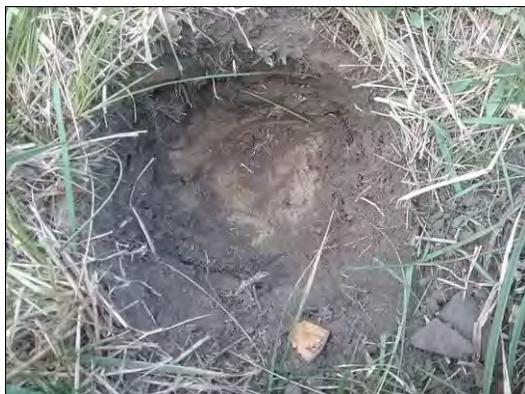
Soils around Temporary Structure T15 consisted of about 25 cm. of 10YR 3/2 dark brown sandy loam over 5YR 5/8 yellow red sandy clay subsoil mottled with 7.5YR 6/2 pale gray sandy clay (Figure 8-61).

10YR 3/2 sandy loam
0-25 cm

5YR 5/8 sandy clay mottled
w/ 7.5YR 6/2 sandy clay
25-36 cm

Figure 8-61: Soil profile for shovel test C at Temporary Structure T15.

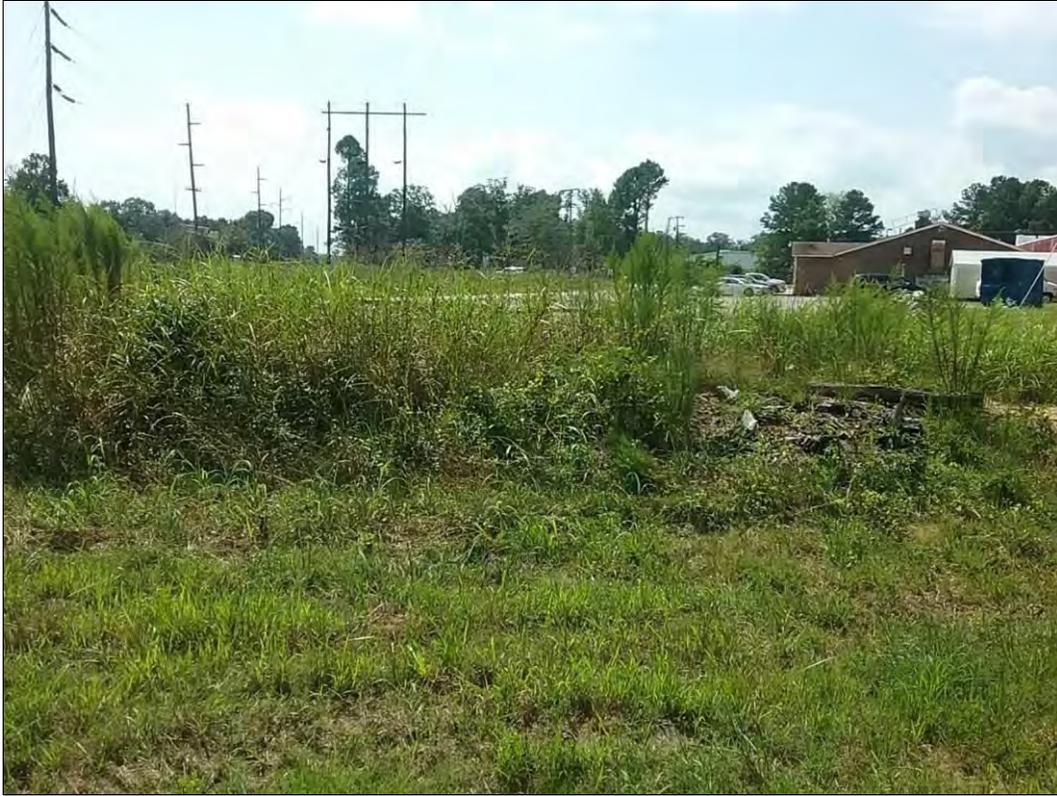
Figure 8-63: Terrain and vegetation around Structures 34/166, T16 and T17, facing south.

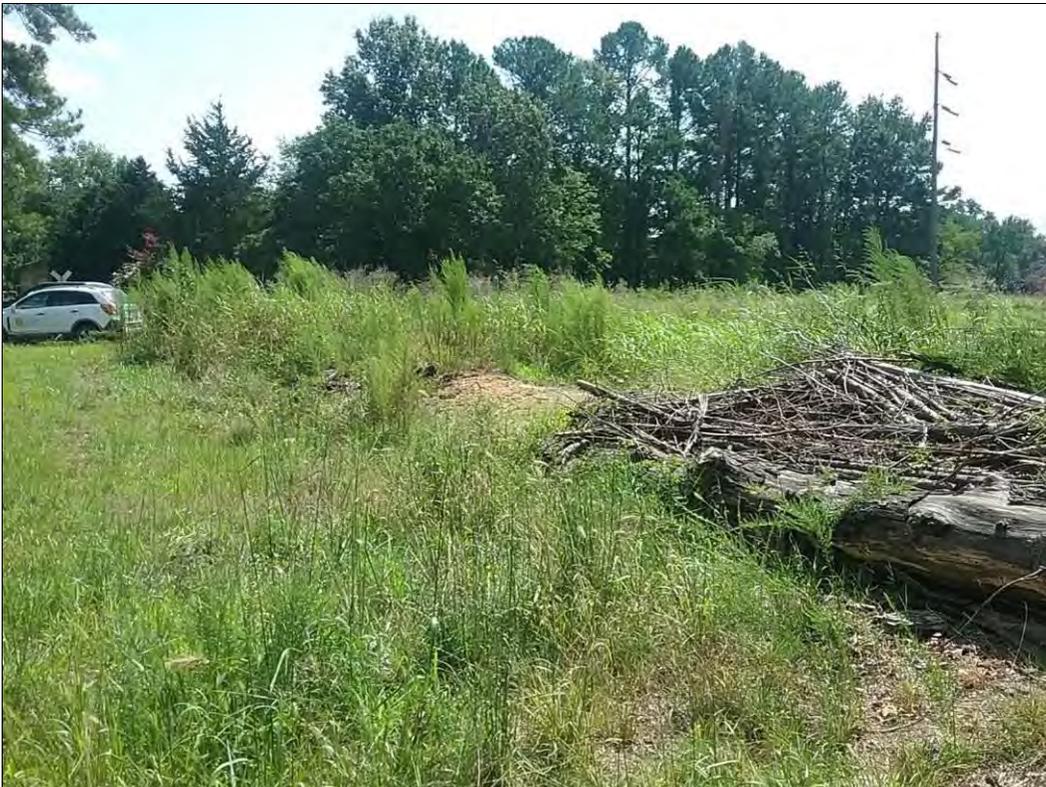
Figure 8-64: View of earthworks (44NN0156) at Structures 34/166, T16 and T17 crossing ROW, facing southeast.

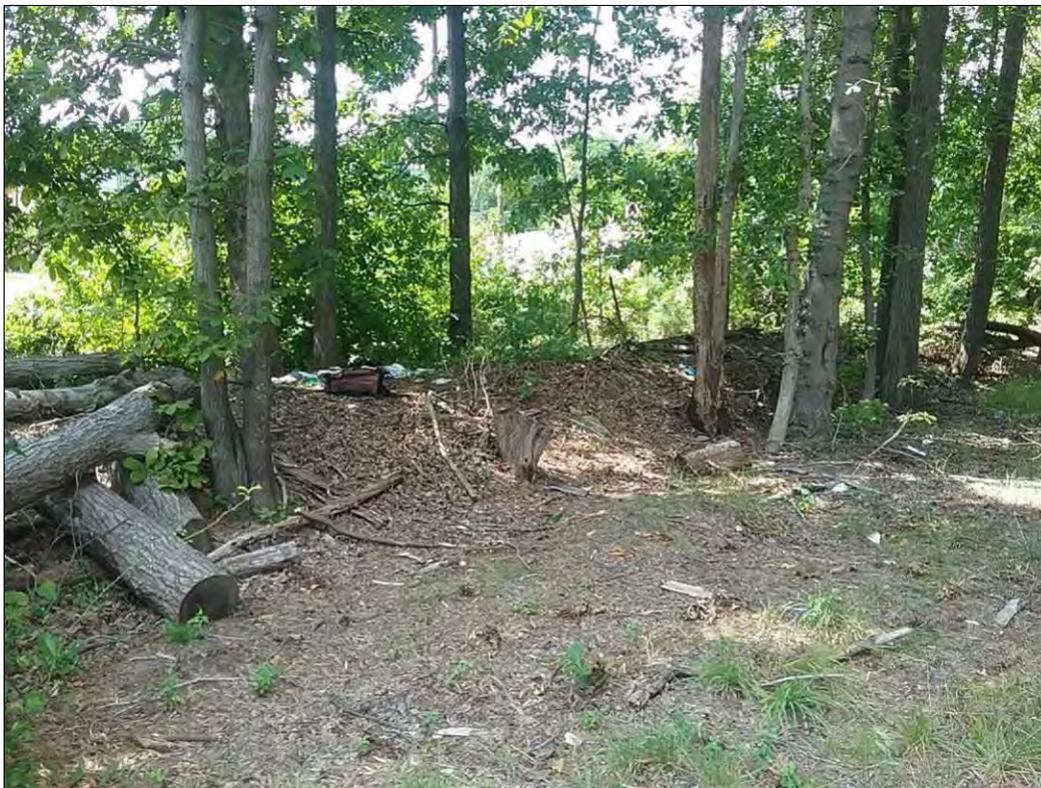
Figure 8-65: View of earthworks (44NN0156) at Structures 34/166, T16 and T17 outside of ROW, facing southwest.

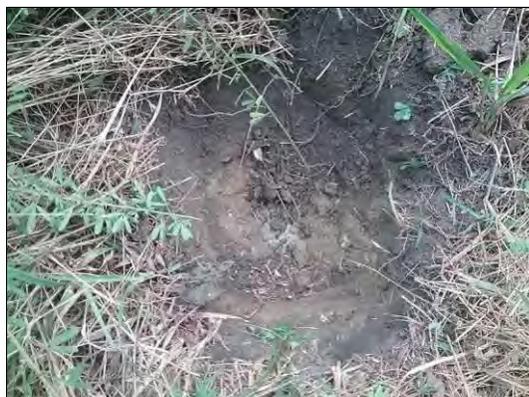
Soils around Structures 34/166, T16, and T17 consisted of about 17 cm of 10YR 3/2 deep brown sandy clay loam over 10YR 5/3 brown sandy clay subsoil mottled with 7.5YR 6/2 pale gray sandy clay (Figure 8-66).

10YR 3/2 sandy clay loam
0-17 cm

10YR 5/3 sandy clay subsoil
mottled w/ 7.5YR 6/2 sandy
clay
17-20 cm

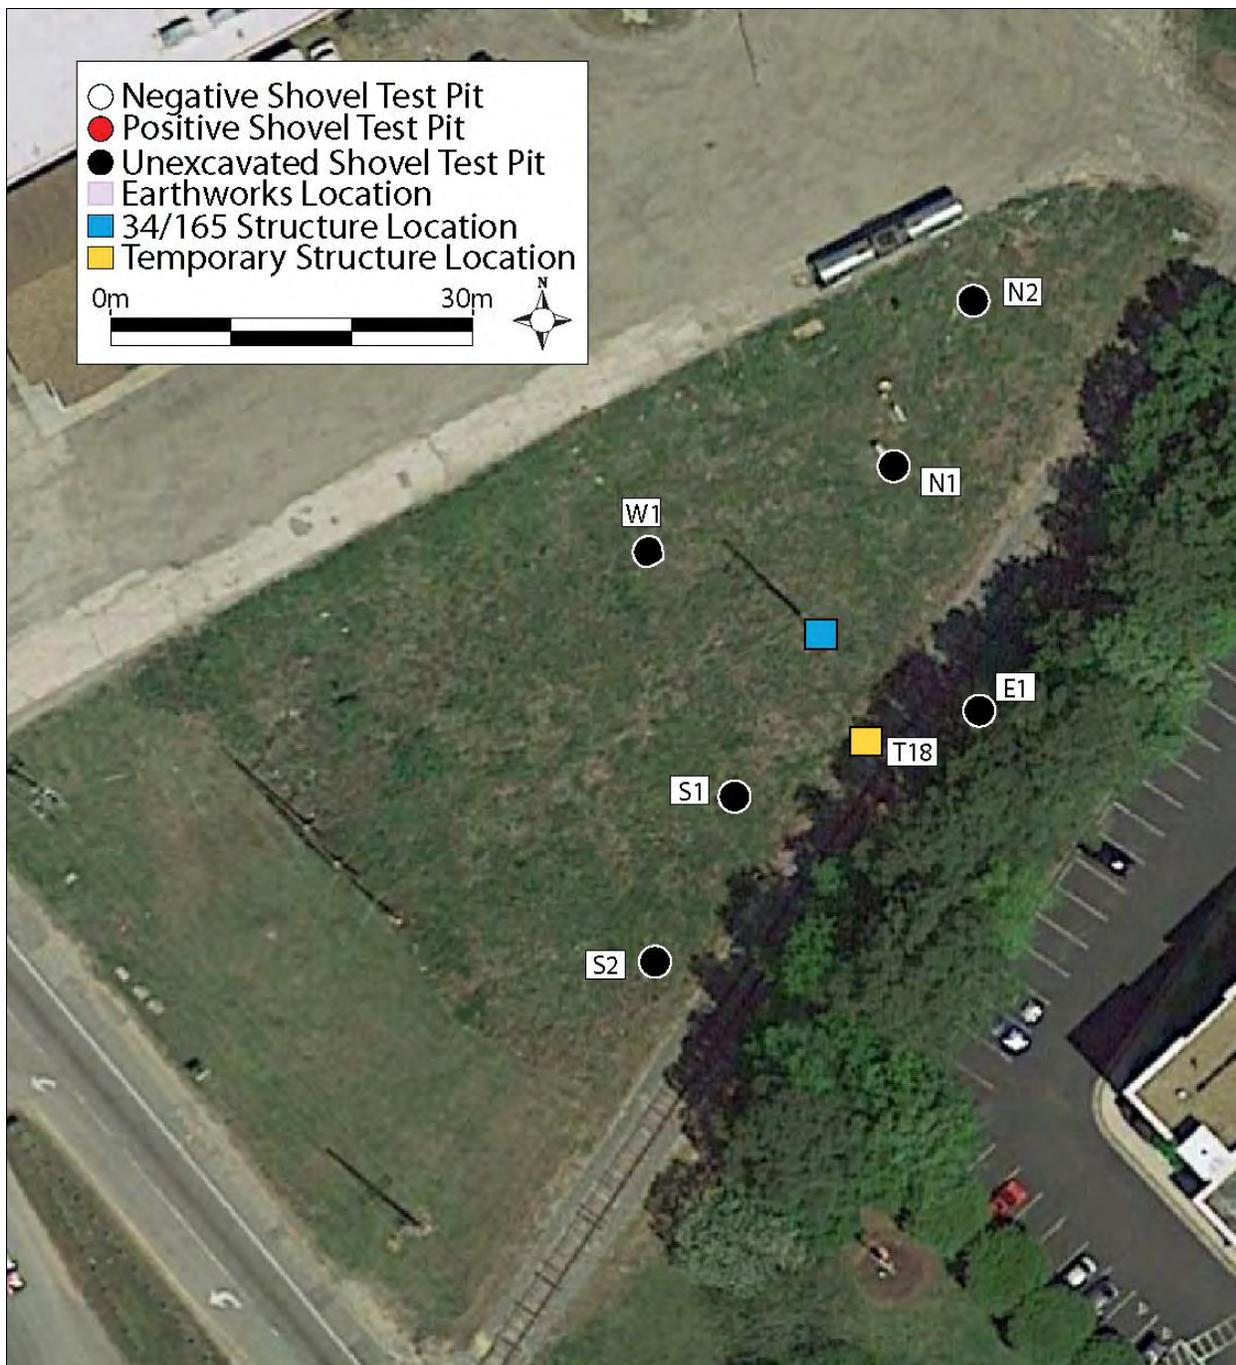
Figure 8-67: Aerial view of shovel tests at Structures 34/165 and T18.

Structures 34/165 and T18 are located in the existing ROW, which runs across a grassed area adjacent to a spur of the rail line. The structures are located between Reservoir Road to the northeast and Route 60 to the southwest. The terrain is flat and vegetation in the area consists of tall grasses with gravel mixed into the soil. In addition, other utilities both above and below ground were observed. No shovel tests were excavated around these structure locations and no evidence of subsurface or surface cultural features was observed. (Figures 8-67 and 8-68).

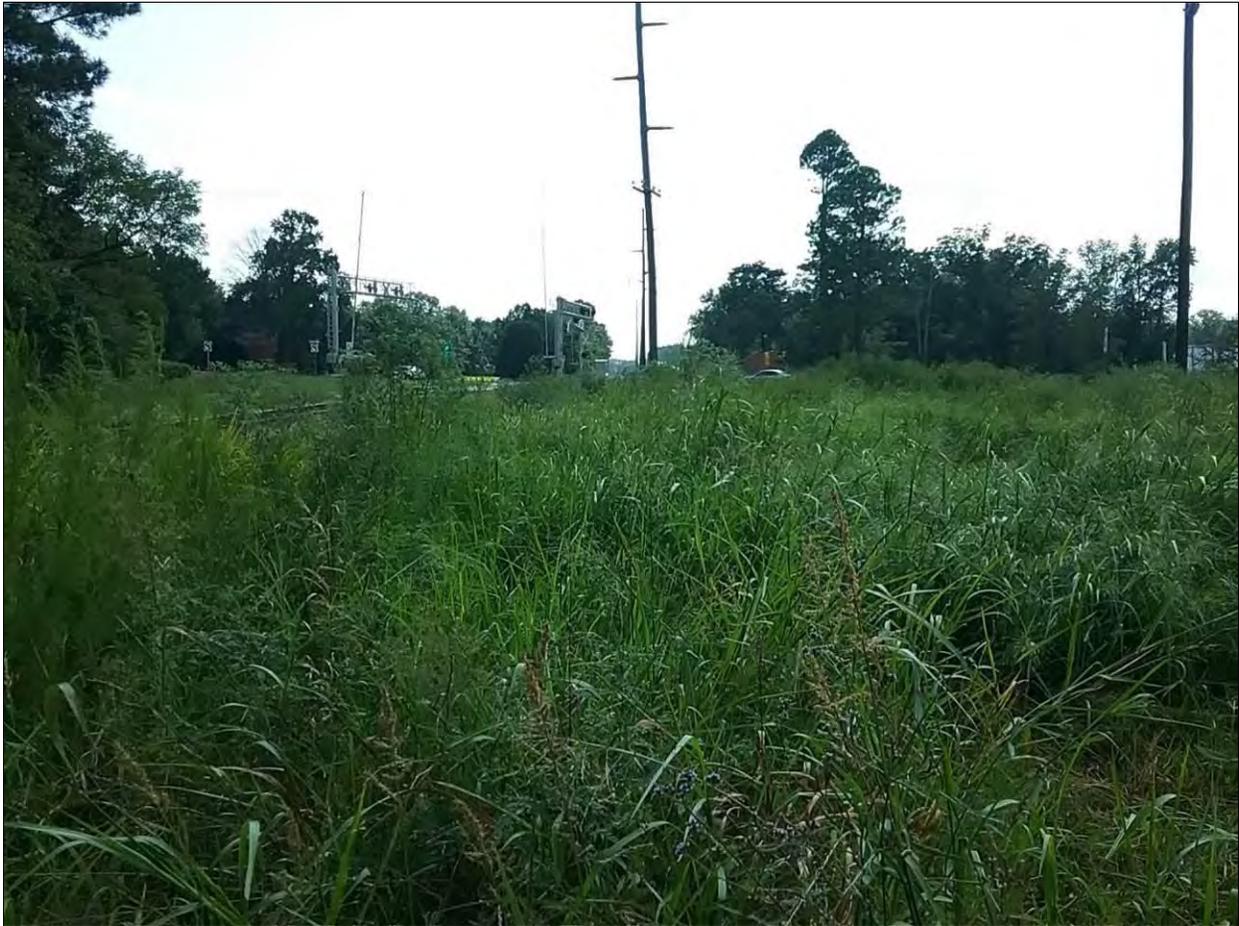
Figure 8-68: Terrain and vegetation around Structures 34/165 and T18, facing south.

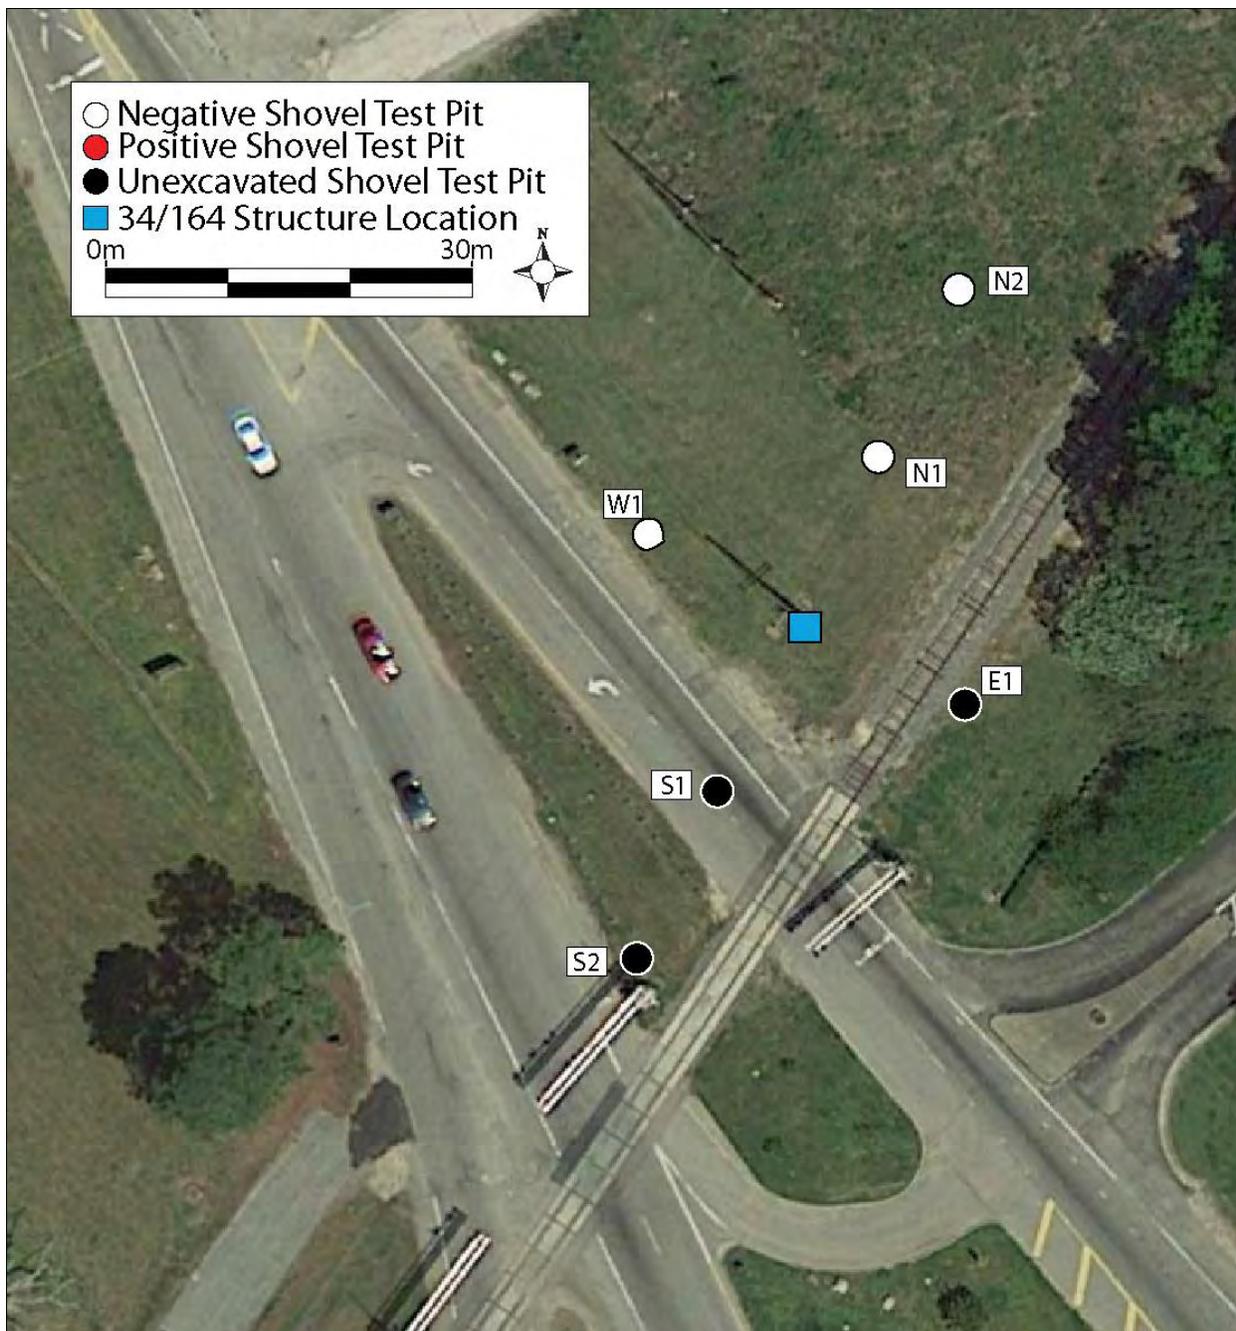
Figure 8-70: Aerial view of shovel tests at Structure 34/164.

Structure 34/164 is located in the existing ROW, which runs across a grassed area adjacent to a spur of the rail line. The structure is located immediately northeast of Route 60. The terrain is flat and vegetation in the area consists of tall grasses with gravel mixed into the soil. In addition, other utilities both above and below ground were observed. Three (3) shovel tests were excavated around this structure location and all were negative for cultural material (Figures 8-70 and 8-71). In addition, no evidence of subsurface or surface cultural features was observed.

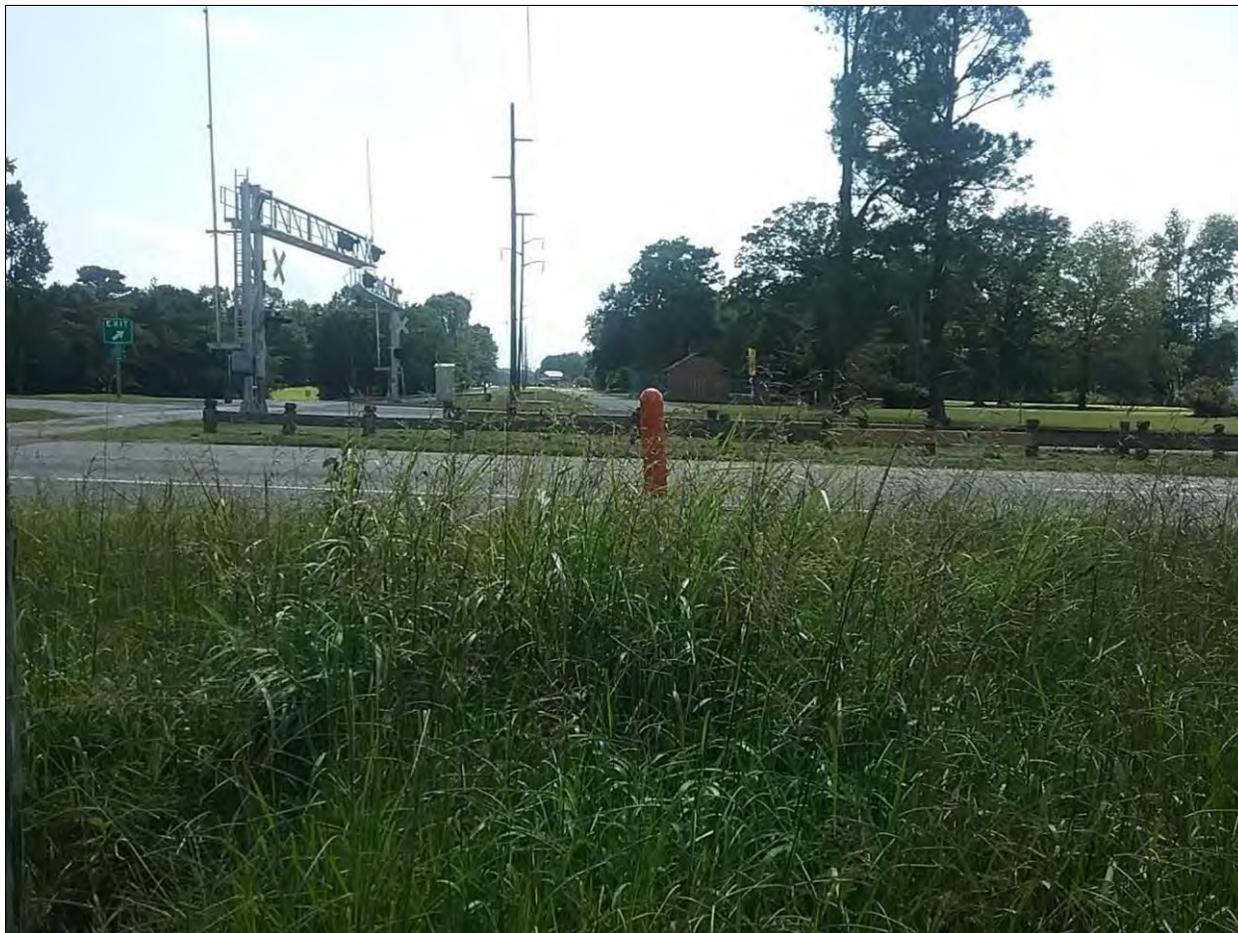
Figure 8-71: Terrain and vegetation around Structure 34/164 facing south.

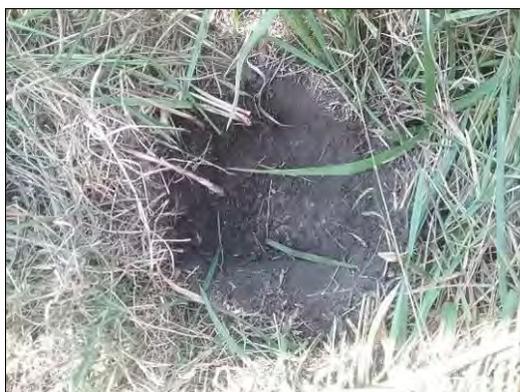
10YR 2/1 sandy clay loam
0-20 cm

10YR 2/1 sandy clay loam
mottled w/10YR 4/1 sandy
clay loam w/ compact gravels
20-25 cm

Figure 8-72: Soil profile for shovel test W1 at Structure 34/164.

Soils around Structure 34/164 consisted of about 20 cm of 10YR 2/1 black sandy clay loam over 10YR 2/1 black sandy clay loam with compact gravels mottled with 10YR 4/1 dark gray sandy clay loam (Figure 8-72).

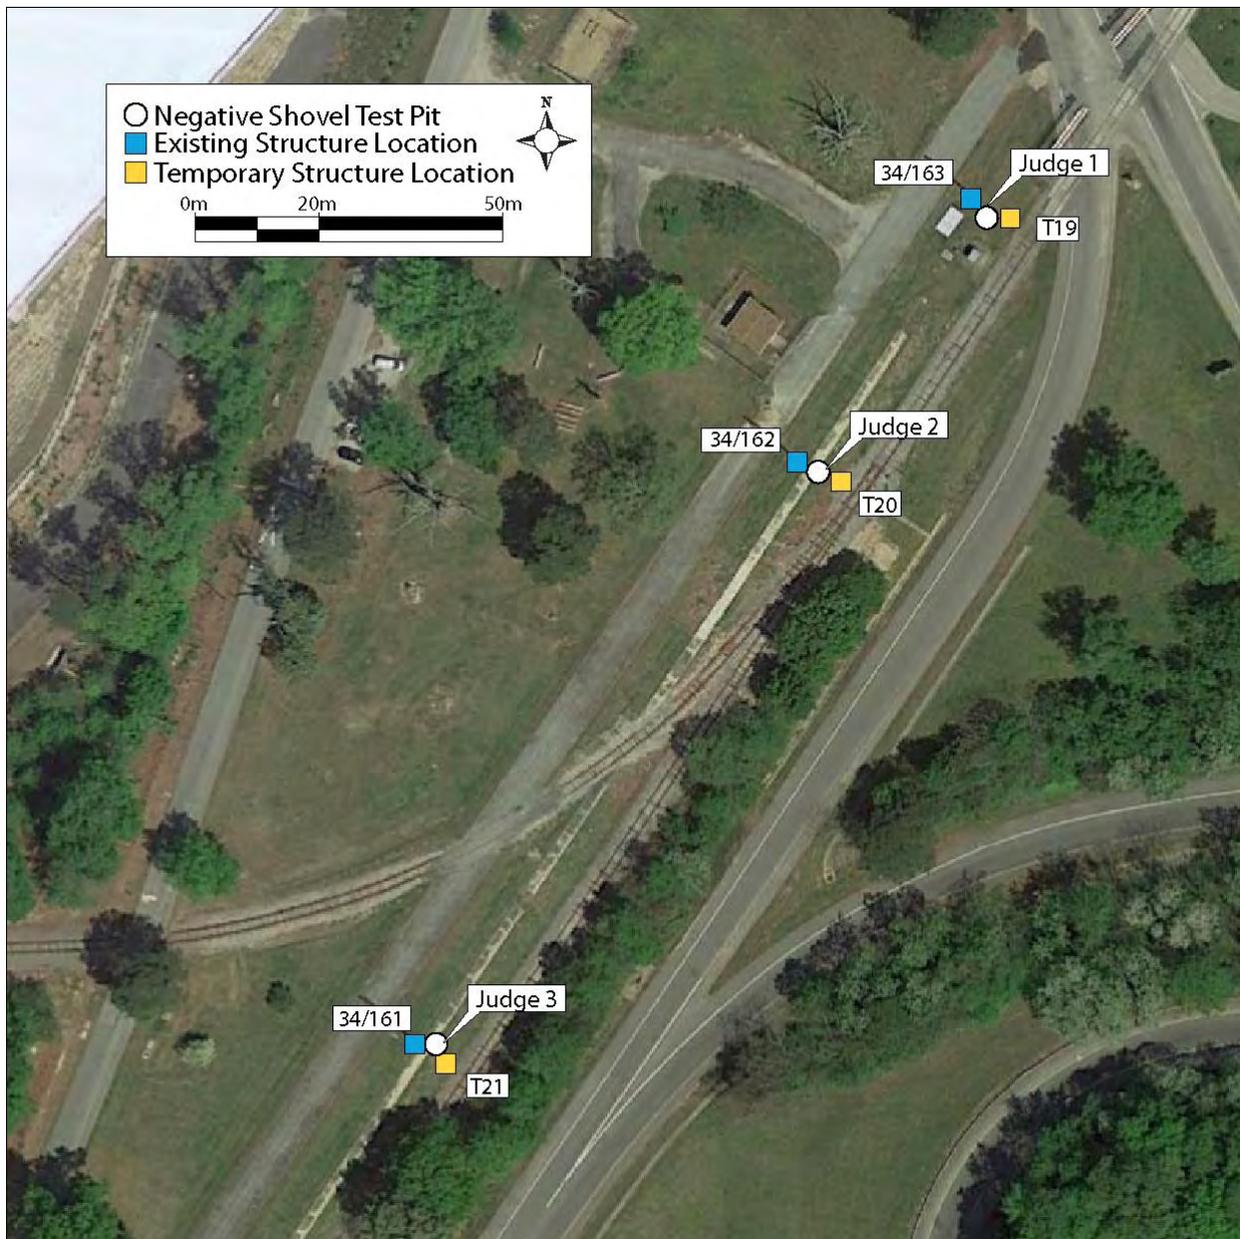
Figure 8-73: Aerial view of judgmental shovel tests at Structures 34/163, 34/162, 34/161, T19, T20, and T21.

Structures 34/163 through 34/157 and T19 through T25 are located in the existing ROW, which consists of a multi utility corridor with above and below ground utility infrastructure and modern transportation infrastructure running along both sides of the structure substantially limiting the amount of undisturbed testable area (Figures 8-73 through 8-81). Accordingly, a single judgmental shovel test was excavated at each structure location documenting disturbed soils. No cultural material was recovered from any of the judgmental shovel tests and no evidence of subsurface or surface cultural features was observed.

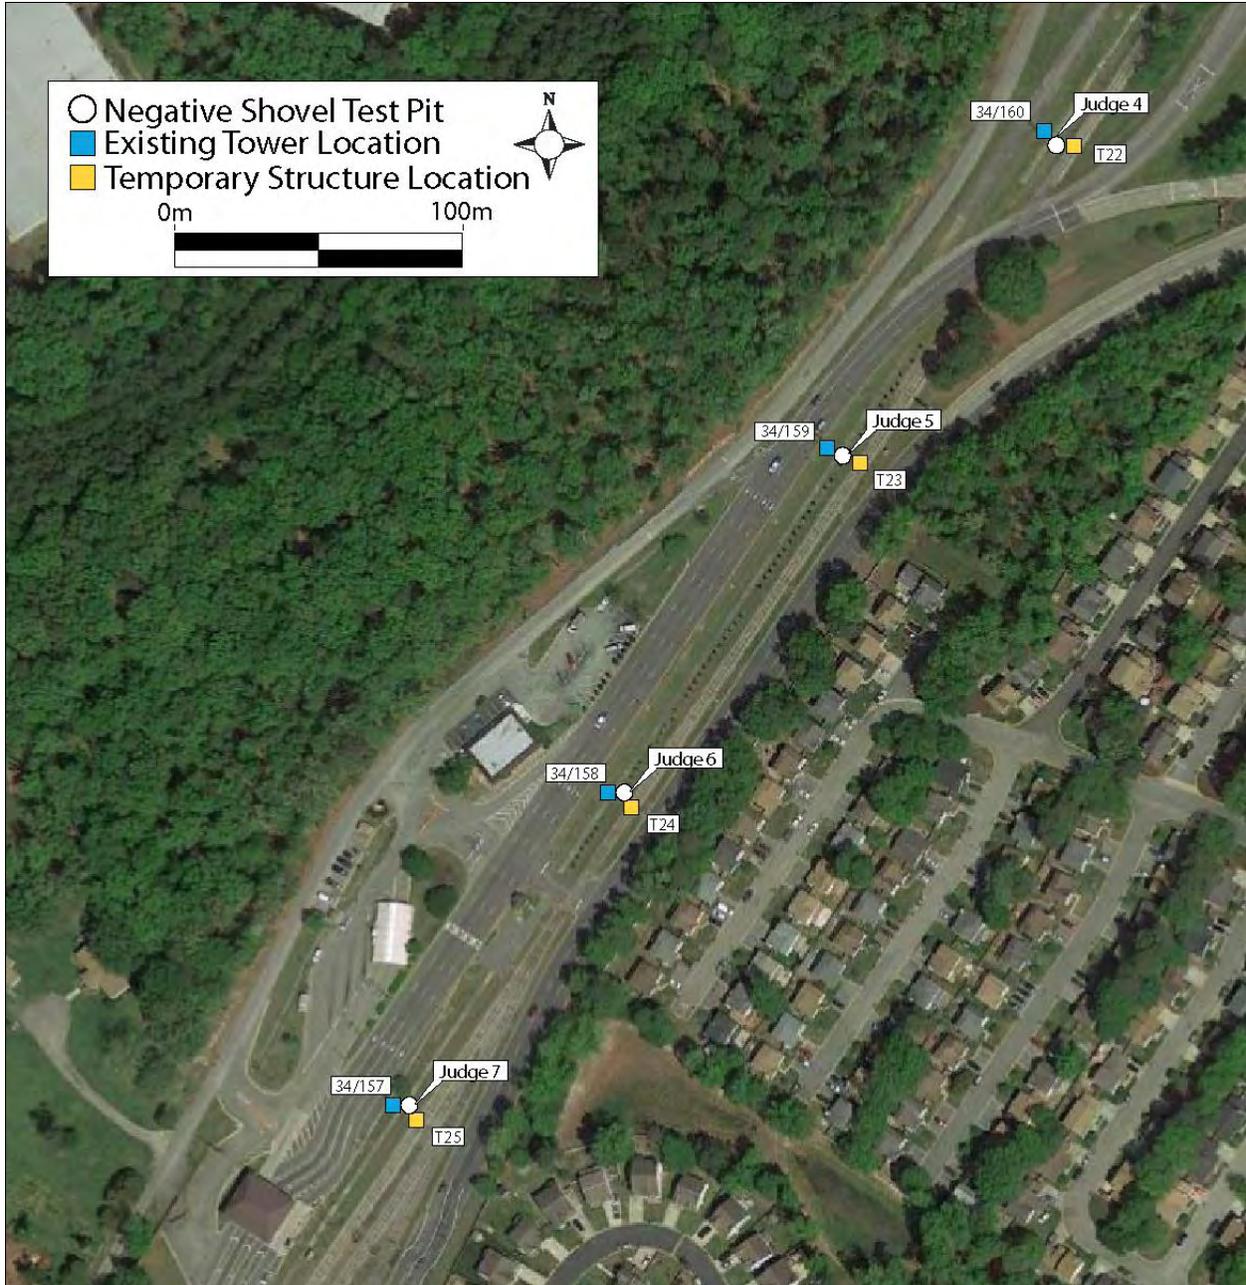
Figure 8-74: Aerial view of judgmental shovel tests at Structures 34/160, 34/159, 34/158, 34/157, T22, T23, T24, and T25.

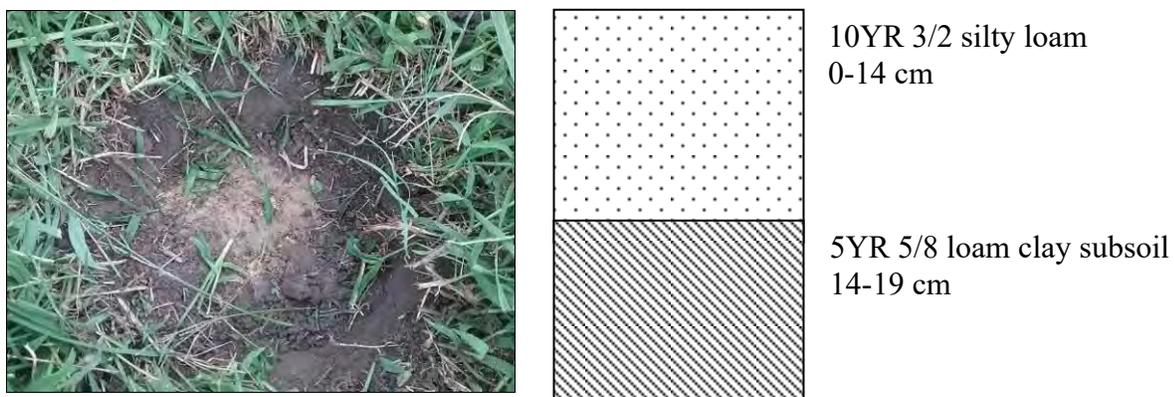
Figure 8-82: Soil profile for judgmental shovel test 1 at Structures 34/163 and T19.

Soils around Structures 34/163 through 34/157 and Temporary Structures T19 through T25 were all similar in composition and consisted of about 14 cm to 25 cm of 10YR 3/2 very dark gray brown silty loam over 5YR 5/8 yellow red loamy clay subsoil (Figures 8-82 through 8-85).

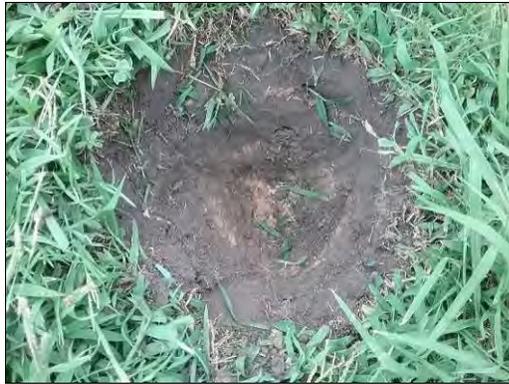
10YR 3/2 silty loam
0-14 cm

5YR 5/8 loam clay subsoil
14-19 cm

Figure 8-83: Soil profile for judgmental shovel test 3 at Structures 34/161 and T21.

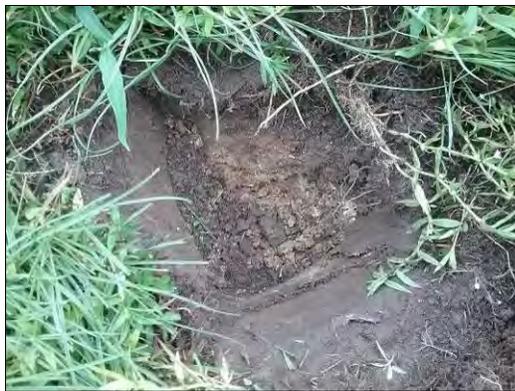
10YR 3/2 silty loam
0-14 cm

5YR 5/8 loam clay subsoil
14-19 cm

Figure 8-84: Soil profile for judgmental shovel test 5 at Structures 34/159 and T23.
