Phase I Cultural Resource Survey of the Fort Eustis Tap/Line 34 Rebuild Project

LOCATION > City of Newport News, Virginia

DATE > October 2020

PREPARED BY >
Dutton + Associates, LLC

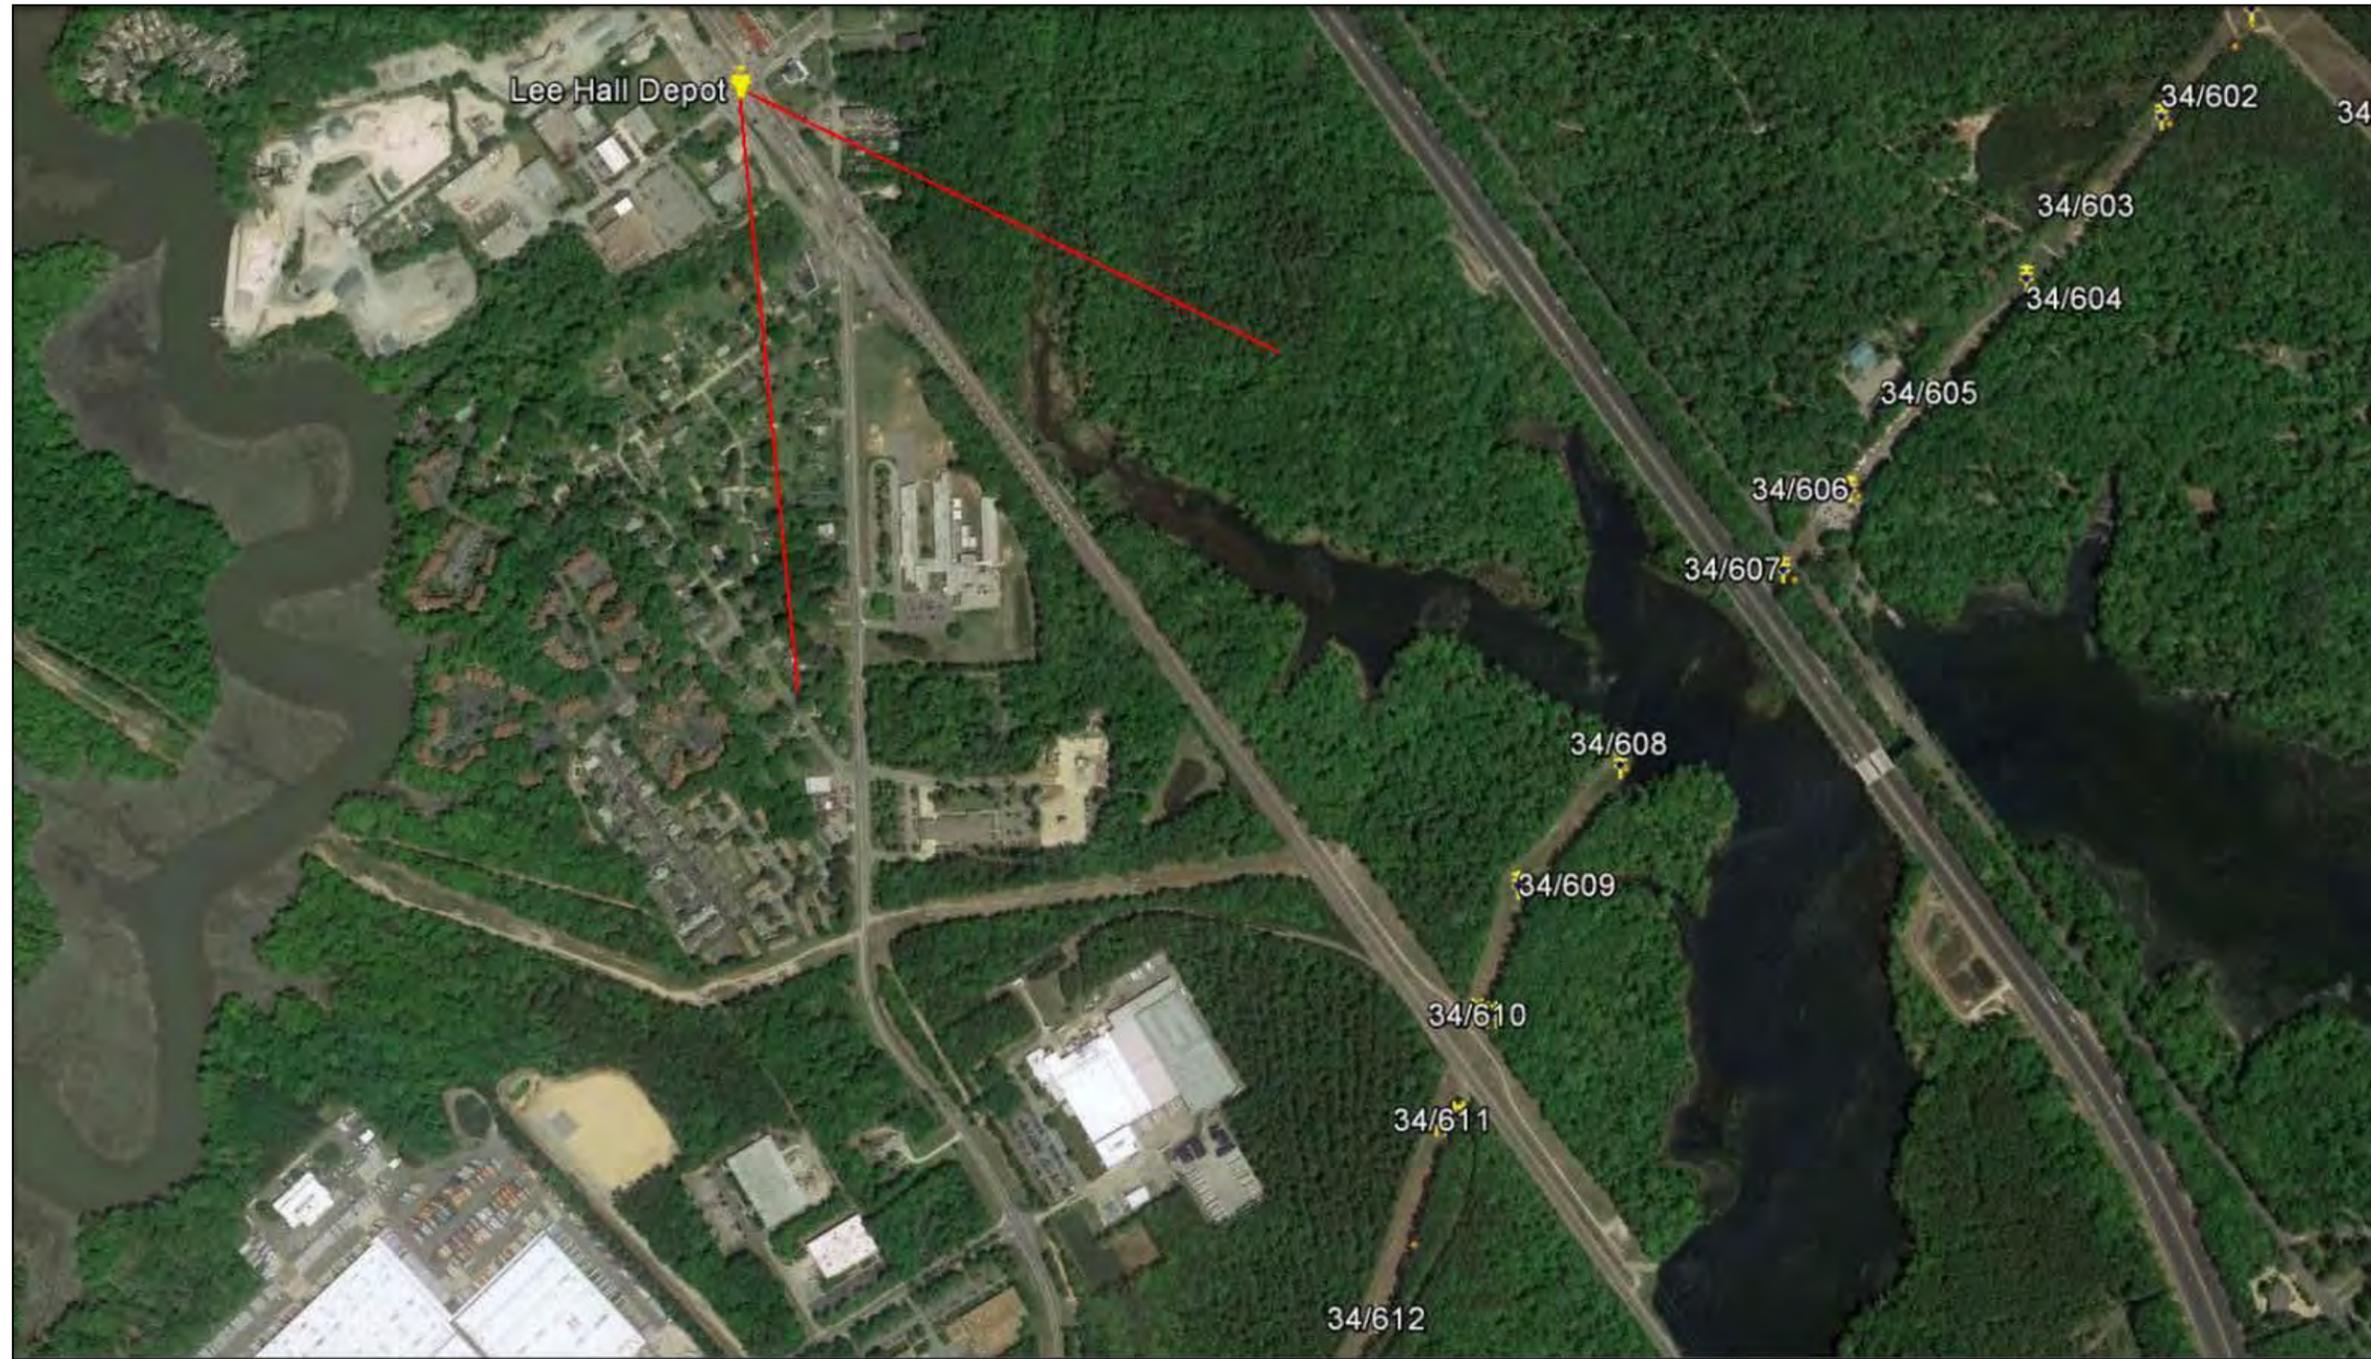
Photo location: Lee Hall Depot		Structure Name	Structure New Name	Height ft	Distance ft	Structure Name	Structure New Name	Height ft	Distance ft

Photo simulations prepared by: GTTE LLC email: info@gttllc.com	Project: Dominion Energy Fort Eustis Tap Rebuild	34/608	1038/186, 34/172	130.00	4493.00	34/611	1038/189L	65.00	5599.00
		34/609	1038/187, 34/171	100.00	4506.00	34/611A	34/169R	60.00	5092.00
		34/610	1038/188	65.00	4779.00	34/612	1038/190, 34/168	100.00	6063.00
		34/610A	34/170	60.00	4846.00	34/613	1038/191, 34/167	110.00	6585.00

Photo Sim 1: Location of photo sim 1 depicting field of view and modeled structures from Lee Hall Depot within the Williamsburg Battlefield. Source: GTTE LLC

To assess whether the project or any associated components may pose an effect to the battlefield, a viewshed assessment was conducted. Inspection was performed and photo simulations were prepared from public right-of-way and vantage points throughout the portion of battlefield in the vicinity of the project area to document existing setting, visibility, and lines of sight (Figure 9-4; Photos 1 through 9; Photo Sims 1 through 4).

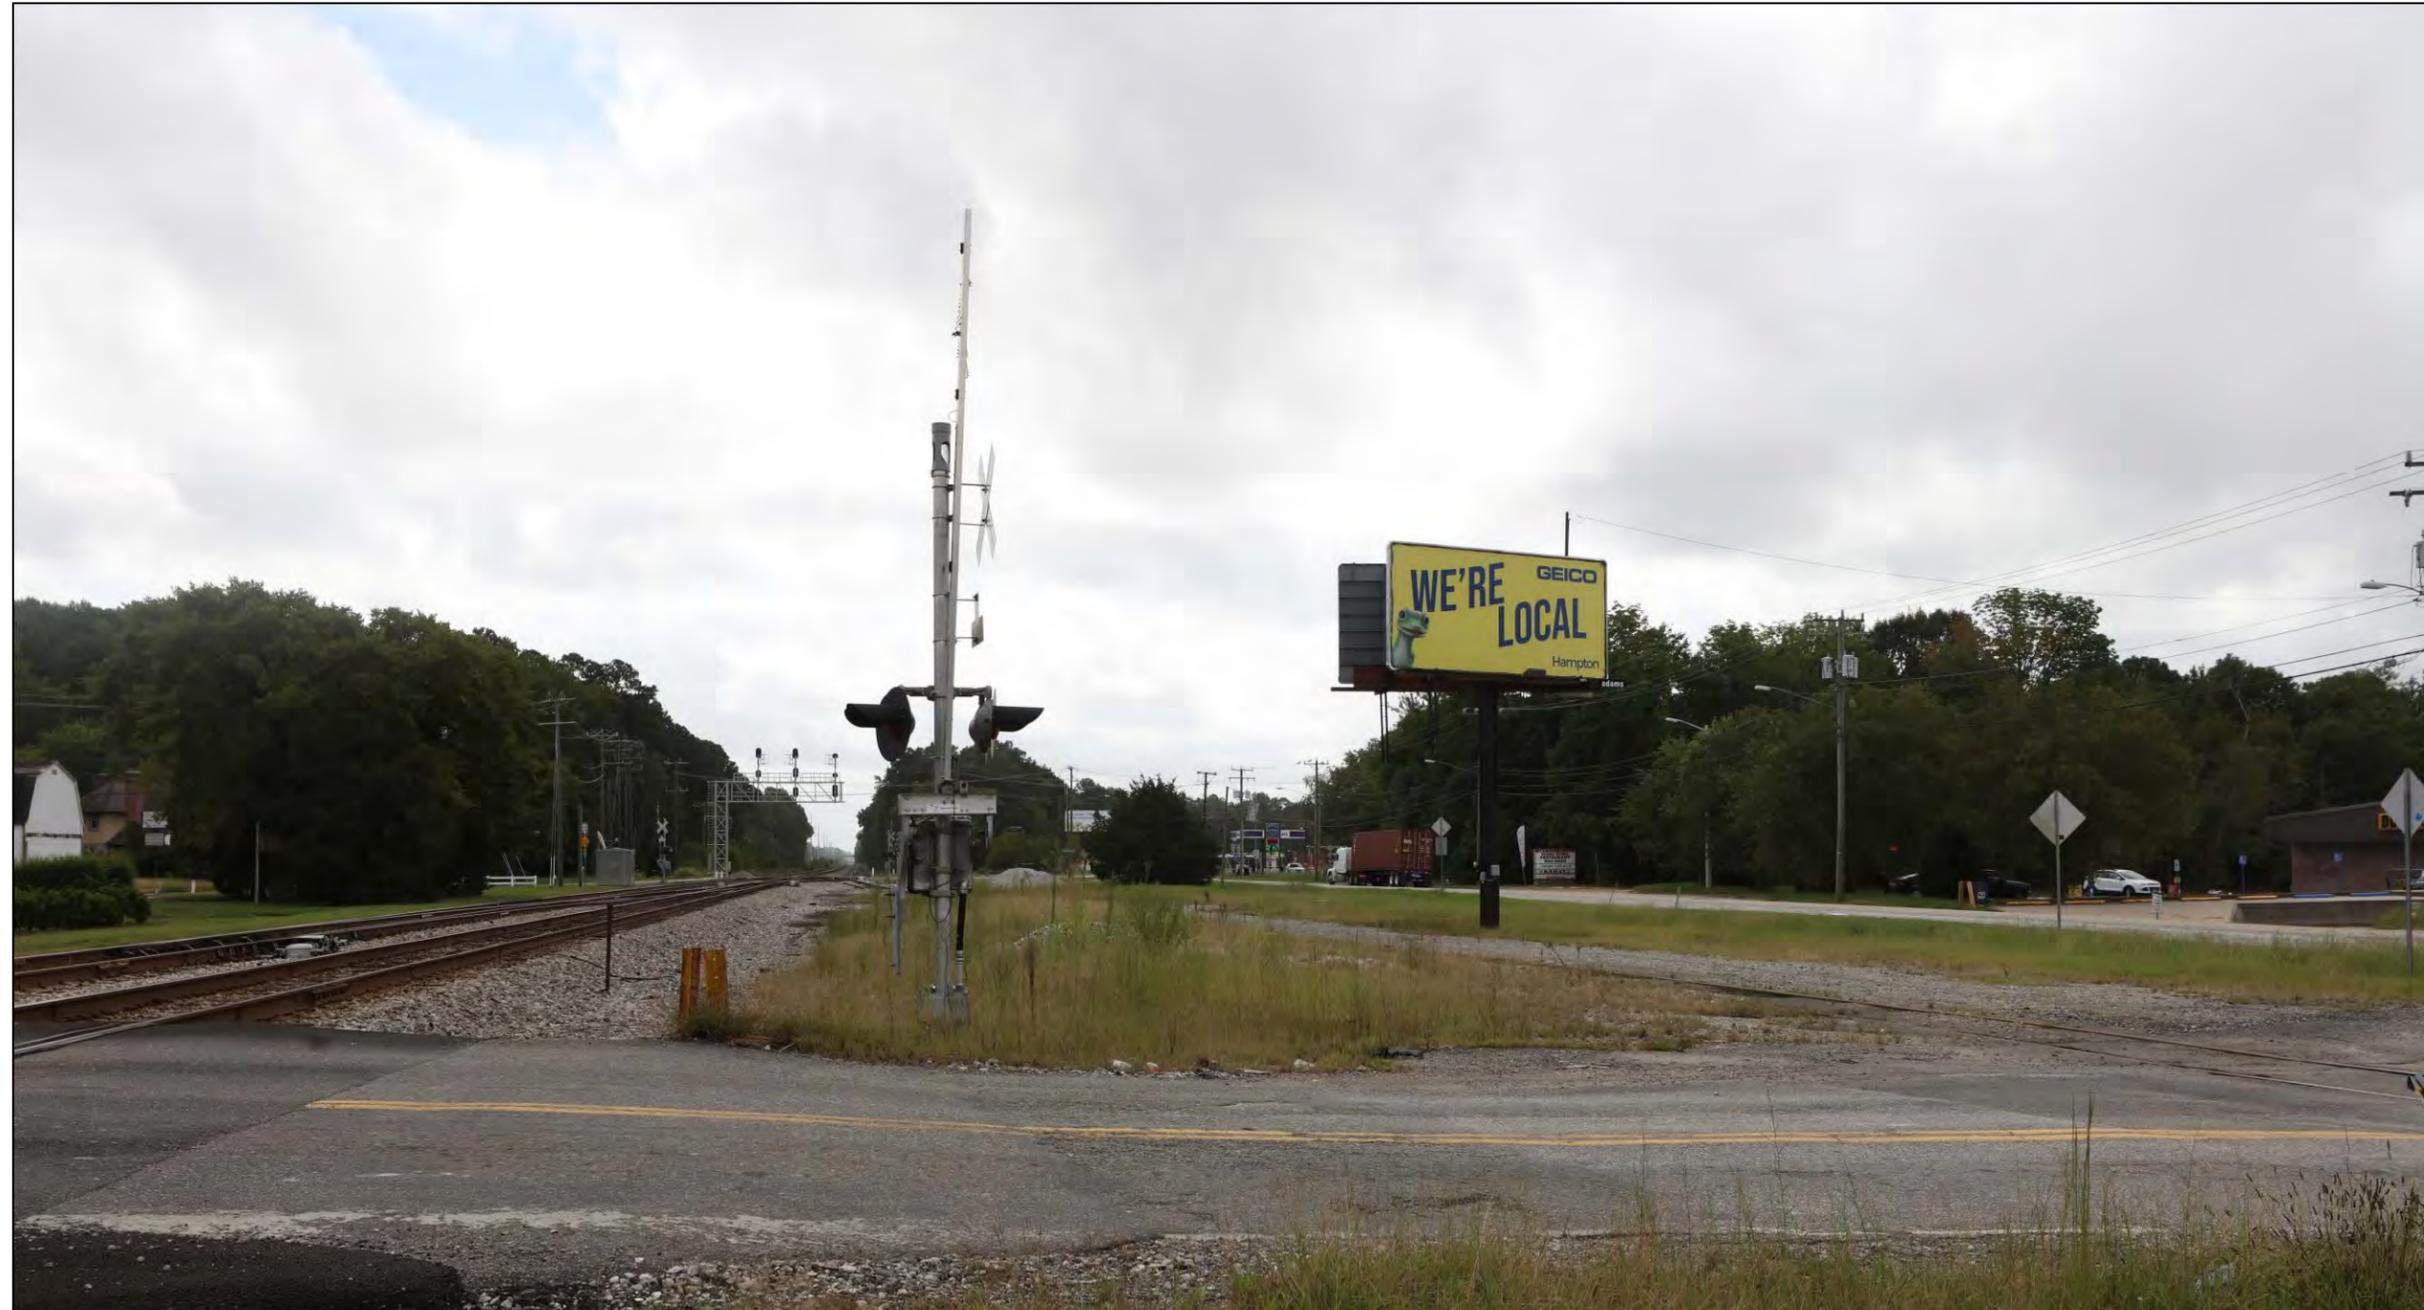
<p>Dominion Energy: Fort Eustis Tap Rebuild</p>	<p>Lee Hall Depot Existing View</p>

<p>Photo simulations prepared by: GTTE LLC email: info@gttellc.com 703 447 1350</p>	<p>Photo simulations and diagrams represent approximate heights for electric transmission structures from the conceptual design used for the proposed project. These illustrations do not necessarily depict exact structure design or location. The approximate heights include foundation reveal (minimum of 18 inches) and are also subject to change based on final design.</p>	<div style="text-align: center;">

Inspection and photo simulation from those portions of the battlefield within the APE at this time found that in general, the existing transmission line is visible from vantage points directly within the project area ROW and in the immediate vicinity, but quickly becomes screened by vegetation and development. Because the battlefield generally follows the alignment of Route 60 in this area, this public thoroughfare does allow visibility of the project area and the existing transmission line, however, the views are generally limited to narrow windows between buildings lining the road and the thick vegetation surrounding them. Where the existing transmission line can be seen, the views are intermittent set amongst or behind other existing transmission and utility lines, road infrastructure, and/or modern development. Inspection from vantage points further from the project area generally do not include the existing transmission line as the current structures are generally shorter than the average vegetation in the area.

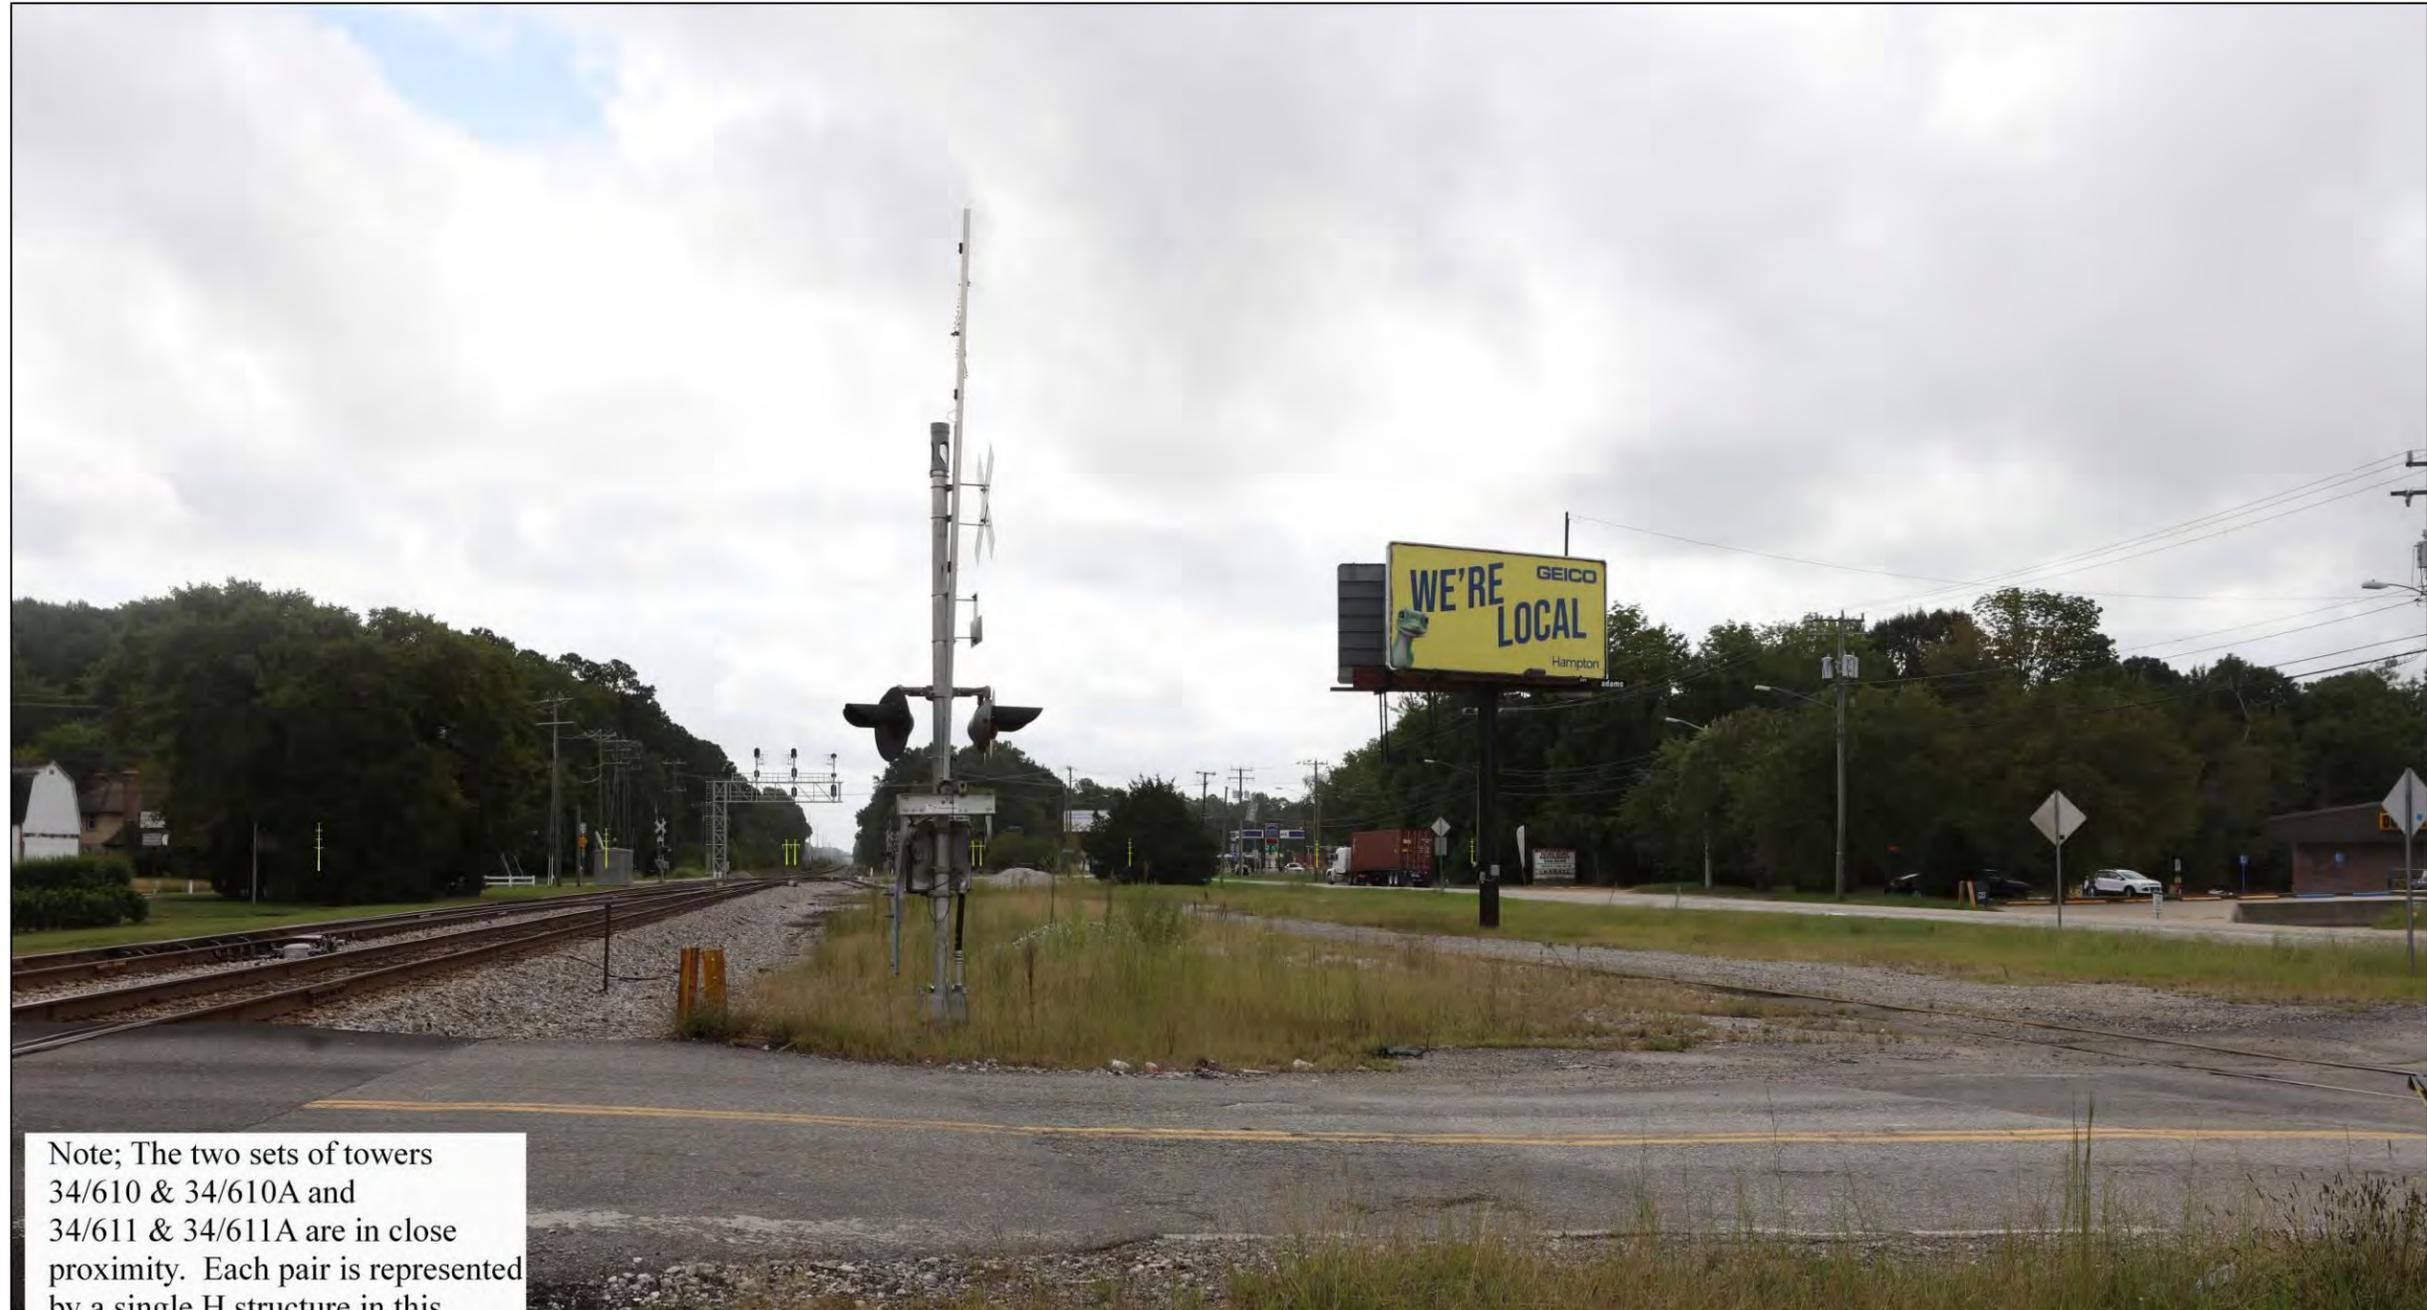
Note; The two sets of towers 34/610 & 34/610A and 34/611 & 34/611A are in close proximity. Each pair is represented by a single H structure in this simulation.

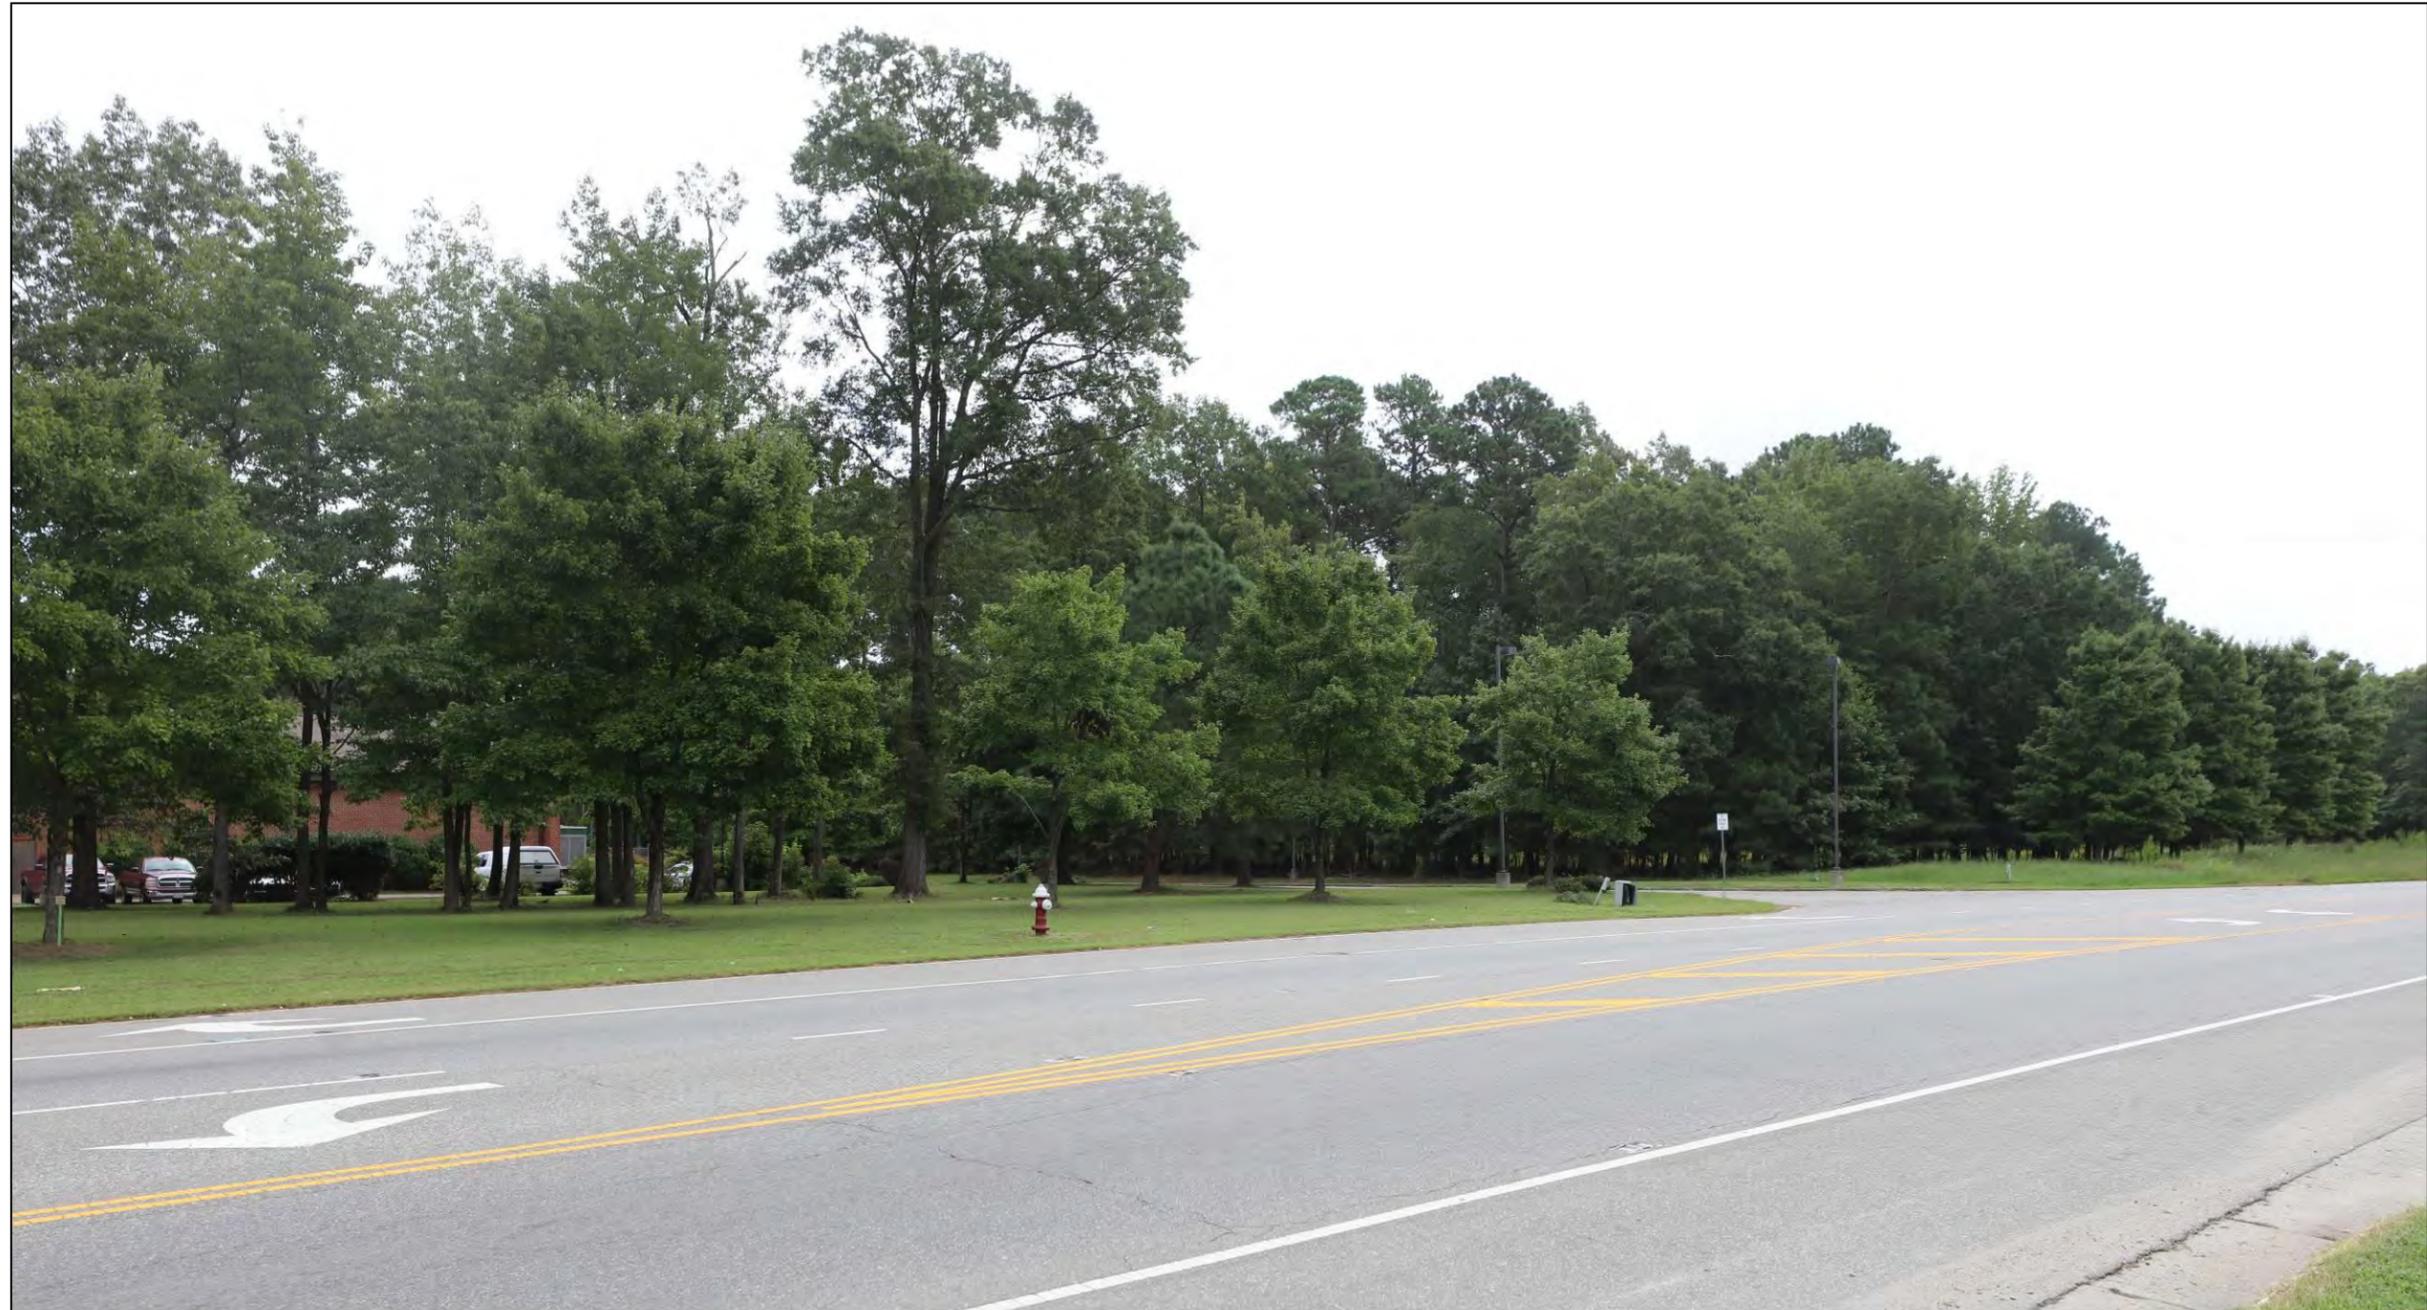
Dominion Energy: Fort Eustis Tap Rebuild	Battle Field 5 Existing View

Photo simulations prepared by: GTTE LLC email: info@gttellc.com	Project: Dominion Energy Fort Eustis Tap Rebuild	34/609	1038/187, 34/171	100.00	2714.00	34/611A	34/169R	60.00	2736.00
		34/610	1038/188	65.00	2652.00	34/612	1038/190, 34/168	100.00	2933.00
		34/610A	34/170	60.00	2712.00	34/613	1038/191, 34/167	110.00	3213.00
		34/611	1038/189L	65.00	2685.00	34/614	1038/192, 34/166	100.00	3642.00

Photo Sim 2: Location of photo sim 2 depicting field of view and modeled structures from US-60 at Curtis Drive within the Williamsburg Battlefield. Source: GTTE LLC

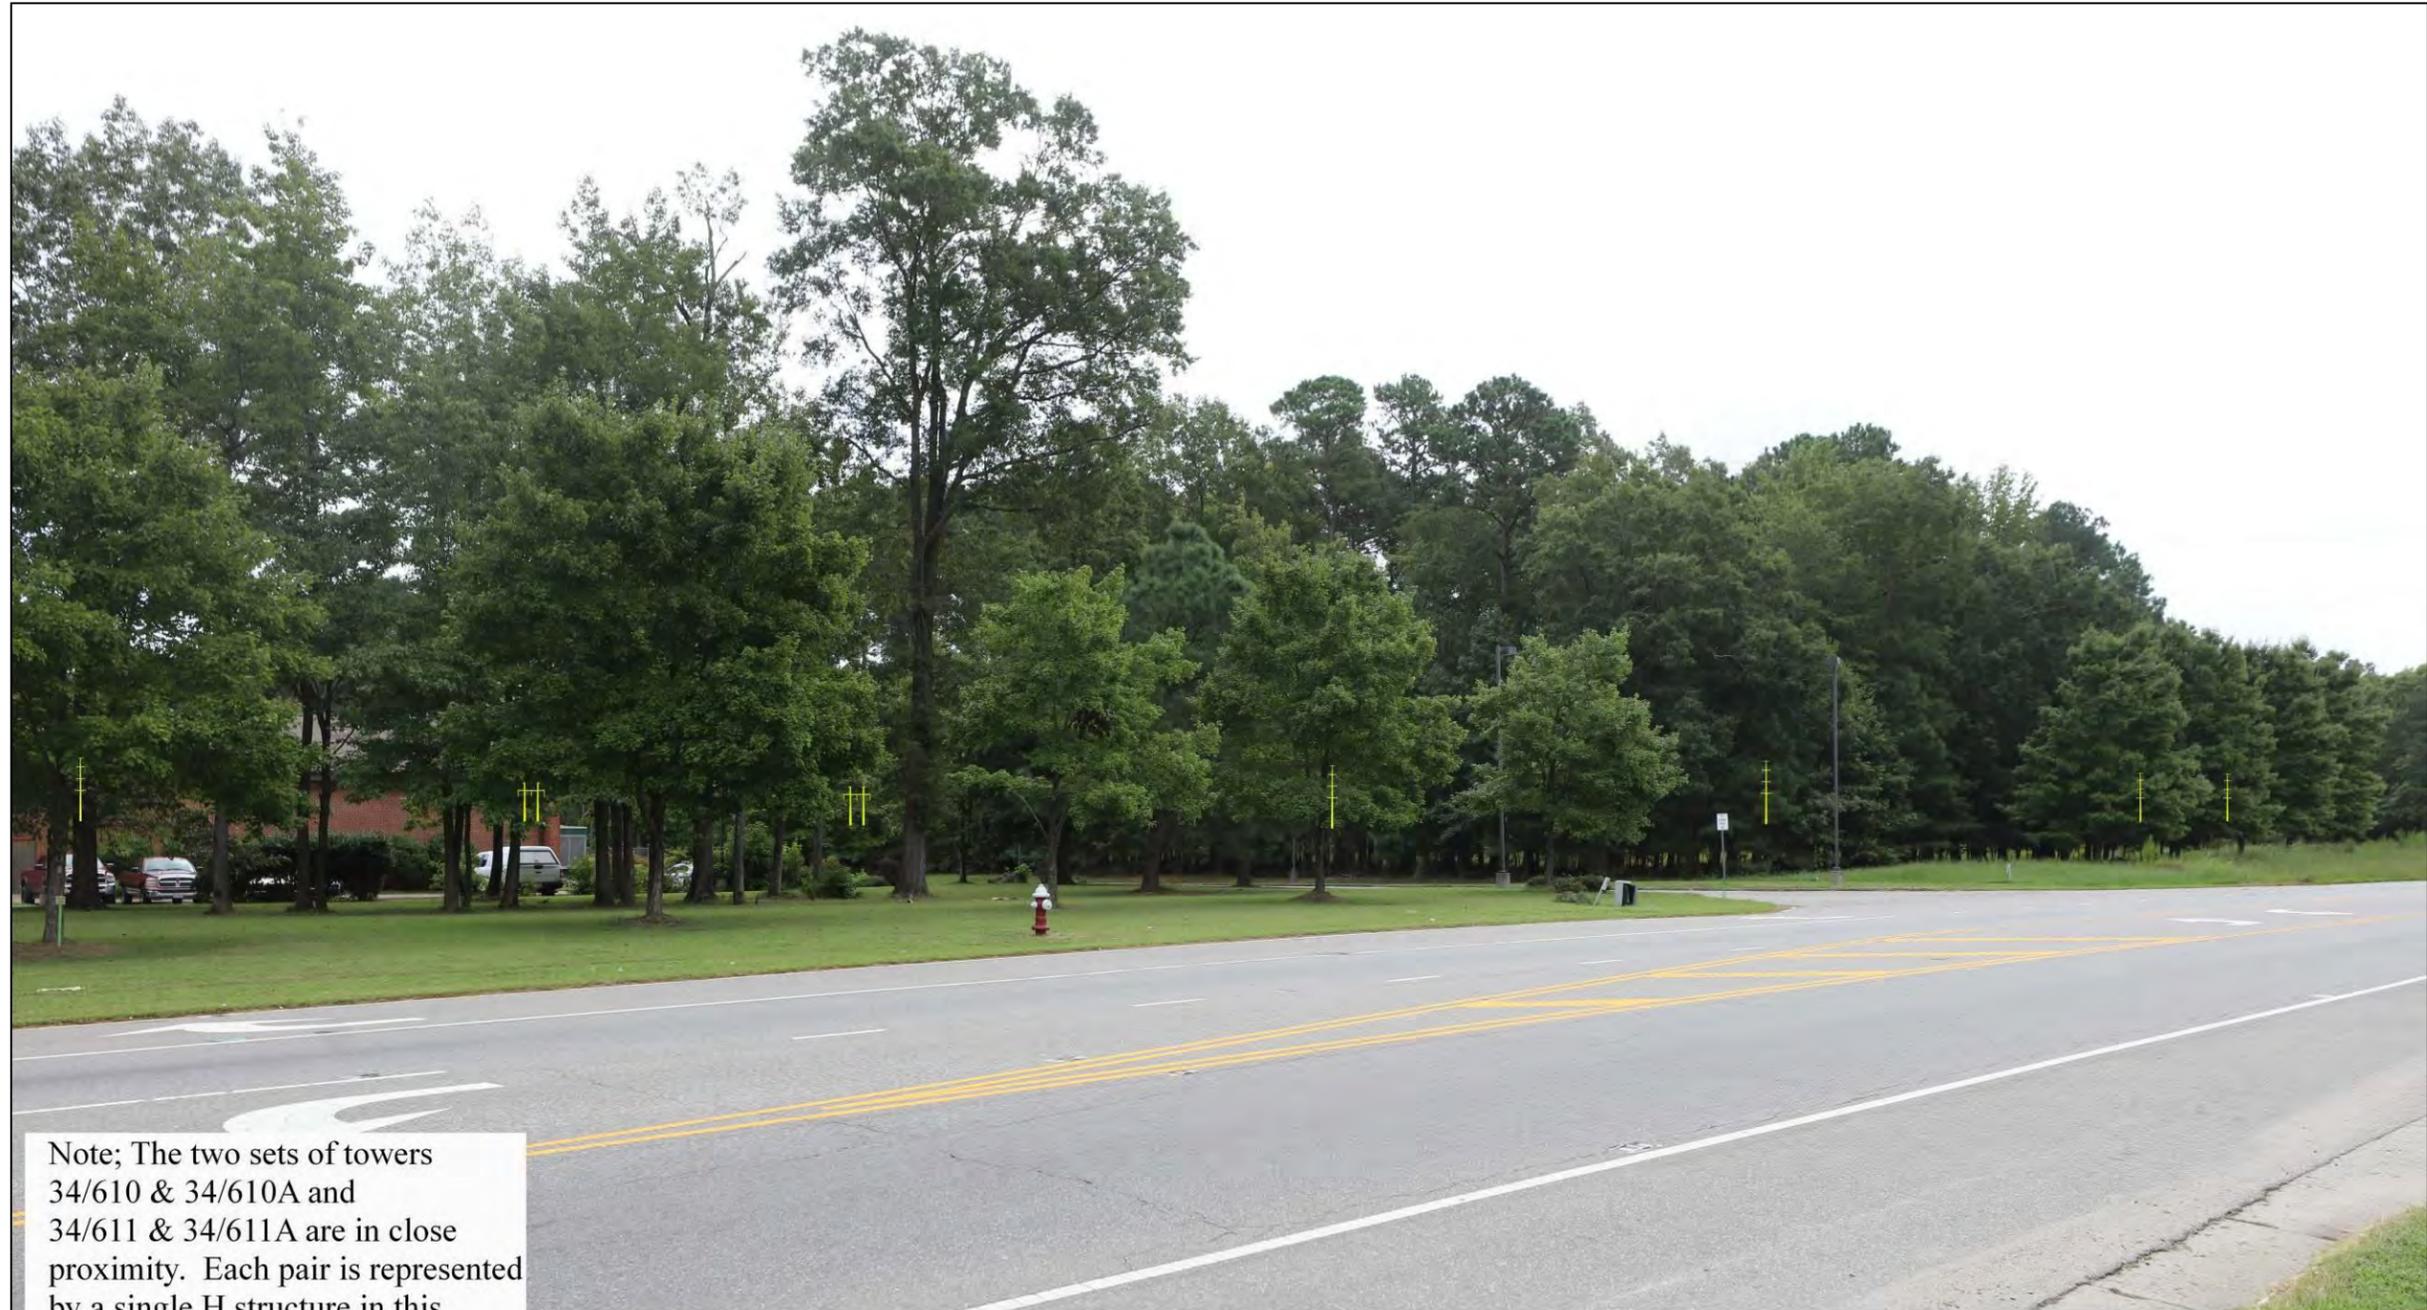
Note; The two sets of towers 34/610 & 34/610A and 34/611 & 34/611A are in close proximity. Each pair is represented by a single H structure in this simulation.

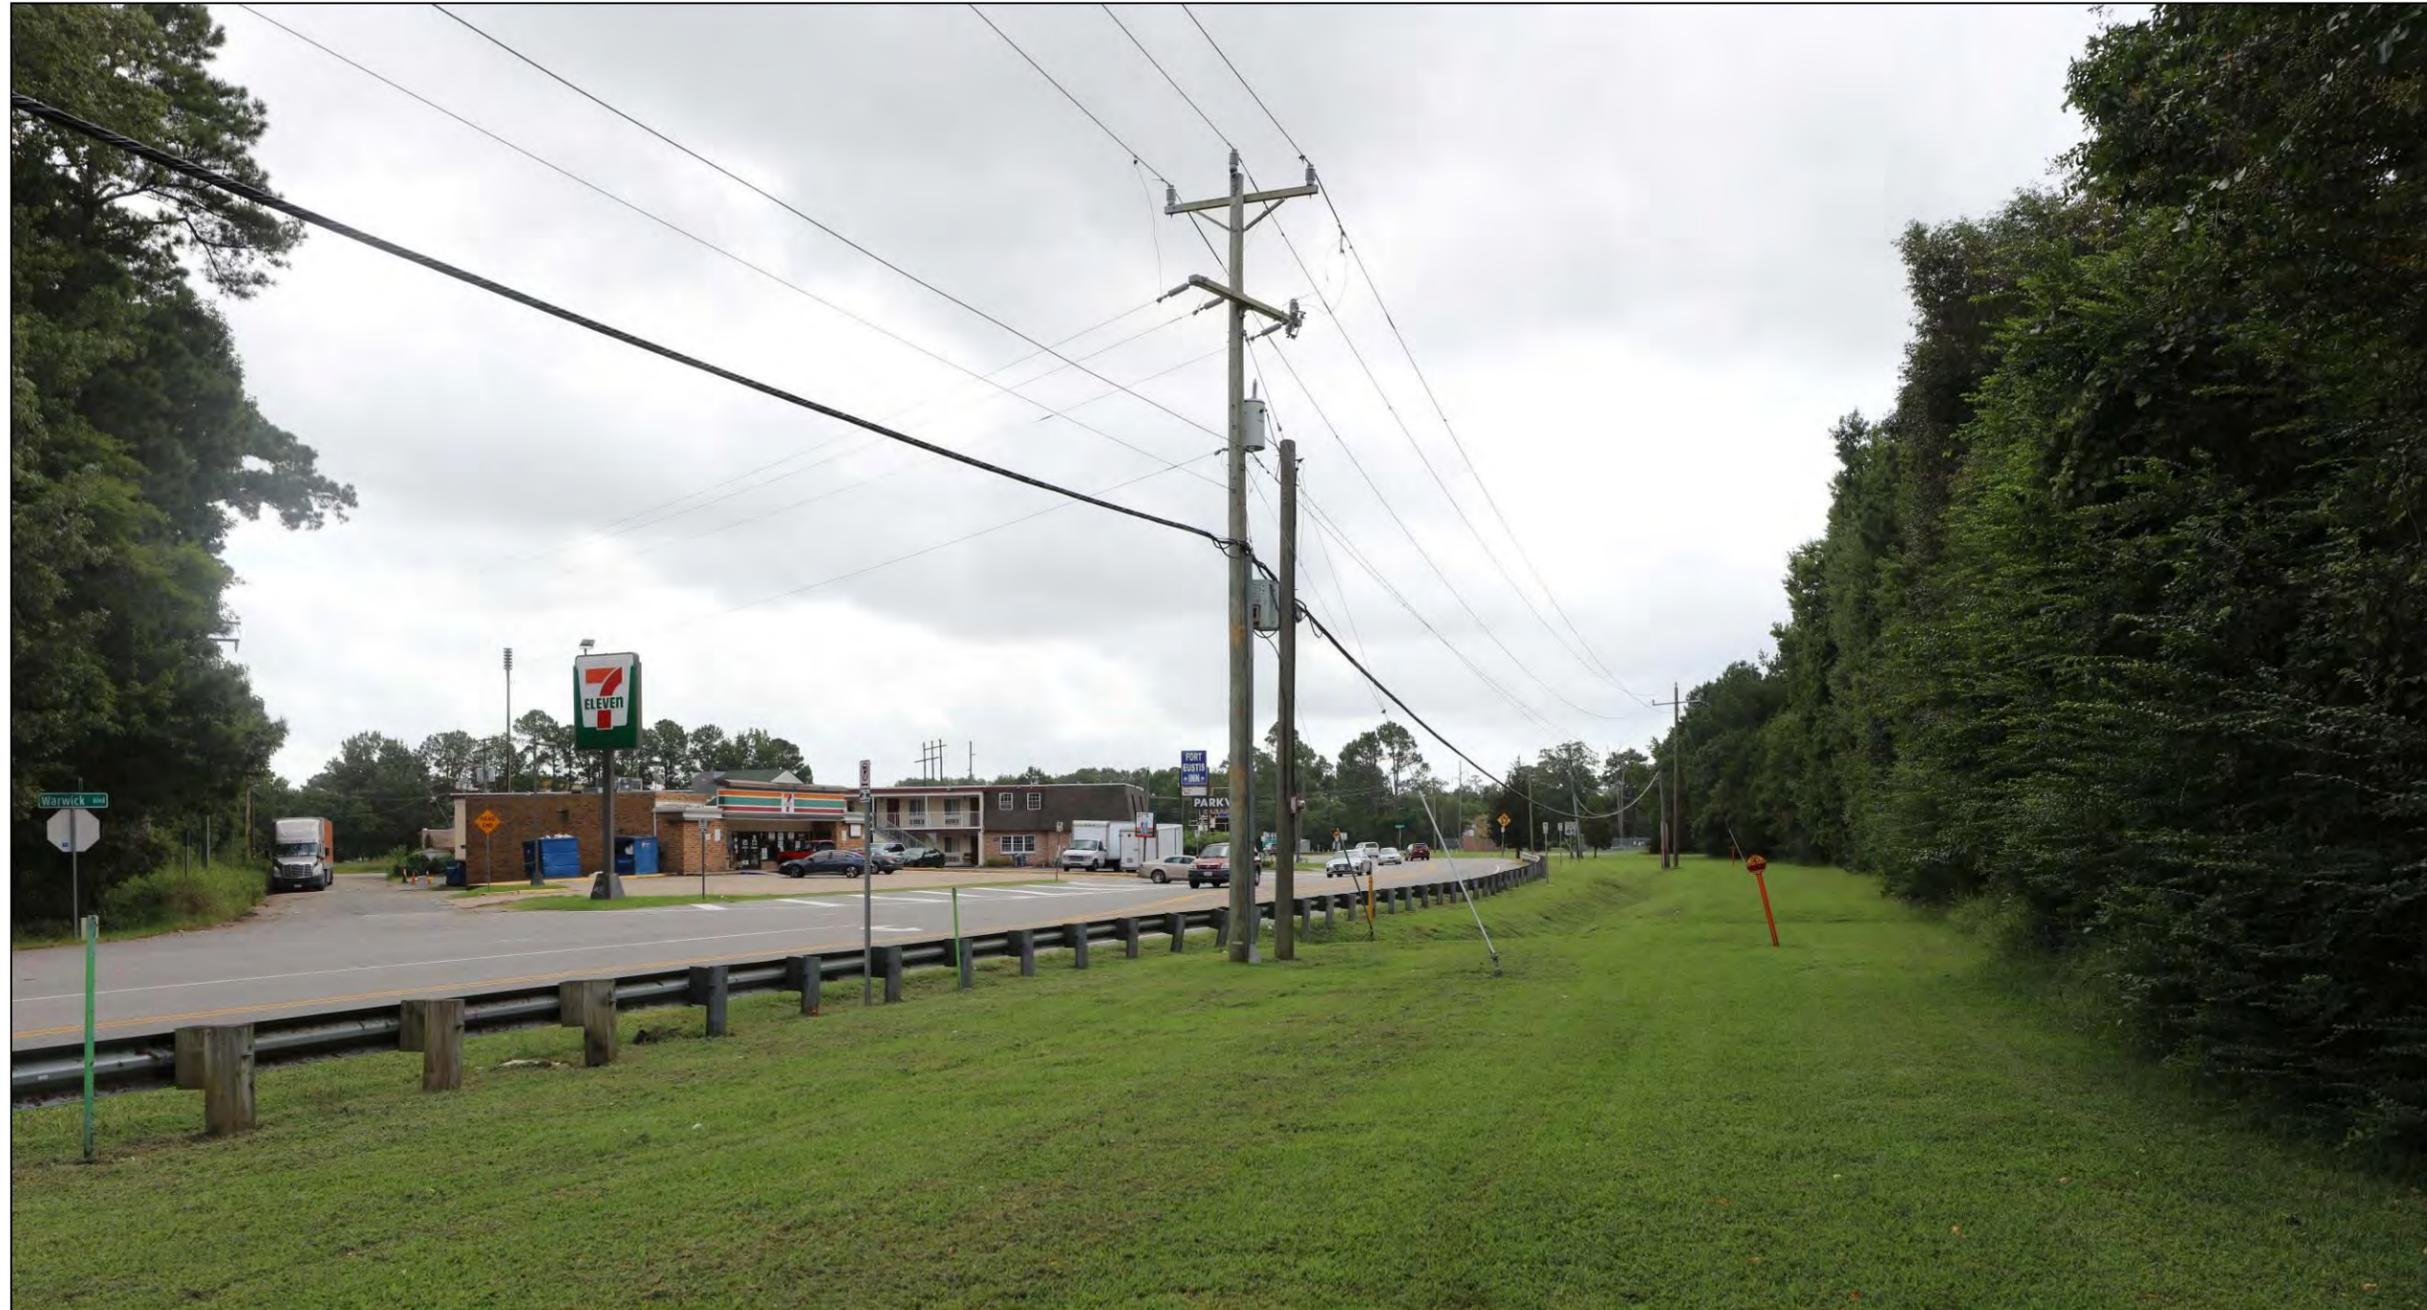
<p>Dominion Energy: Fort Eustis Tap Rebuild</p>	<p>Oakland Farm Earthworks 2 Existing View</p>

Photo simulations prepared by: GTTE LLC email: info@gttelle.com	Project: Dominion Energy Fort Eustis Tap Rebuild	34/614	1038/192, 34/166	100.00	714.00				
		34/615	1038/193, 34/165	100.00	841.00				
		34/616	1038/194, 34/164	115.00	1097.00				
		34/617	1038/195, 34/163	110.00	1524.00

Photo Sim 3: Location of photo sim 3 depicting field of view and modeled structures from Oakland Park Earthworks within the Williamsburg Battlefield. Source: GTTE LLC
