Phase I Cultural Resource Survey of the Fort Eustis Tap/Line 34 Rebuild Project

LOCATION > City of Newport News, Virginia

DATE > October 2020

PREPARED BY >
Dutton + Associates, LLC

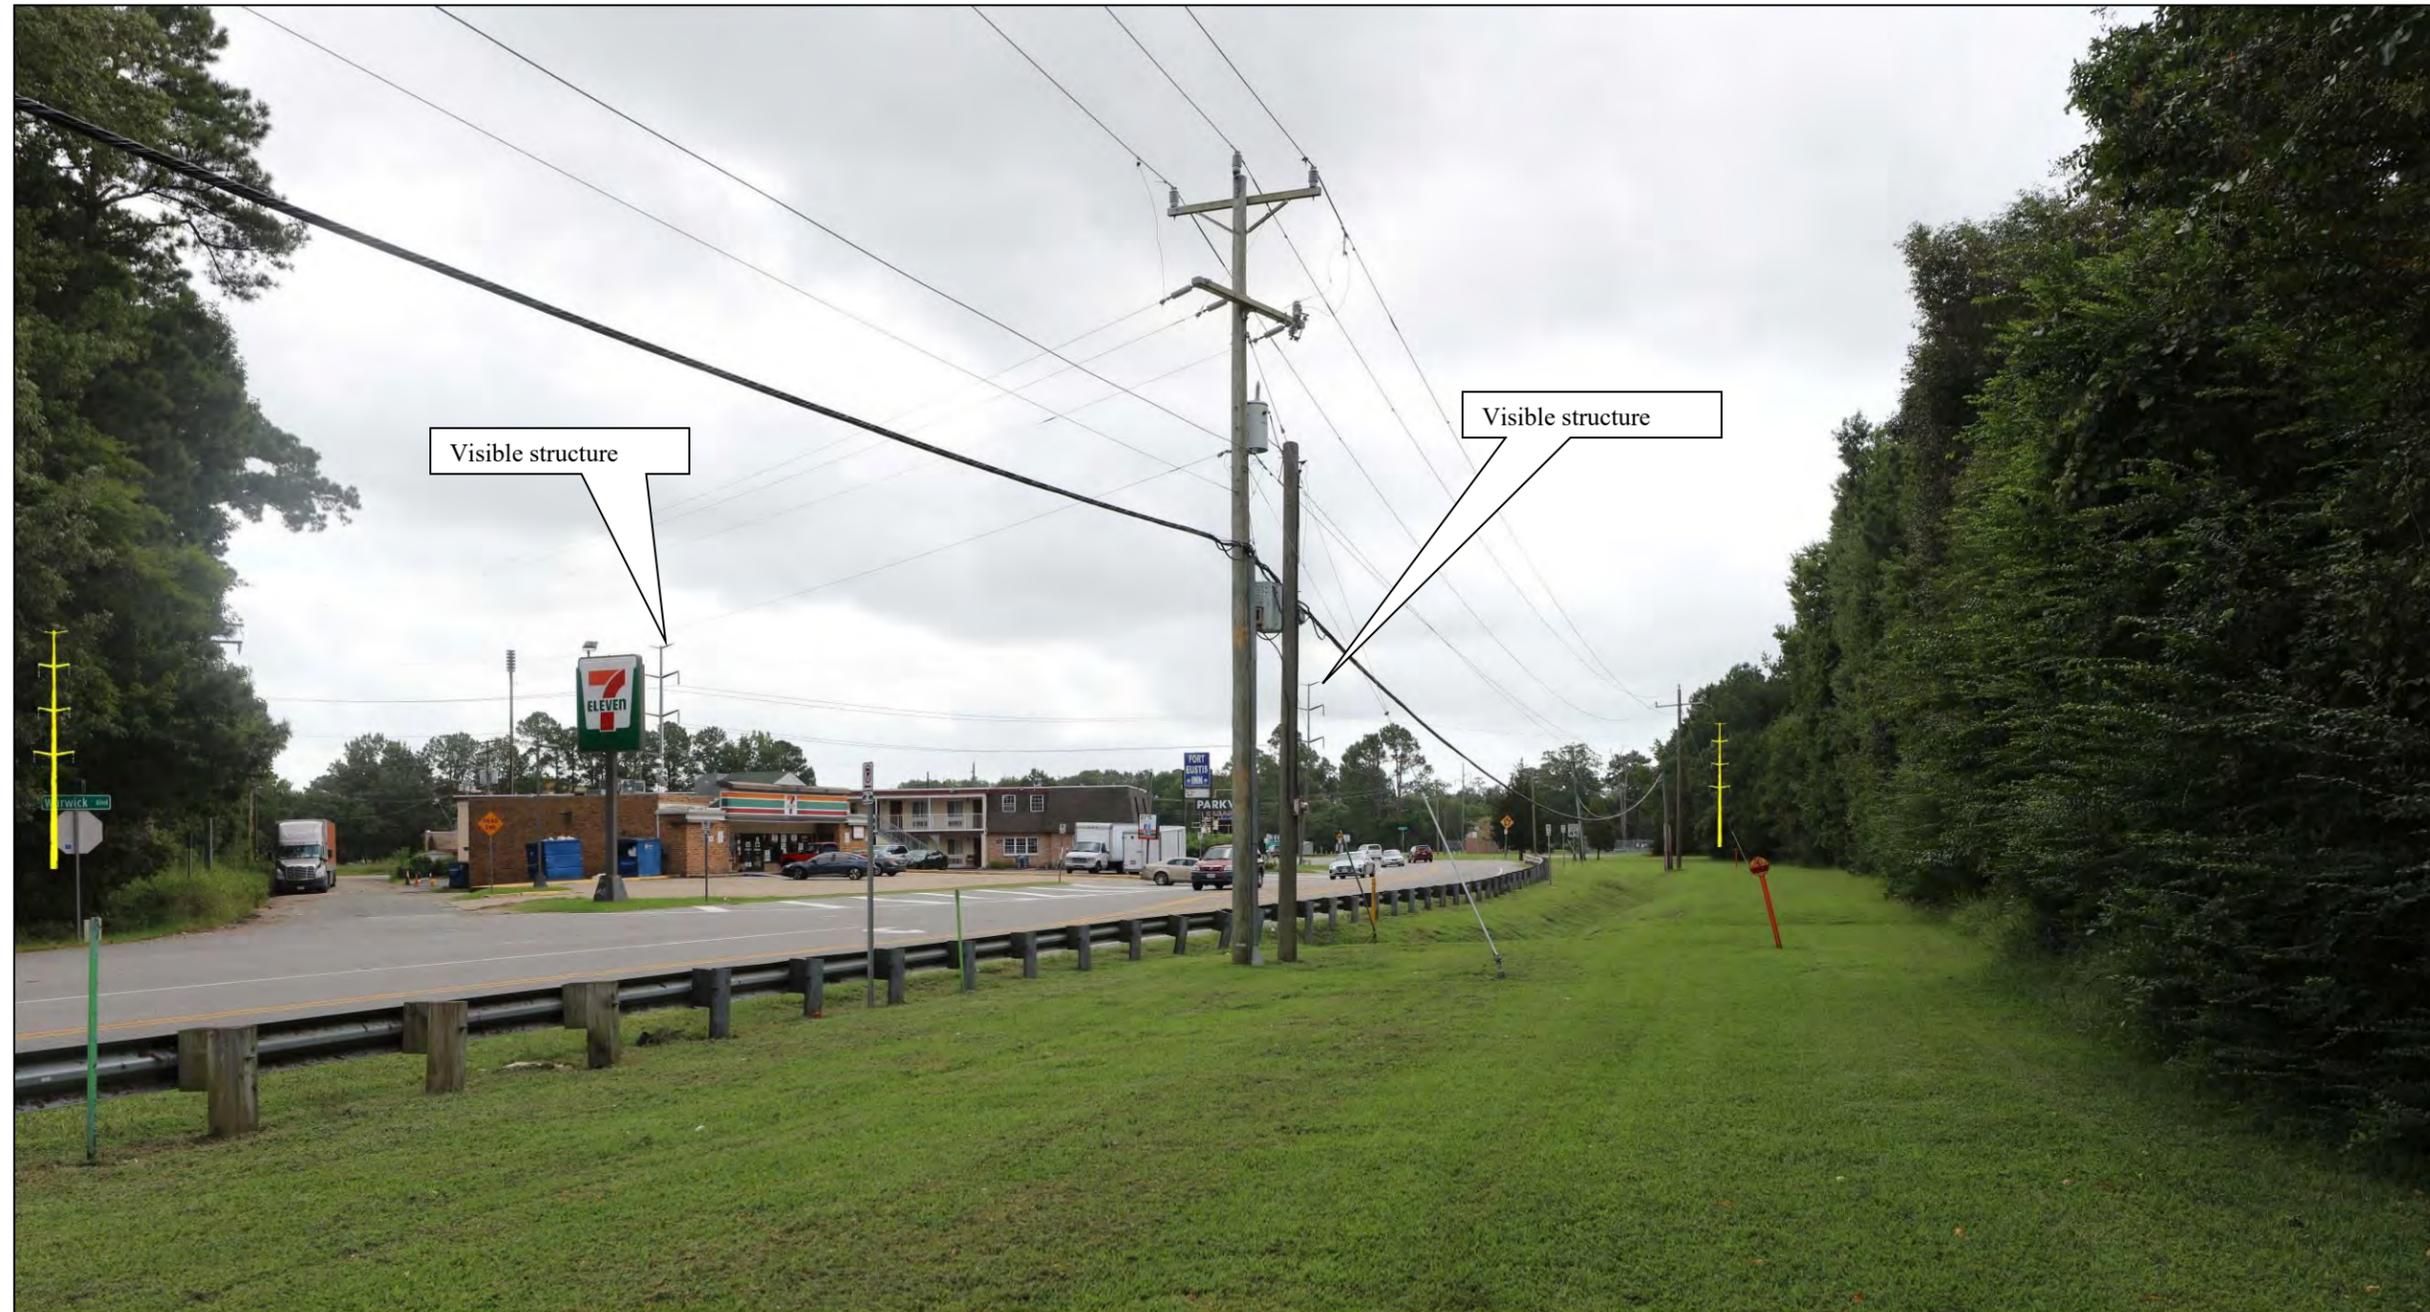
Dominion Energy: Fort Eustis Tap Rebuild	Oakland Farm Earthworks 2	Proposed View

Photo Sim 3: Photo sim 3 depicting existing view from Oakland Park Earthworks within the Williamsburg Battlefield. Source: GTTE LLC

<p>Photo simulations prepared by: GTTE LLC email: info@gttellc.com 703 447 1350</p>	<p>Photo simulations and diagrams represent approximate heights for electric transmission structures from the conceptual design used for the proposed project. These illustrations do not necessarily depict exact structure design or location. The approximate heights include foundation reveal (minimum of 18 inches) and are also subject to change based on final design.</p>

As the proposed replacement structures will average roughly 30-feet taller than the existing structures, there is the potential for a change in visibility. Because of the landscape of the APE, it is anticipated that any change would be minimal and limited to vantage points where the existing line is already visible. Photo simulation confirmed the replacement structures will continue to be visible where the existing structures already are, although in a different configuration. Simulation also revealed that the existing structures that are currently screened by vegetation will likely remain as such. Despite the increase in height, the thick vegetation throughout the portion of the battlefield within the APE will continue to screen visibility of the transmission line except for from vantage points immediately within the project area where views up and down the ROW allow visibility of the structures.

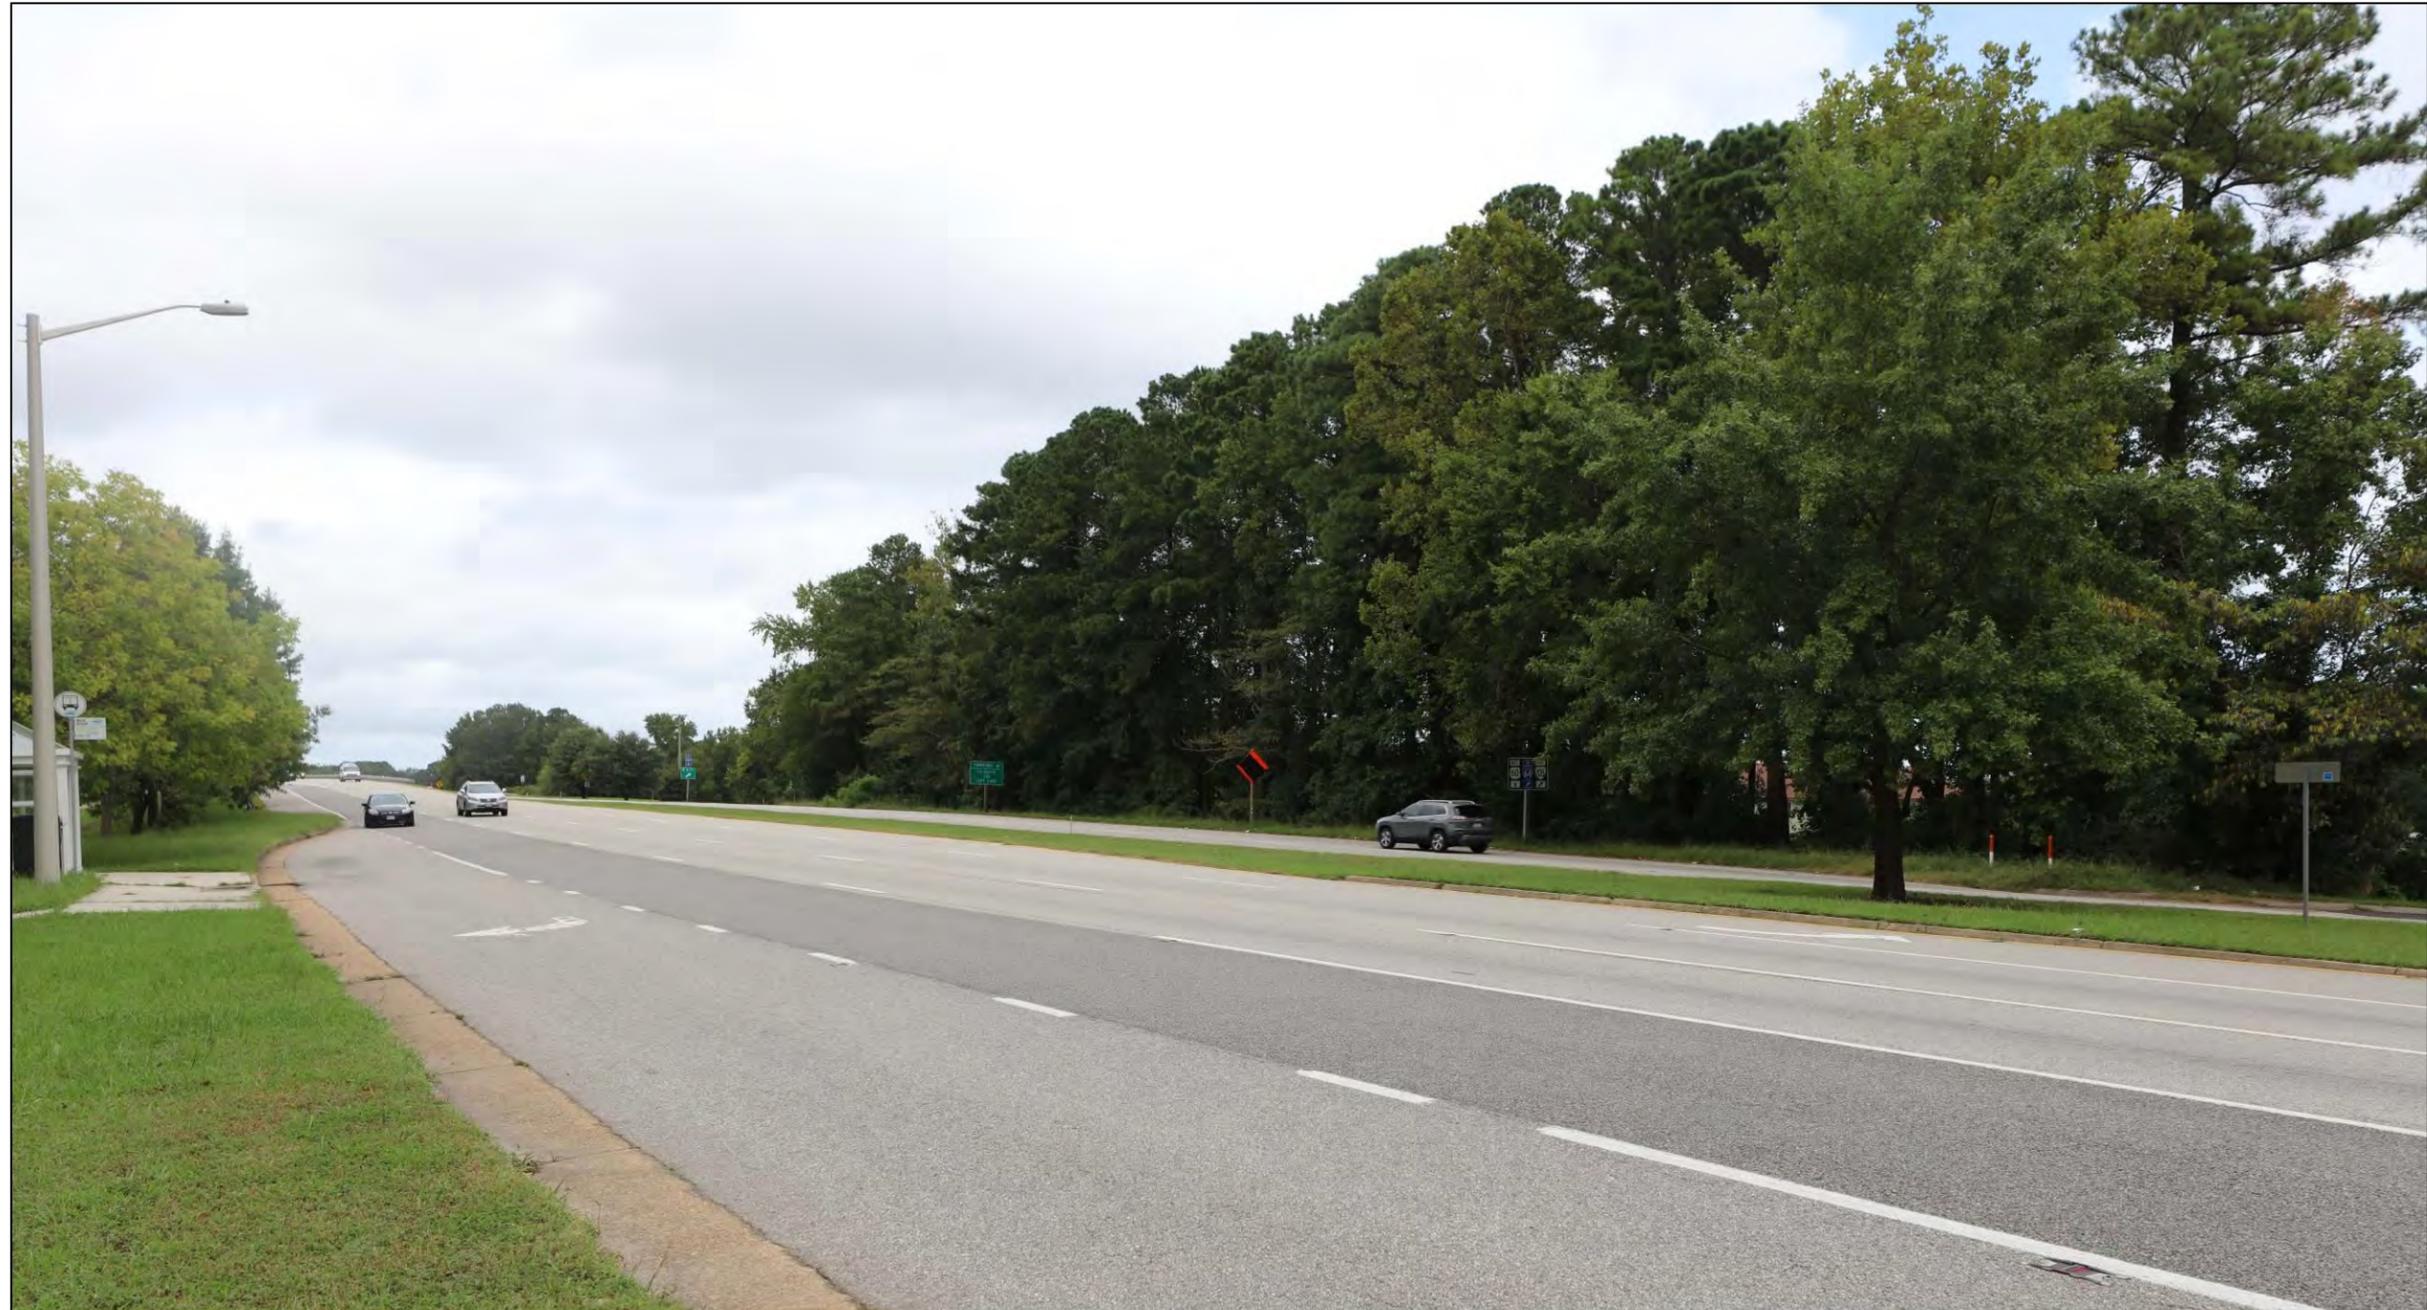
<p>Dominion Energy: Fort Eustis Tap Rebuild</p>	<p>Battle Field 1 Existing View</p>

Photo simulations prepared by: GTTE LLC email: info@gttelle.com	Project: Dominion Energy Fort Eustis Tap Rebuild	34/613	1038/191, 34/167	110.00	3244.00				
		34/614	1038/192, 34/166	100.00	2802.00				
		34/615	1038/193, 34/165	100.00	2642.00				
		34/616	1038/194, 34/164	115.00	2496.00

Photo Sim 4: Location of photo sim 4 depicting field of view and modeled structures from US-60 at Lees Mill Drive within the Williamsburg Battlefield. Source: GTTE LLC

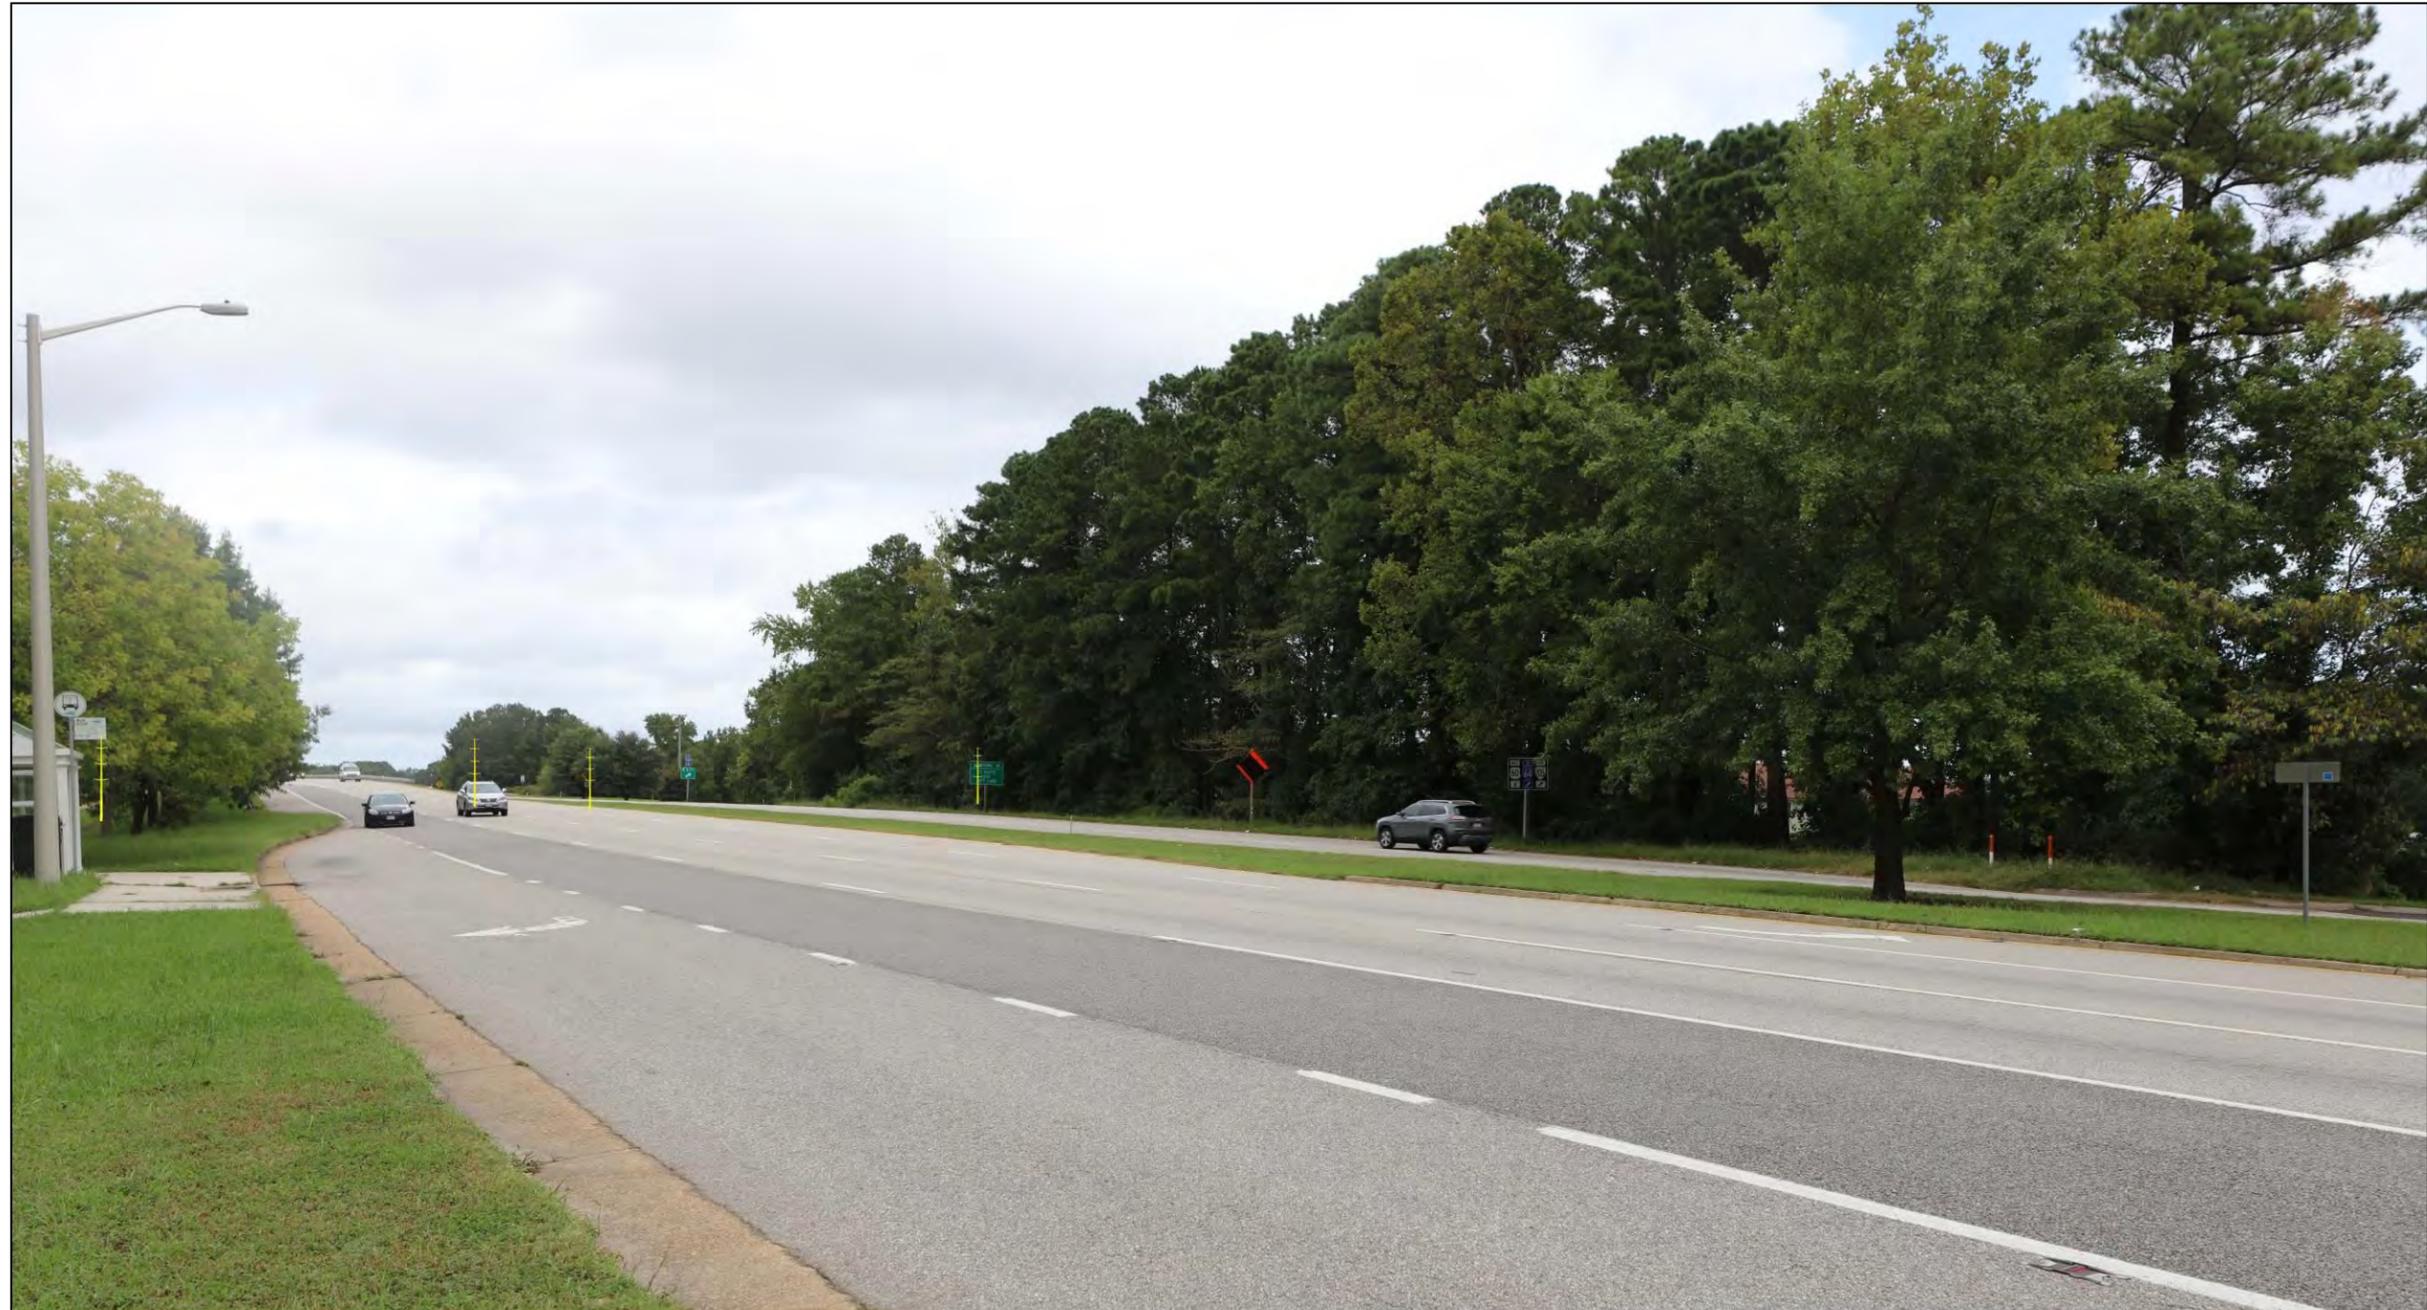
<p>Dominion Energy: Fort Eustis Tap Rebuild</p>	<p>Battle Field 1 Proposed View</p>

Photo Sim 4: Photo sim 4 depicting existing view from US-60 at Lees Mill Drive within the Williamsburg Battlefield. Source: GTTE LLC

Photo Sim 4: Photo sim 4 depicting proposed view from US-60 at Lees Mill Drive within the Williamsburg Battlefield (Structures not visible are illustrated in yellow). Source: GTTE LLC

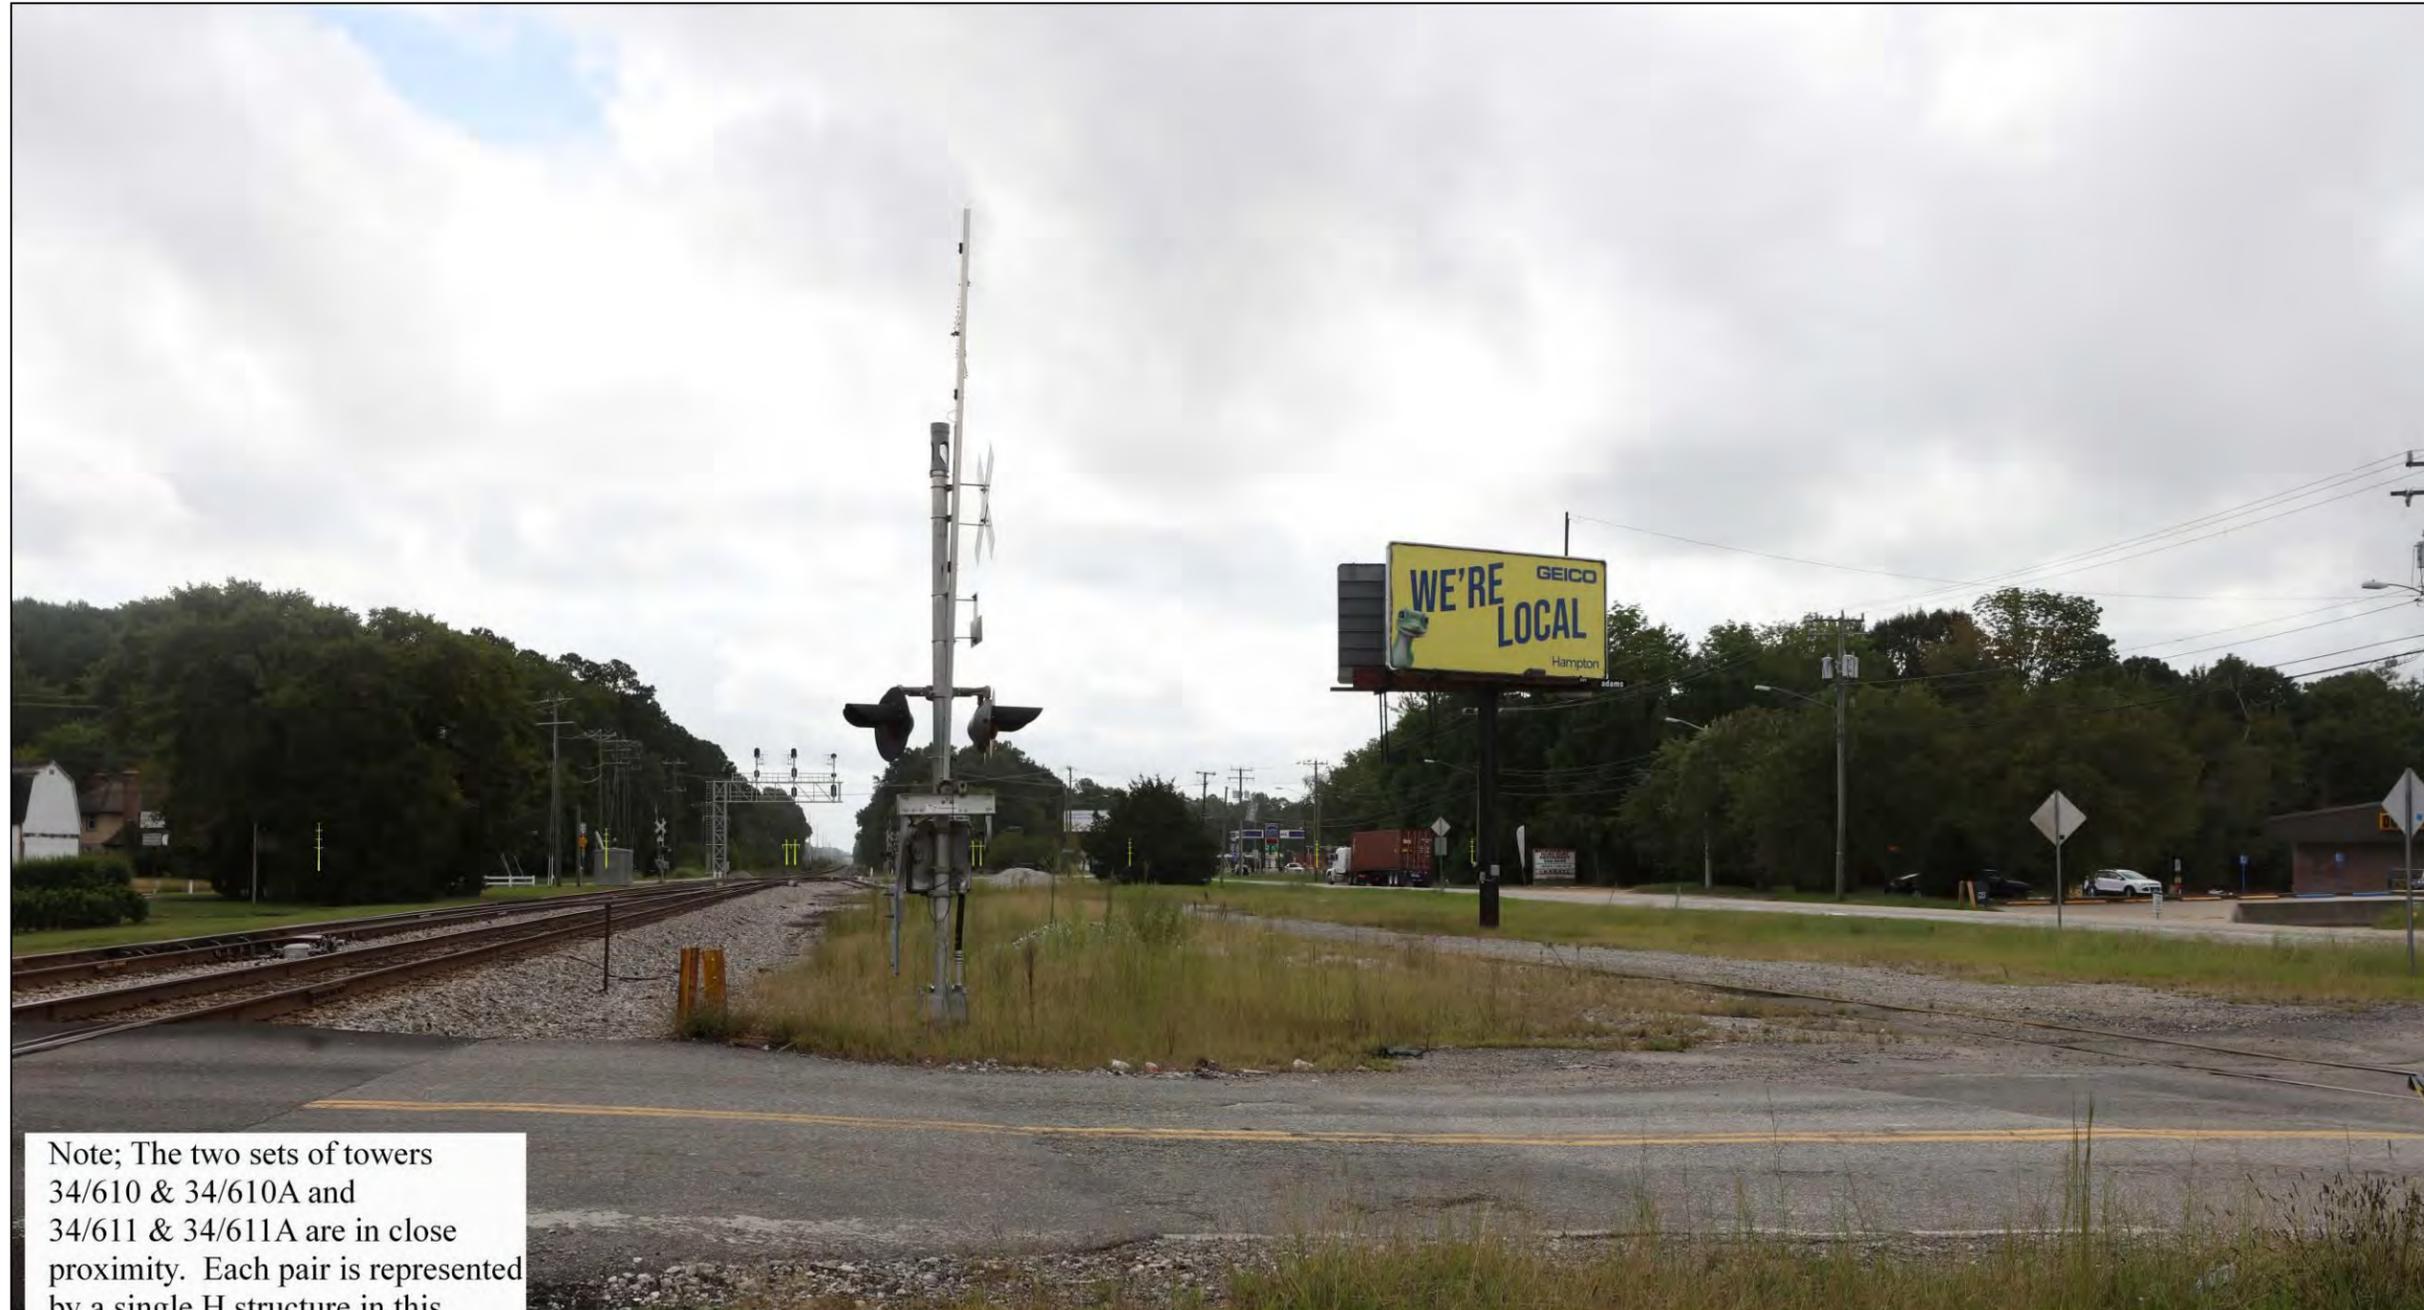
Note; The two sets of towers 34/610 & 34/610A and 34/611 & 34/611A are in close proximity. Each pair is represented by a single H structure in this simulation.

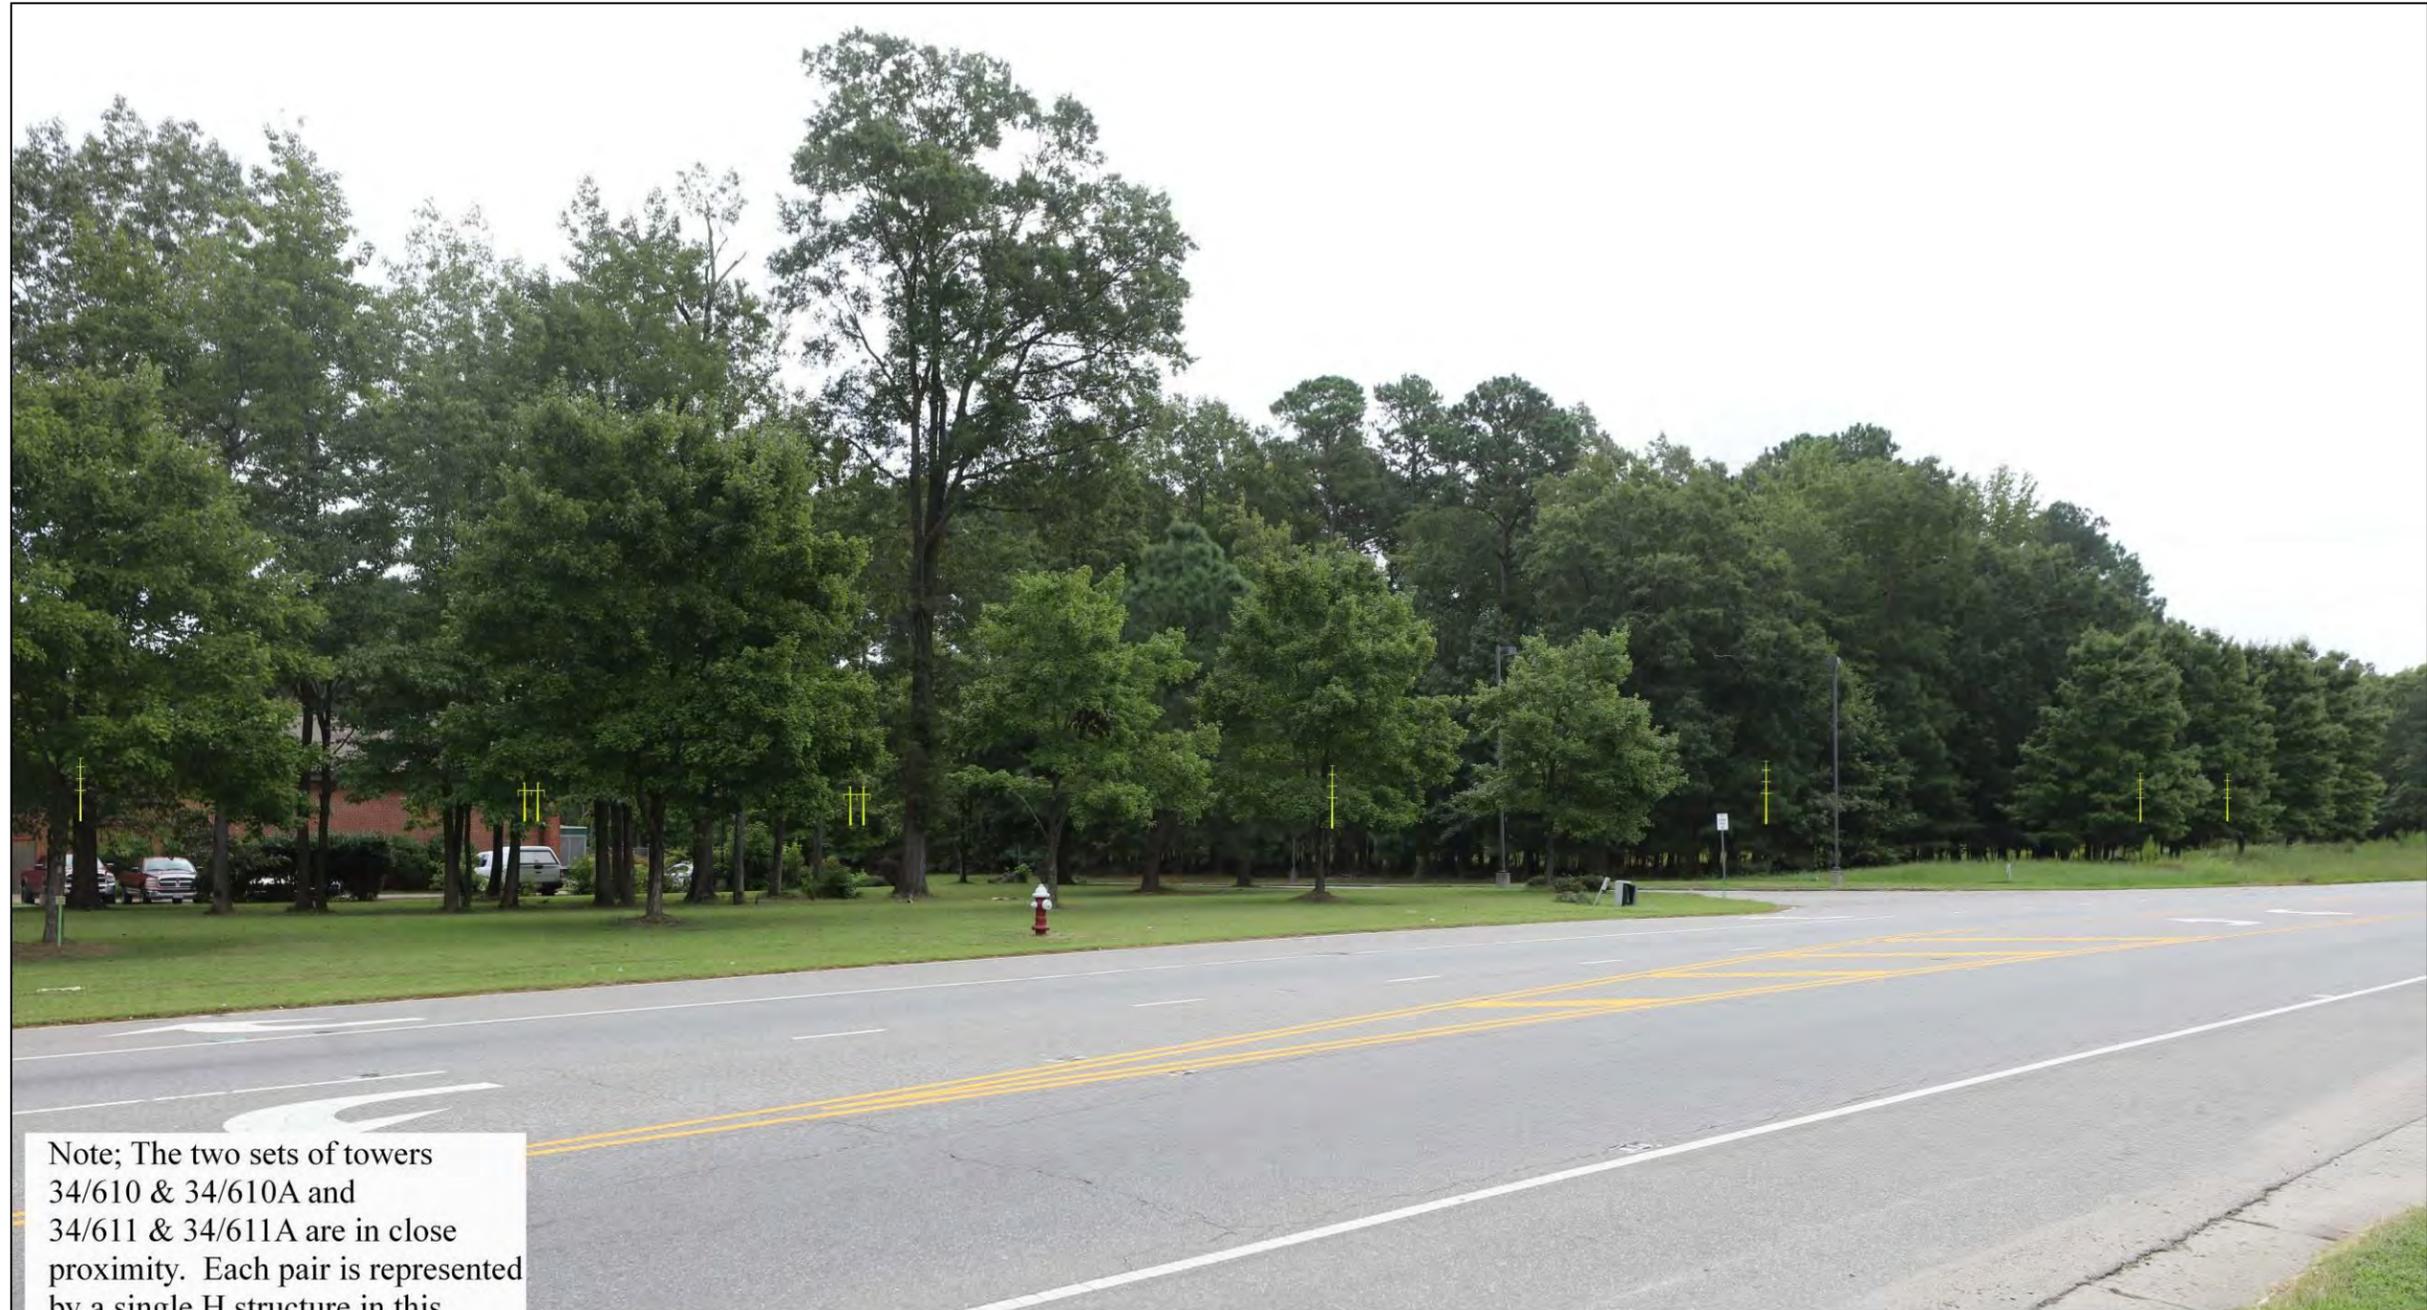
Note; The two sets of towers 34/610 & 34/610A and 34/611 & 34/611A are in close proximity. Each pair is represented by a single H structure in this simulation.

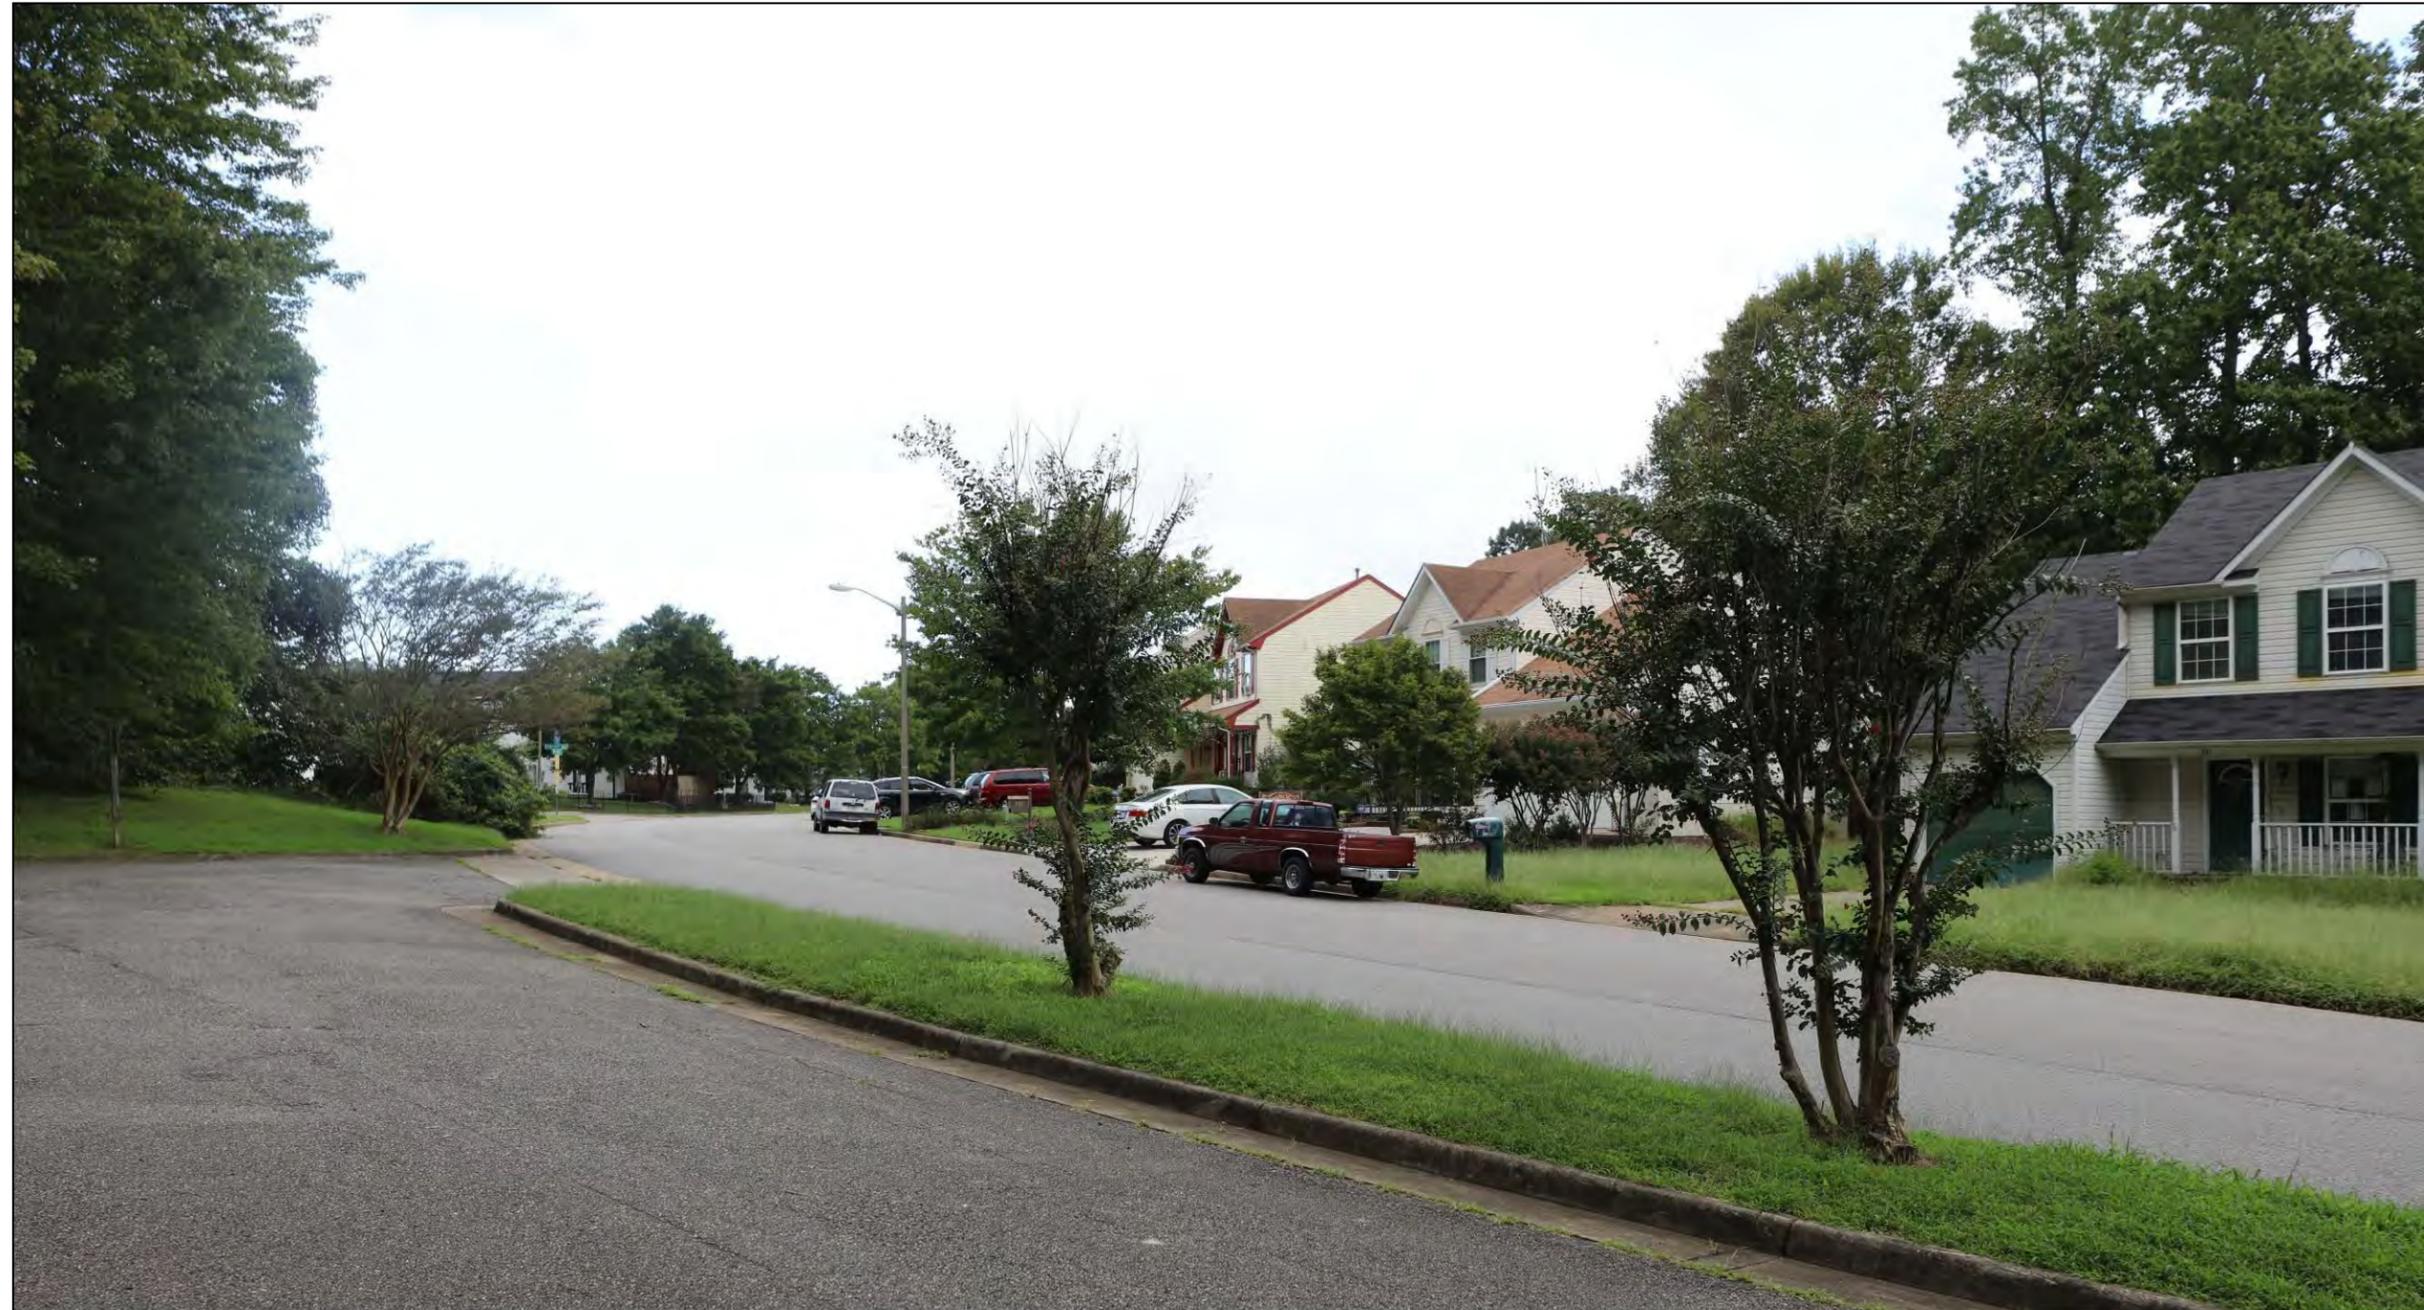
<p>Dominion Energy: Fort Eustis Tap Rebuild</p>	<p>Lee Mill Earthworks Existing View</p>

Photo simulations prepared by: GTTE LLC email: info@gttellc.com	Project: Dominion Energy Fort Eustis Tap Rebuild	34/617	1038/195, 34/163	110.00	3306.00	34/621	1038/199, 34/159	110.00	2841.00
		34/618	1038/196, 34/162	110.00	3097.00	34/622	1038/200, 34/158	110.00	2873.00
		34/619	1038/197, 34/161	110.00	2960.00	34/623	1038/201, 34/157	110.00	2983.00
		34/620	1038/198, 34/160	110.00	2864.00

Photo Sim 5: Location of photo sim 5 depicting field of view and modeled structures from Lees Mill Earthworks within the Yorktown Battlefield. Source: GTTE LLC

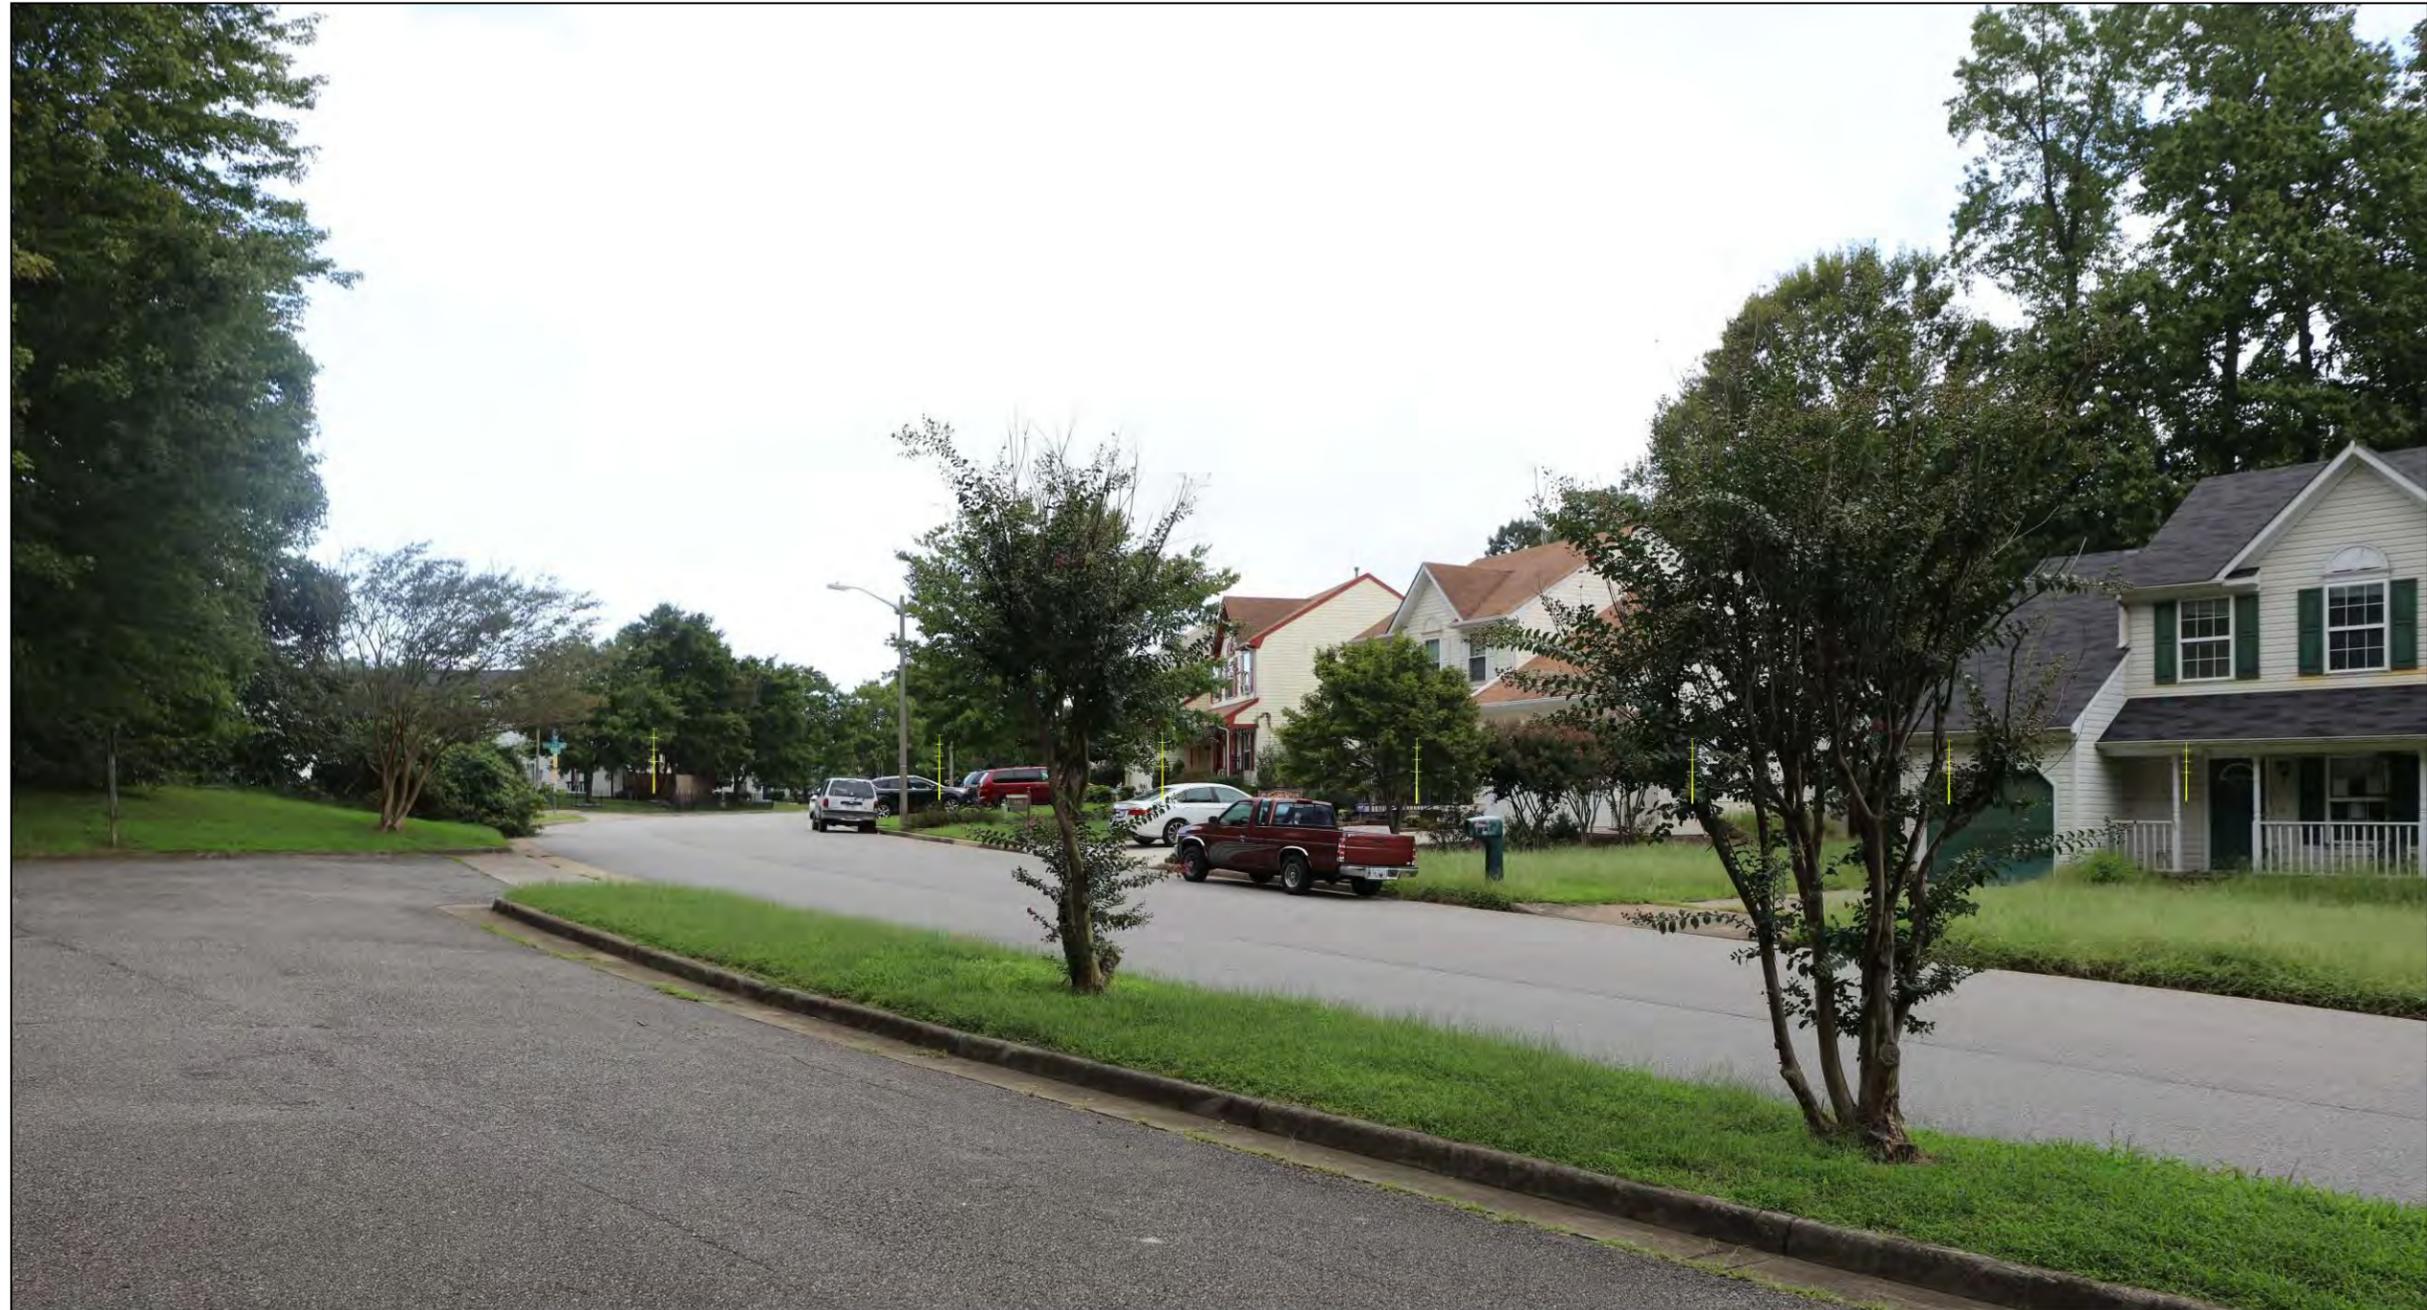
<p>Dominion Energy: Fort Eustis Tap Rebuild</p>	<p>Lee Mill Earthworks Proposed View</p>

Photo Sim 5: Photo sim 5 depicting existing view from Lees Mill Earthworks within the Yorktown Battlefield. Source: GTTE LLC

Photo Sim 5: Photo sim 5 depicting proposed view from Lees Mill Earthworks within the Yorktown Battlefield (Structures not visible are illustrated in yellow). Source: GTTE, LLC
