Phase I Cultural Resource Survey of the Fort Eustis Tap/Line 34 Rebuild Project

LOCATION > City of Newport News, Virginia

DATE > October 2020

PREPARED BY >
Dutton + Associates, LLC

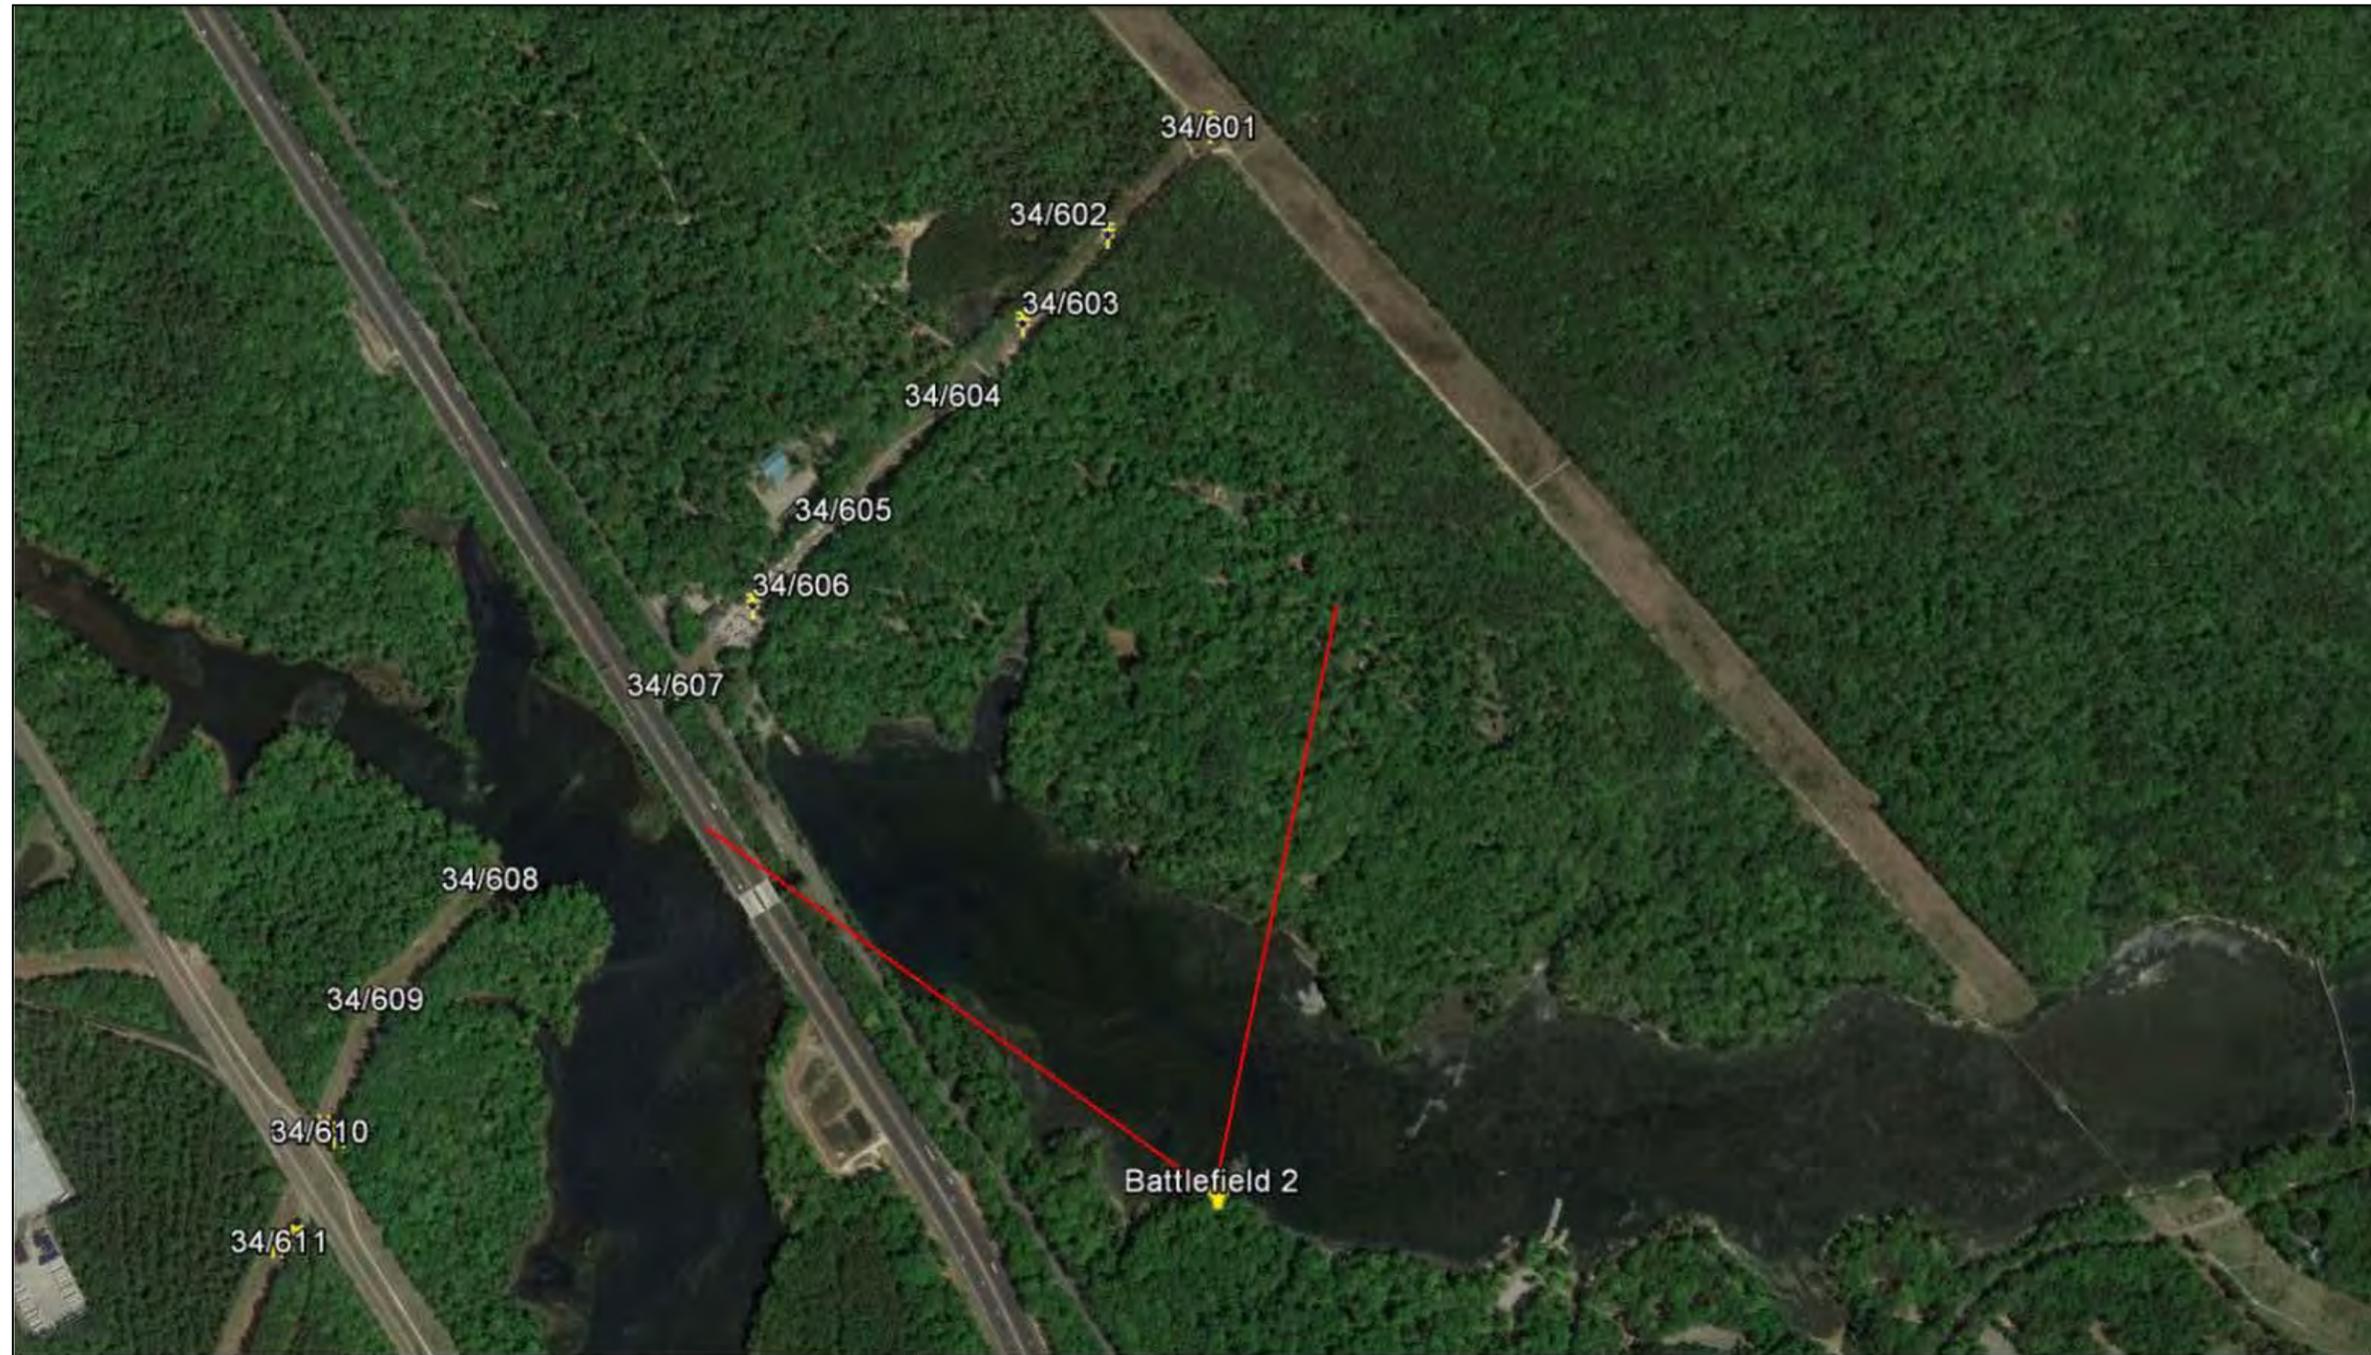
Photo location: Battle Field 2		Structure Name	Structure New Name	Height ft	Distance ft	Structure Name	Structure New Name	Height ft	Distance ft

Photo simulations prepared by: GTTE LLC email: info@gttelle.com	Project: Dominion Energy Fort Eustis Tap Rebuild	34/601	1038/179, 34/179	85	4052	34/605	1038/183, 34/175	100	2965
		34/602	1038/180, 34/178	95	3666	34/606	1038/184, 34/174	100	2858
		34/603	1038/181, 34/177	90	3386	34/607	1038/185, 34/173	130	2833
		34/604	1038/182, 34/176	90	3195

Photo Sim 6: Location of photo sim 6 depicting field of view and modeled structures from Newport News Park within the Yorktown Battlefield. Source: GTTE LLC

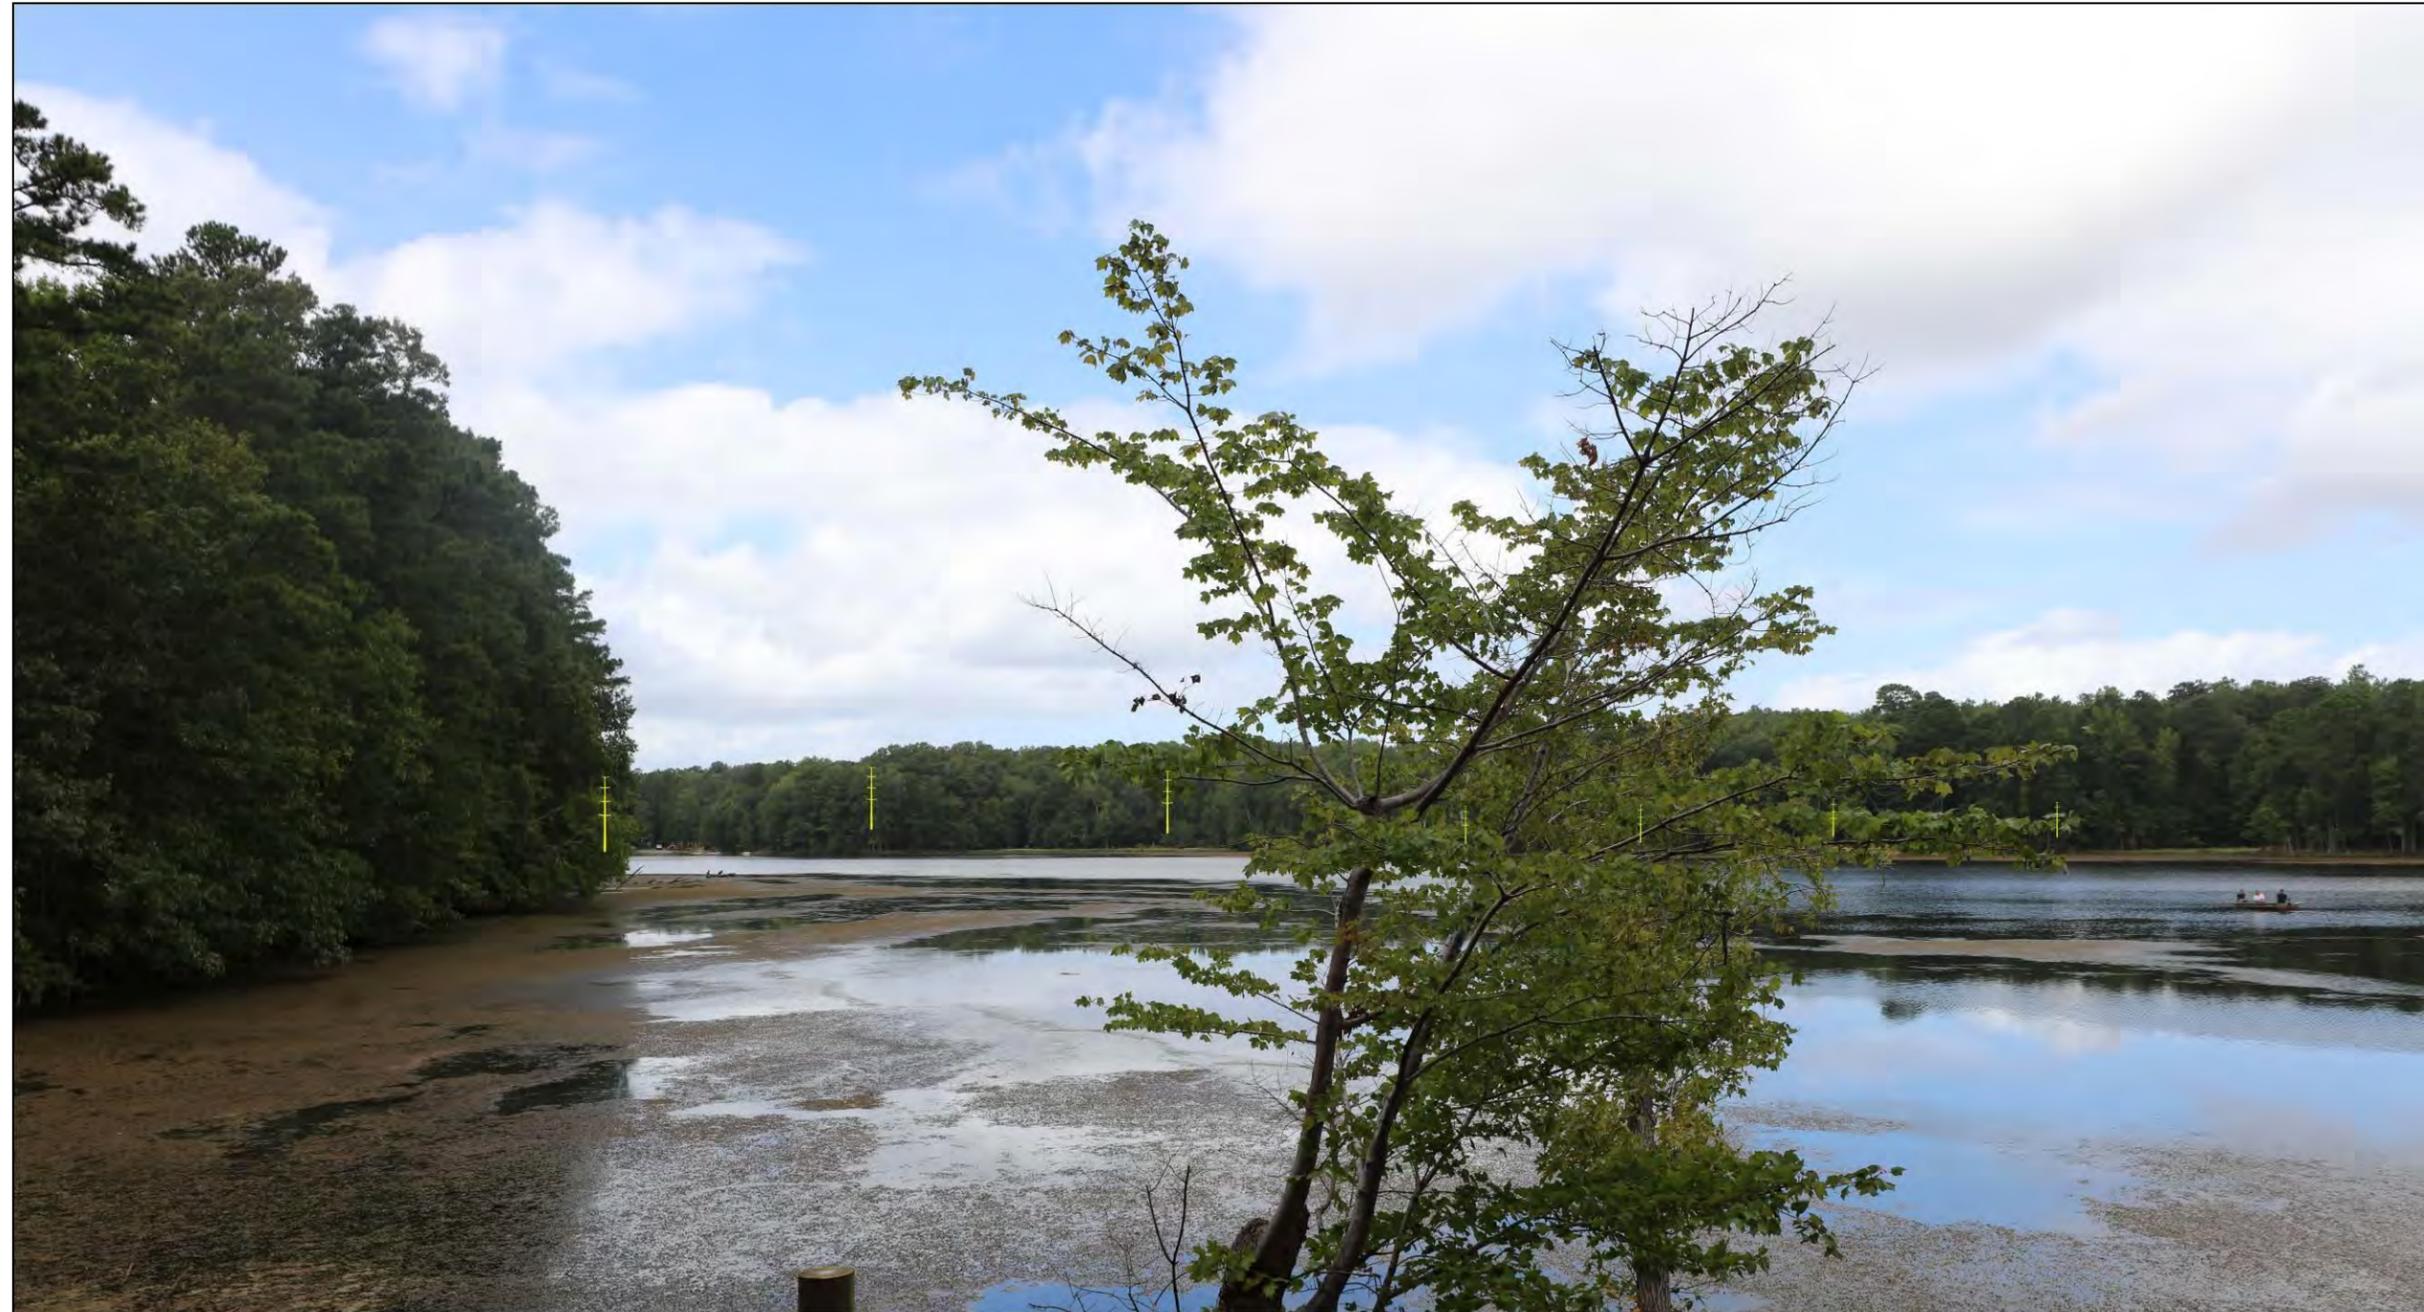
Photo Sim 6: Photo sim 6 depicting existing view from Newport News Park within the Yorktown Battlefield. Source: GTTE LLC

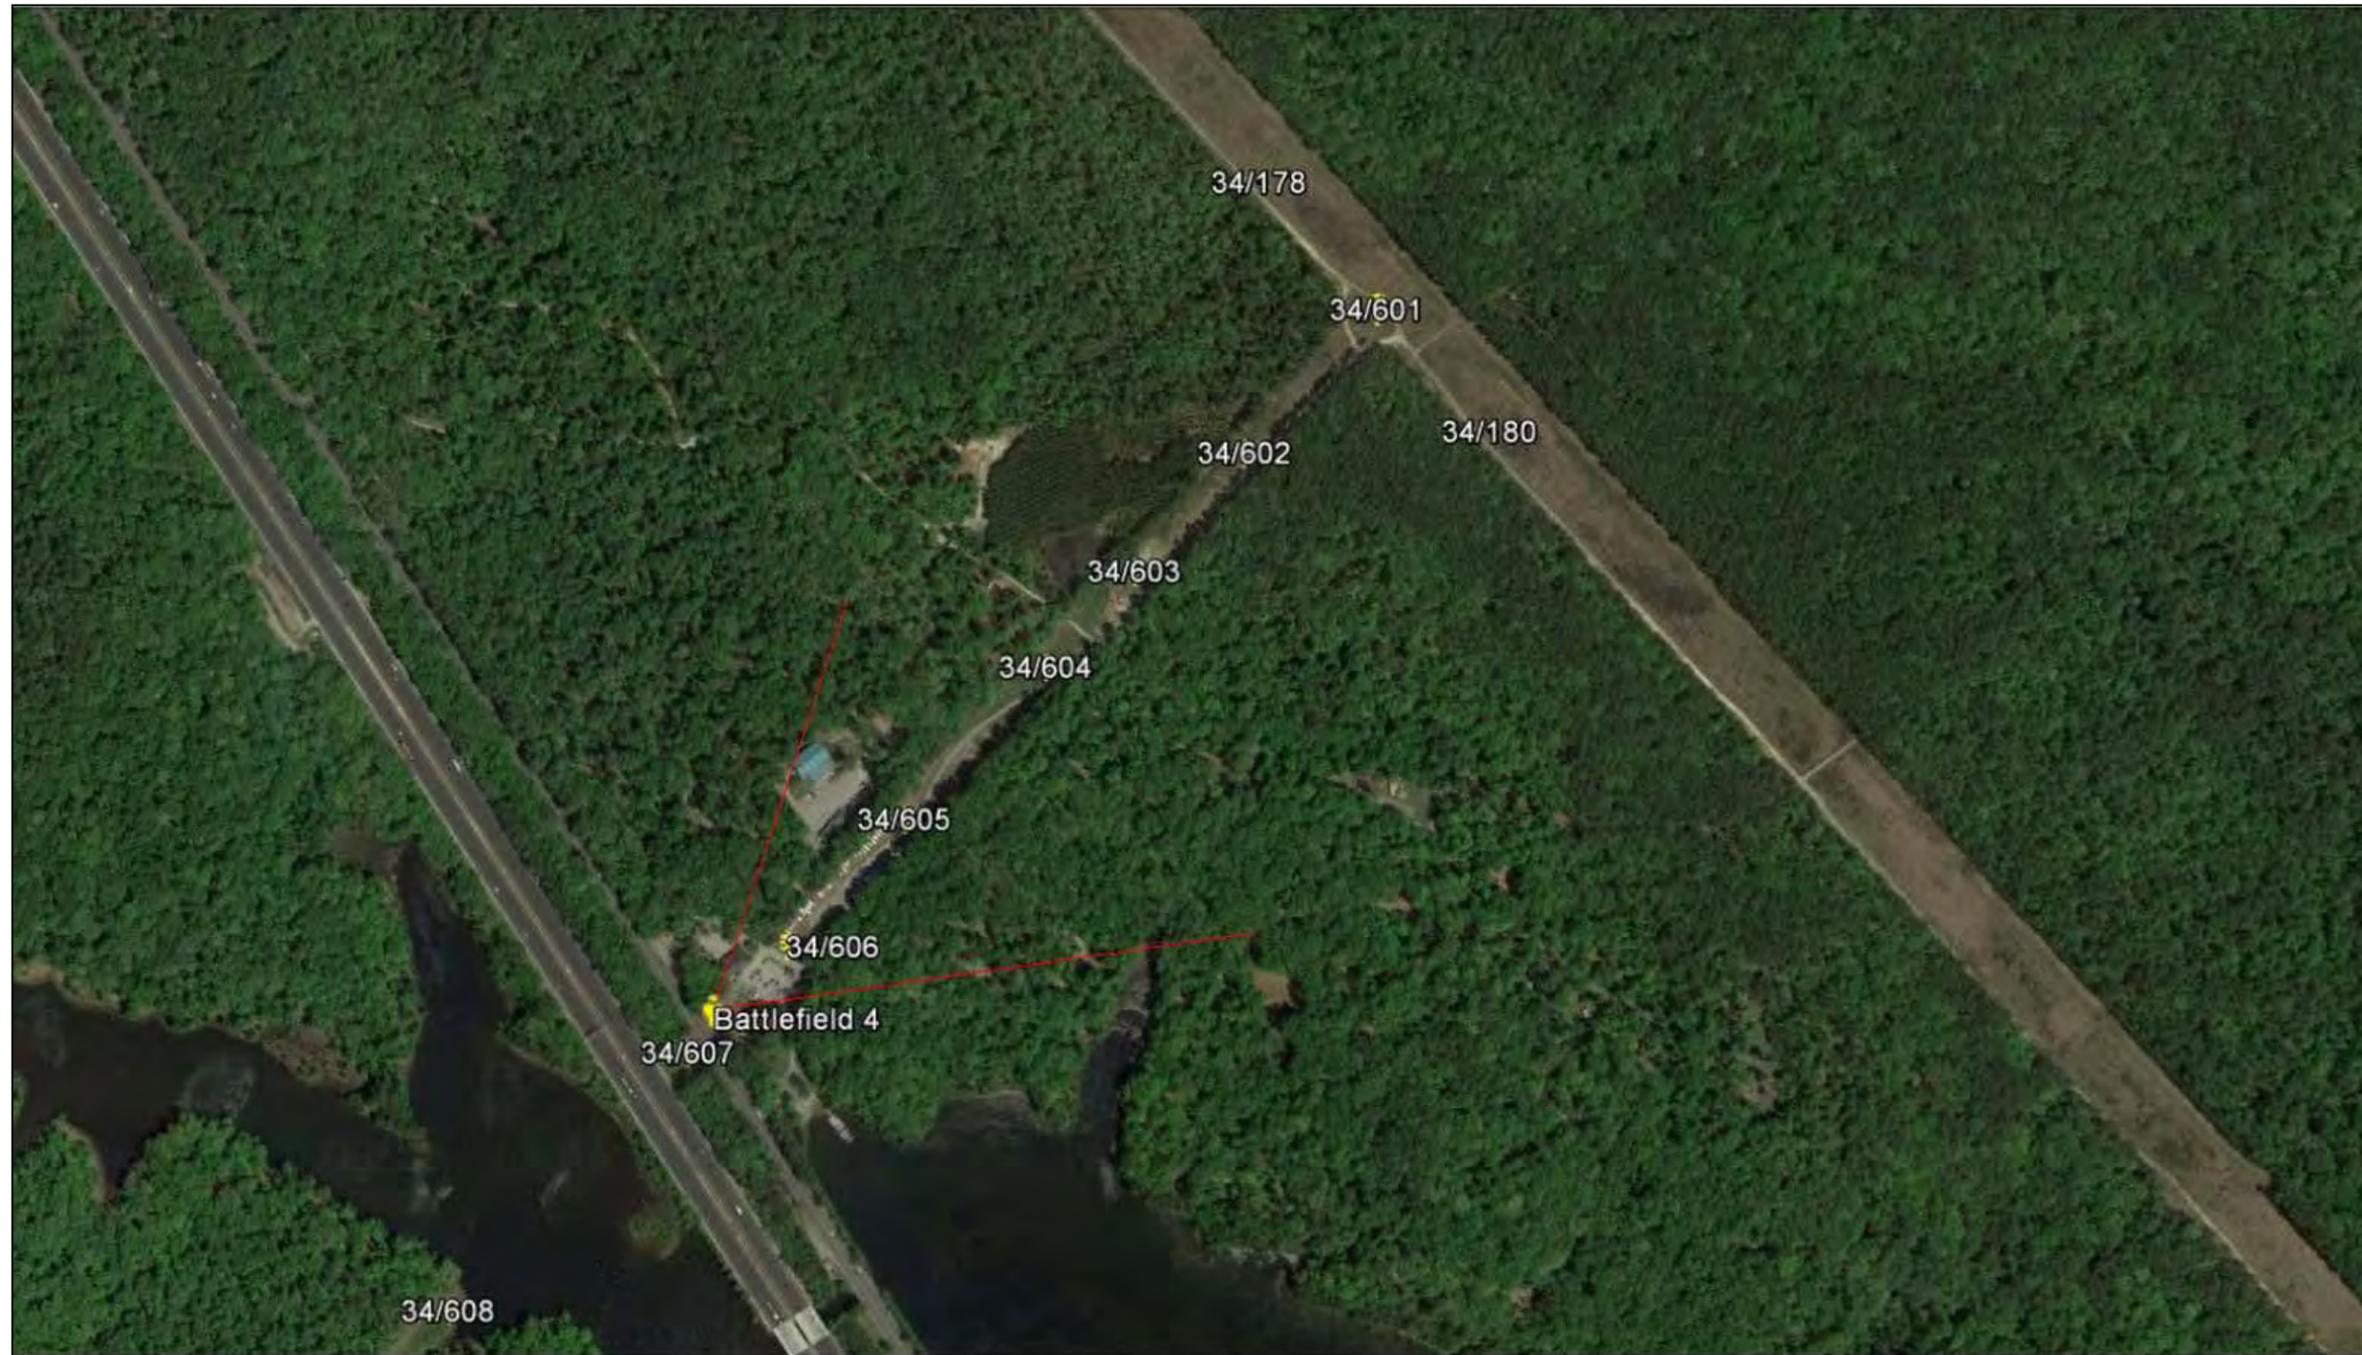
Photo Sim 6: Photo sim 6 depicting proposed view from Newport News Park within the Yorktown Battlefield (Structures not visible are illustrated in yellow). Source: GTTE LLC

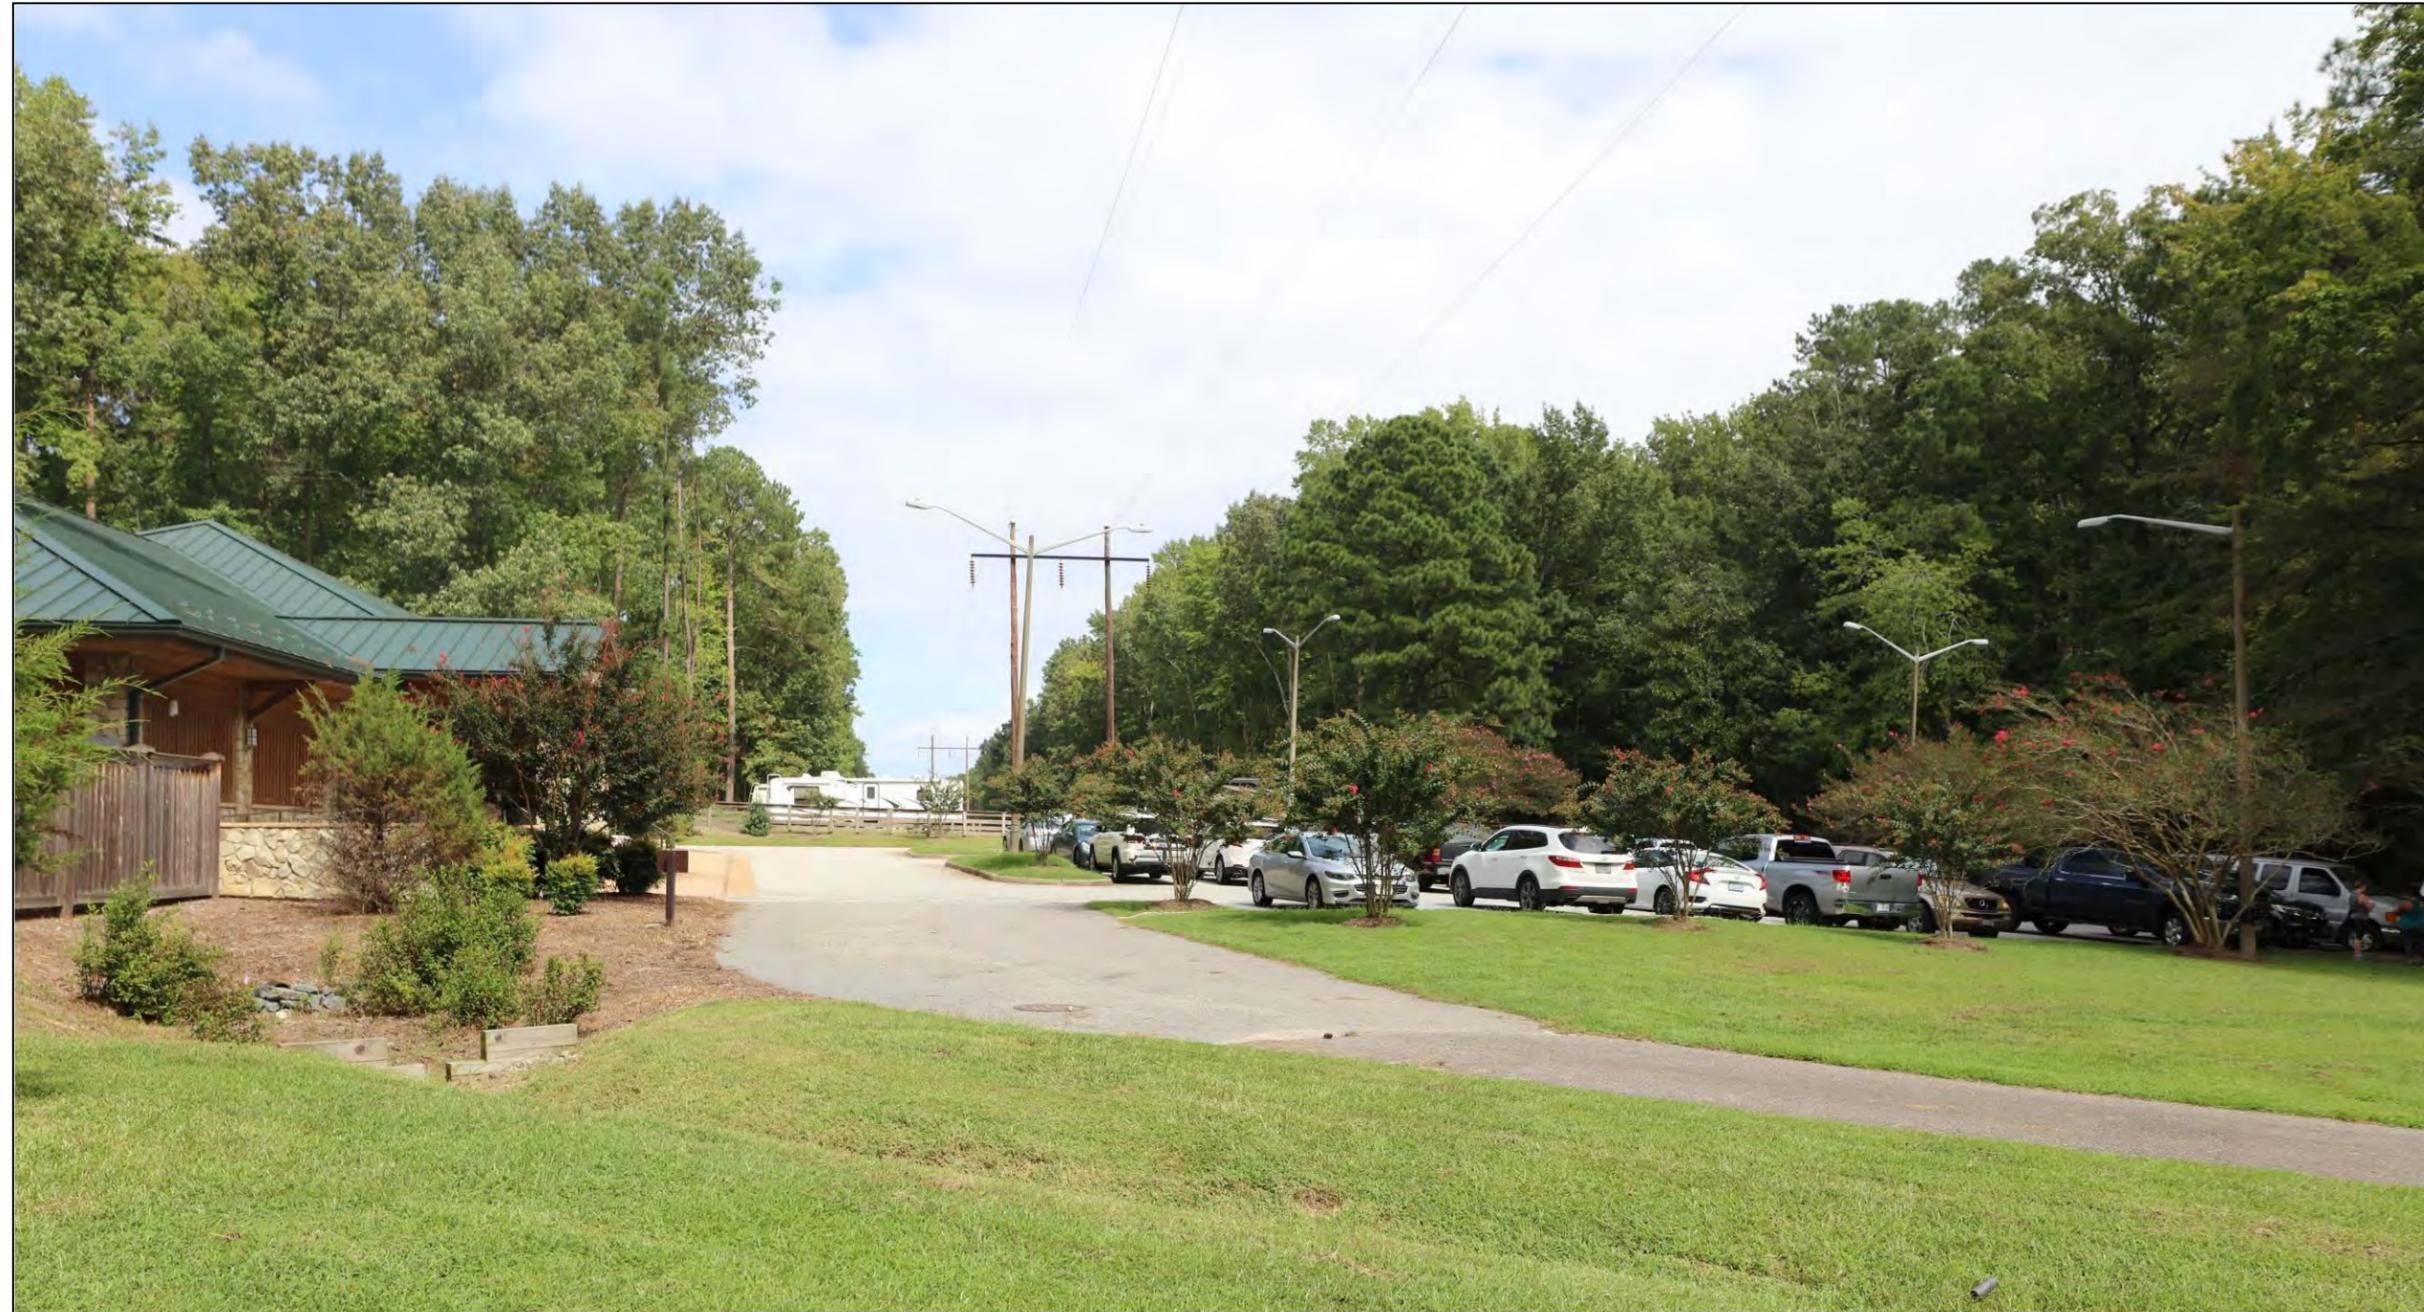
Photo simulations prepared by: GTTE LLC email: info@gttelle.com	Project: Dominion Energy Fort Eustis Tap Rebuild	34/601	1038/179, 34/179	85	2786	34/604	1038/182, 34/176	90	1367
		34/602	1038/180, 34/178	95	2217	34/605	1038/183, 34/175	100	762
		34/603	1038/181, 34/177	90	1747	34/606	1038/184, 34/174	100	257.6

Photo Sim 7: Location of photo sim 7 depicting field of view and modeled structures from Newport News Park Campground within the Yorktown Battlefield. Source: GTTE LLC

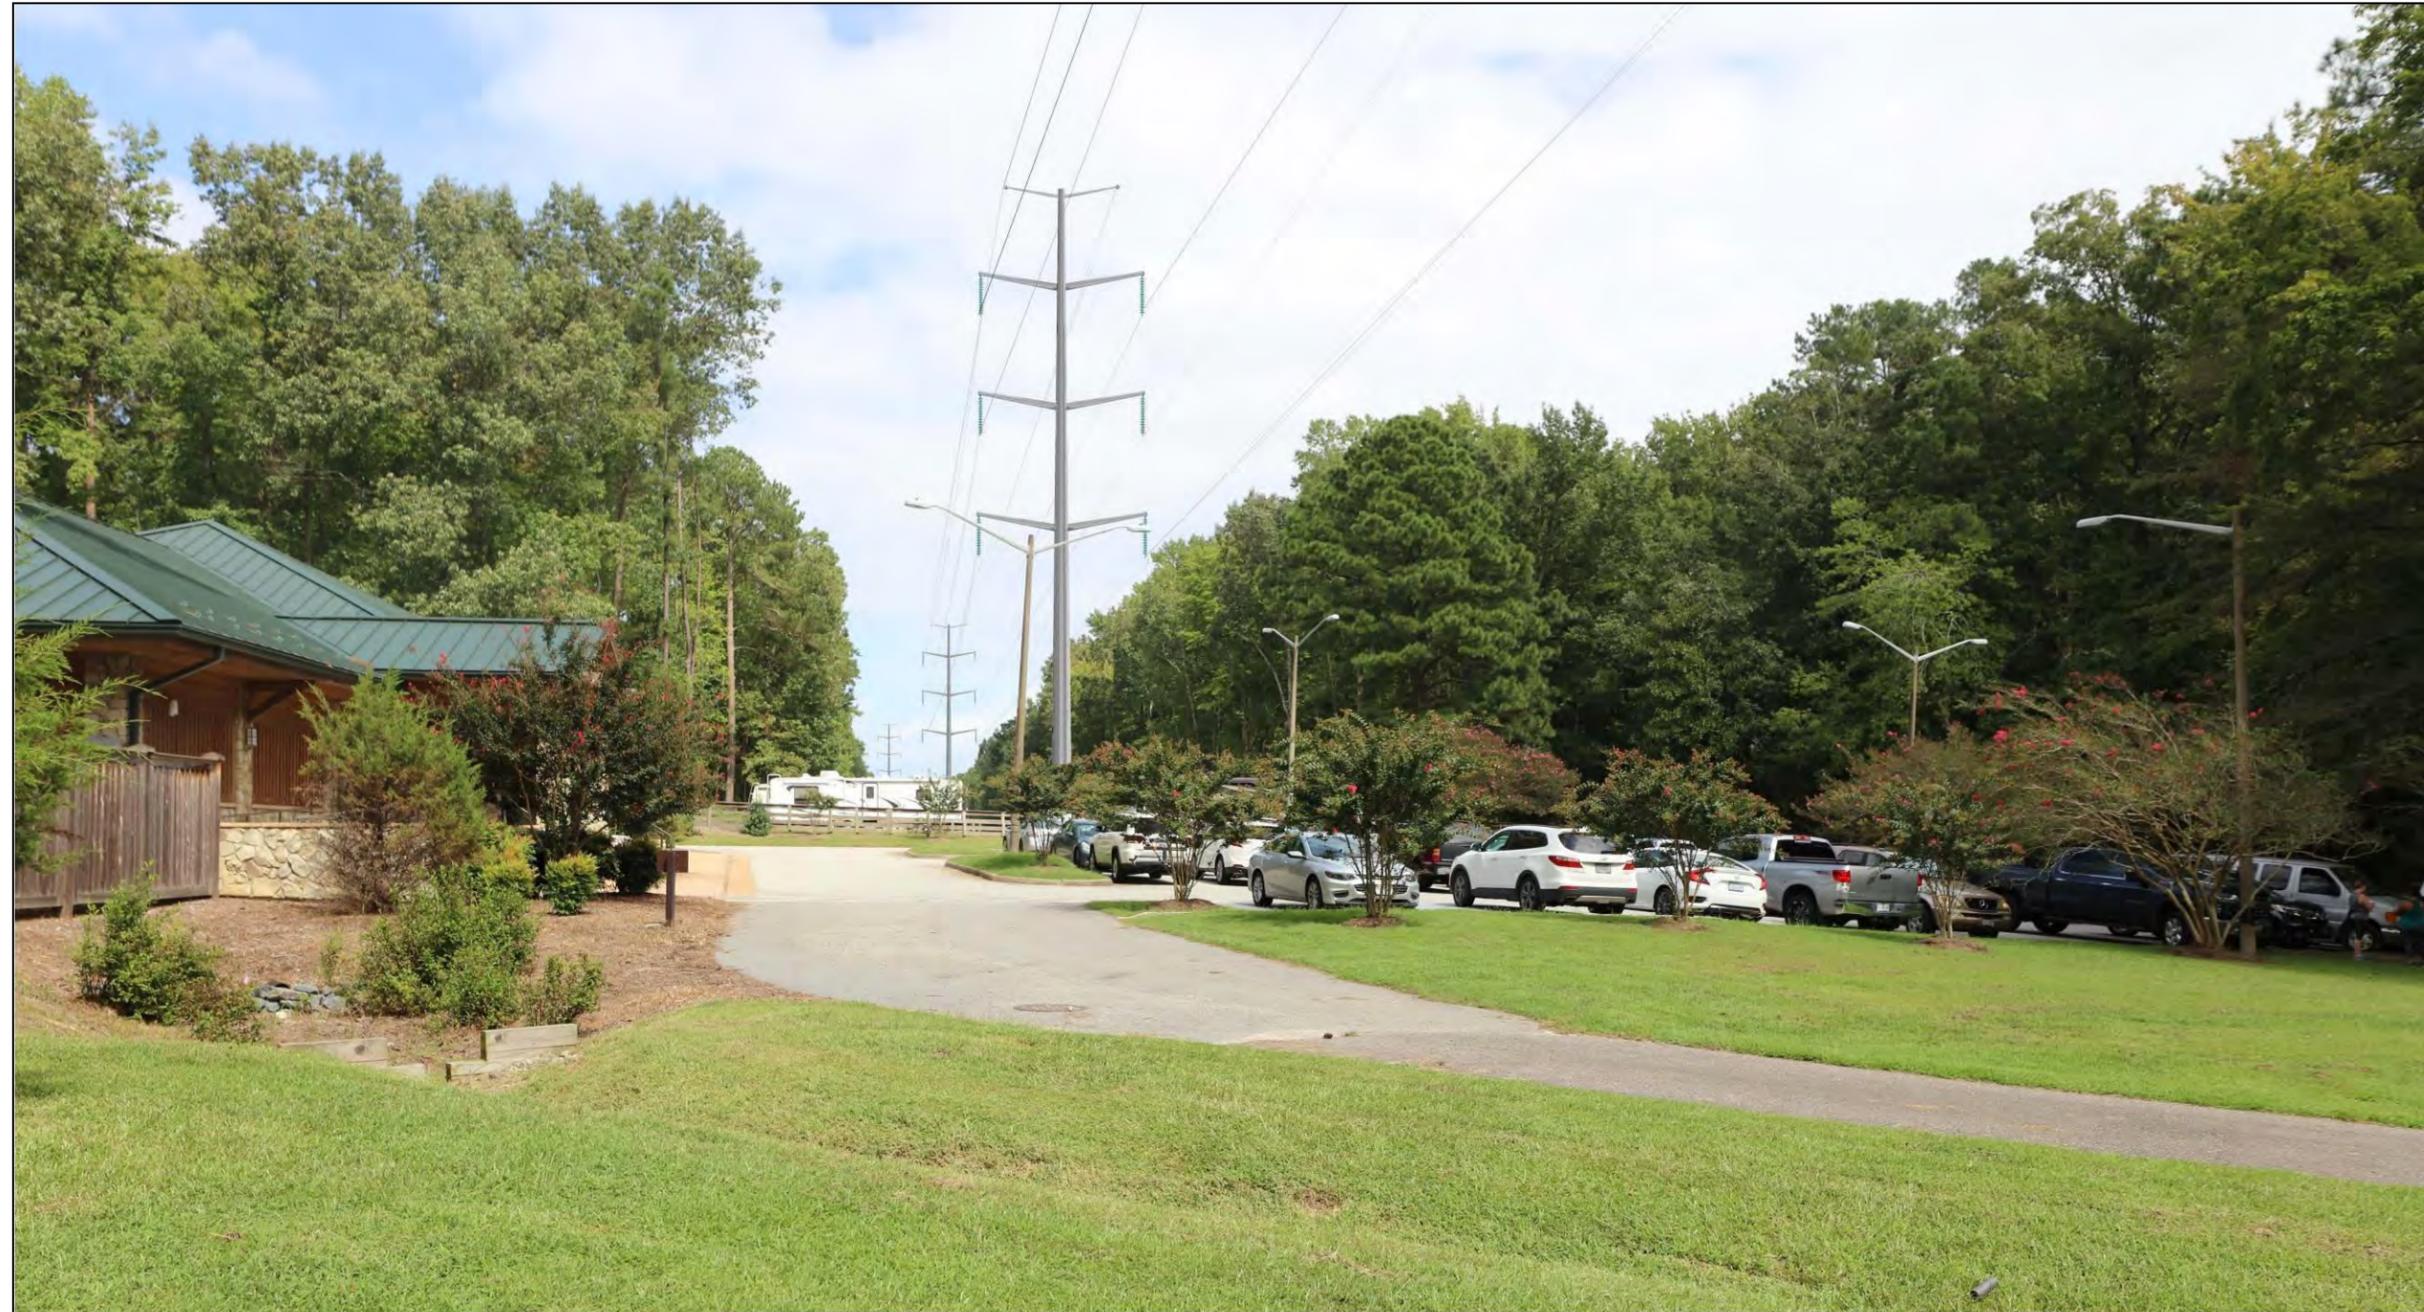
Photo Sim 7: Photo sim 7 depicting existing view from Newport News Park Campground within the Yorktown Battlefield. Source: GTTE LLC

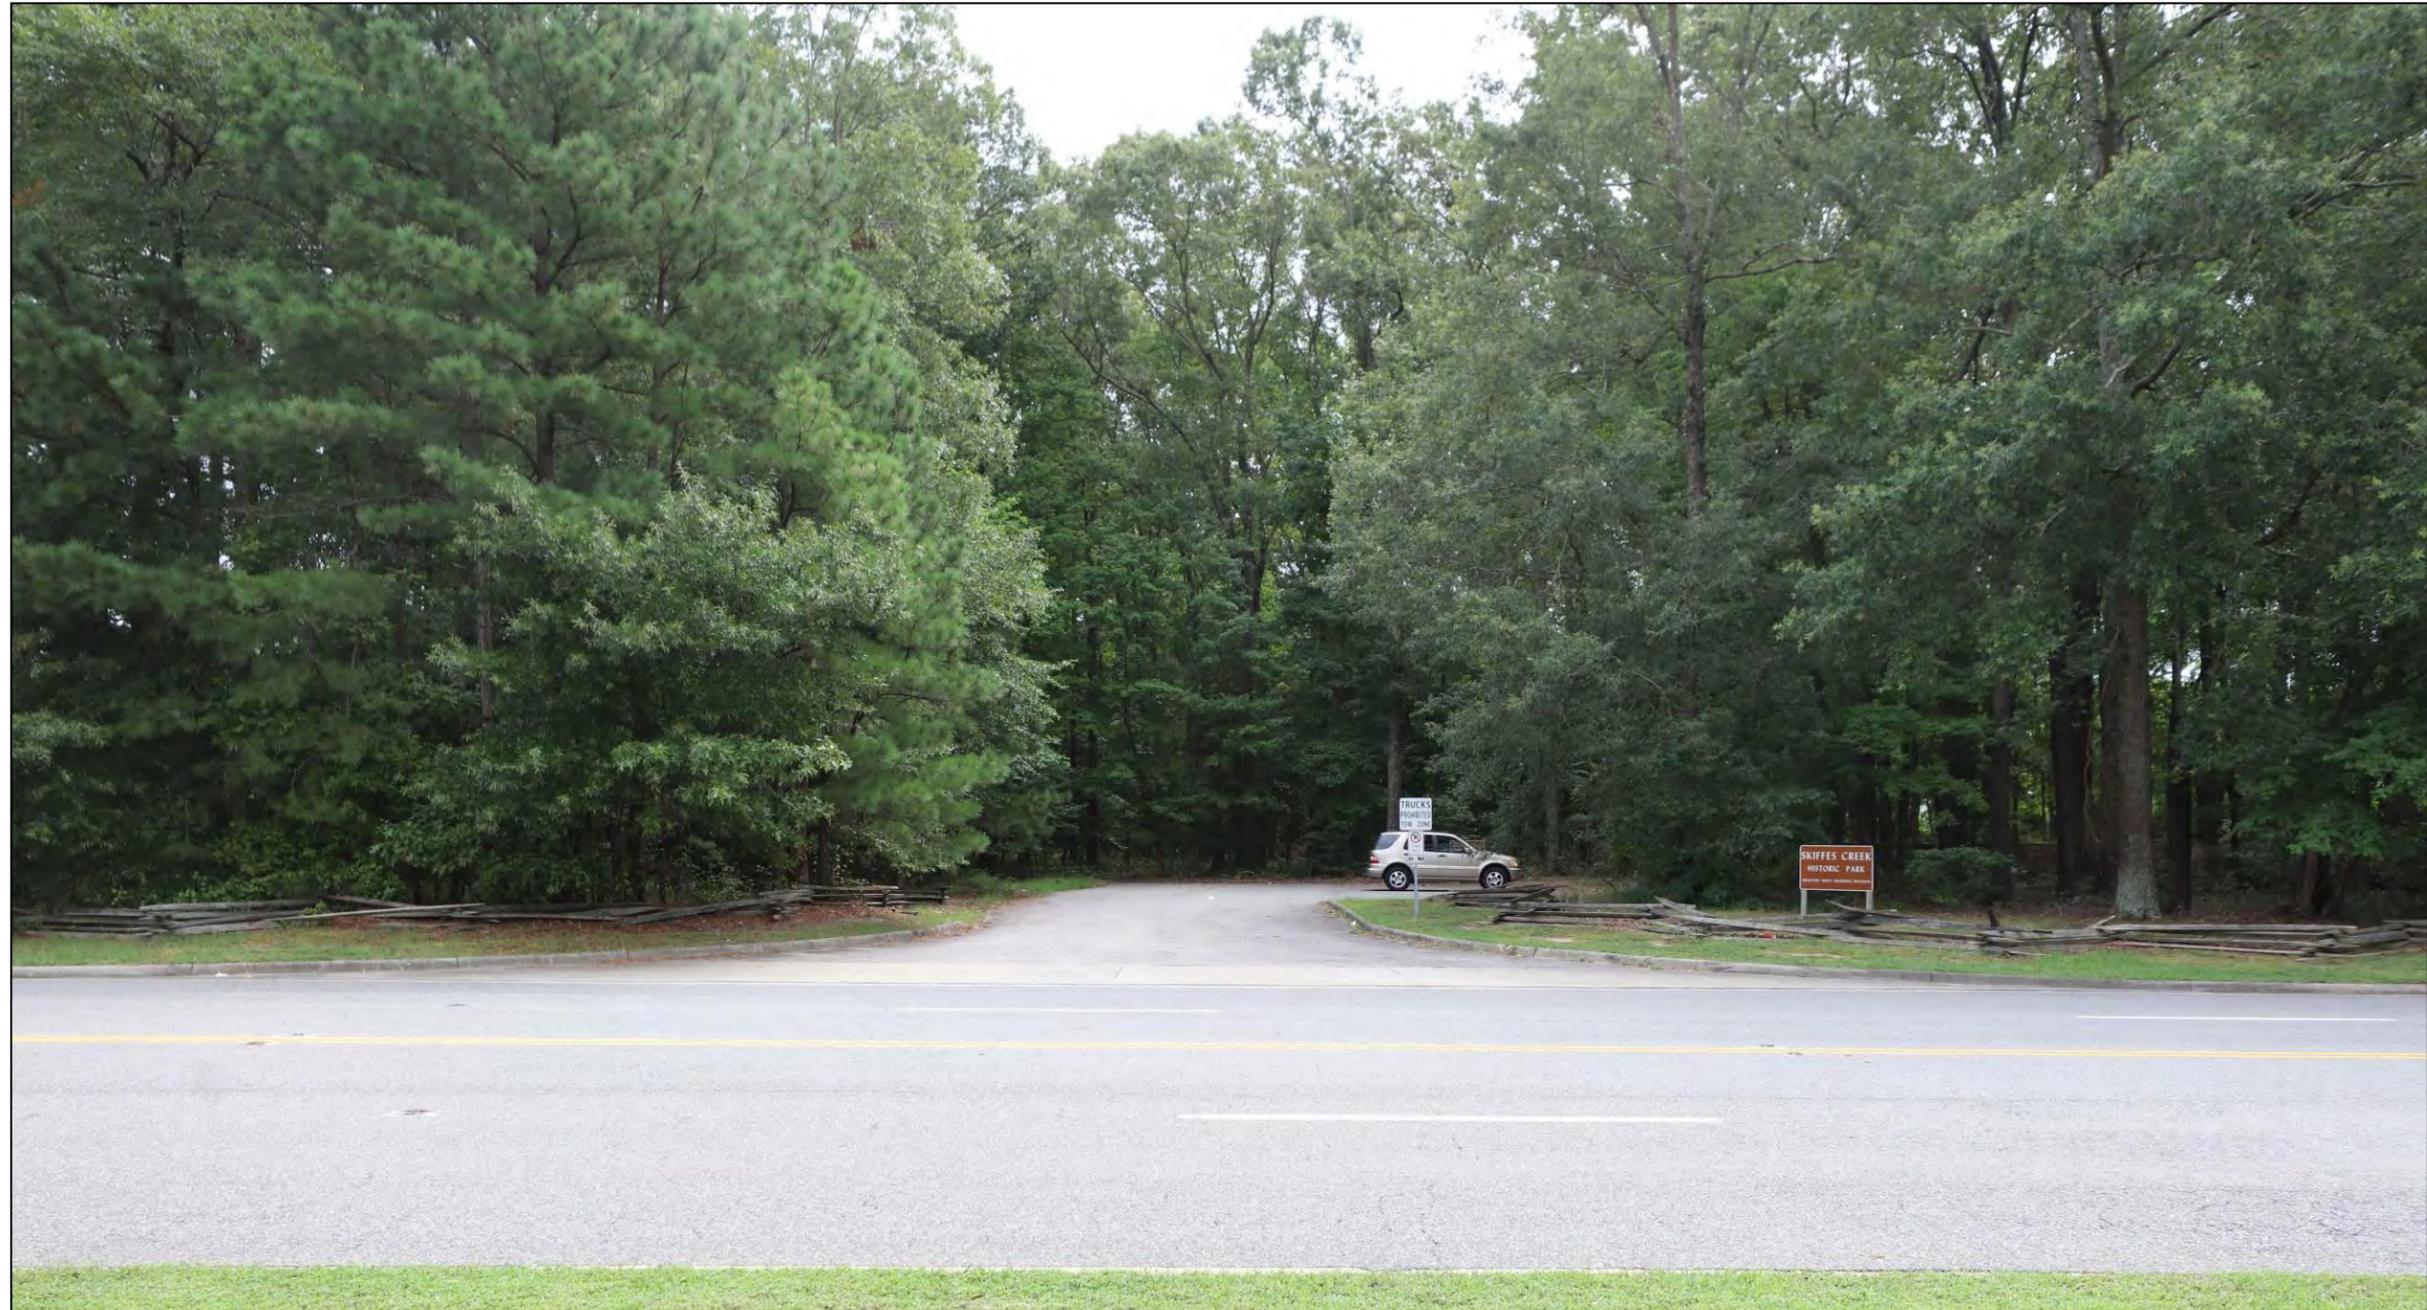
Photo simulations prepared by: GTTE LLC email: info@gttelle.com	Project: Dominion Energy Fort Eustis Tap Rebuild	34/614	1038/192, 34/166	100.00	2435.00	34/617	1038/195, 34/163	110.00	2467.00
		34/615	1038/193, 34/165	100.00	2442.00	34/618	1038/196, 34/162	110.00	2594.00
		34/616	1038/194, 34/164	115.00	2404.00	34/619	1038/197, 34/161	110.00	2892.00

Photo Sim 2: Location of photo sim 2 depicting field of view and modeled structures from Southern Terminus Redoubt within Oakland Farm Industrial Park Multiple Resource Area. Source: GTTE LLC

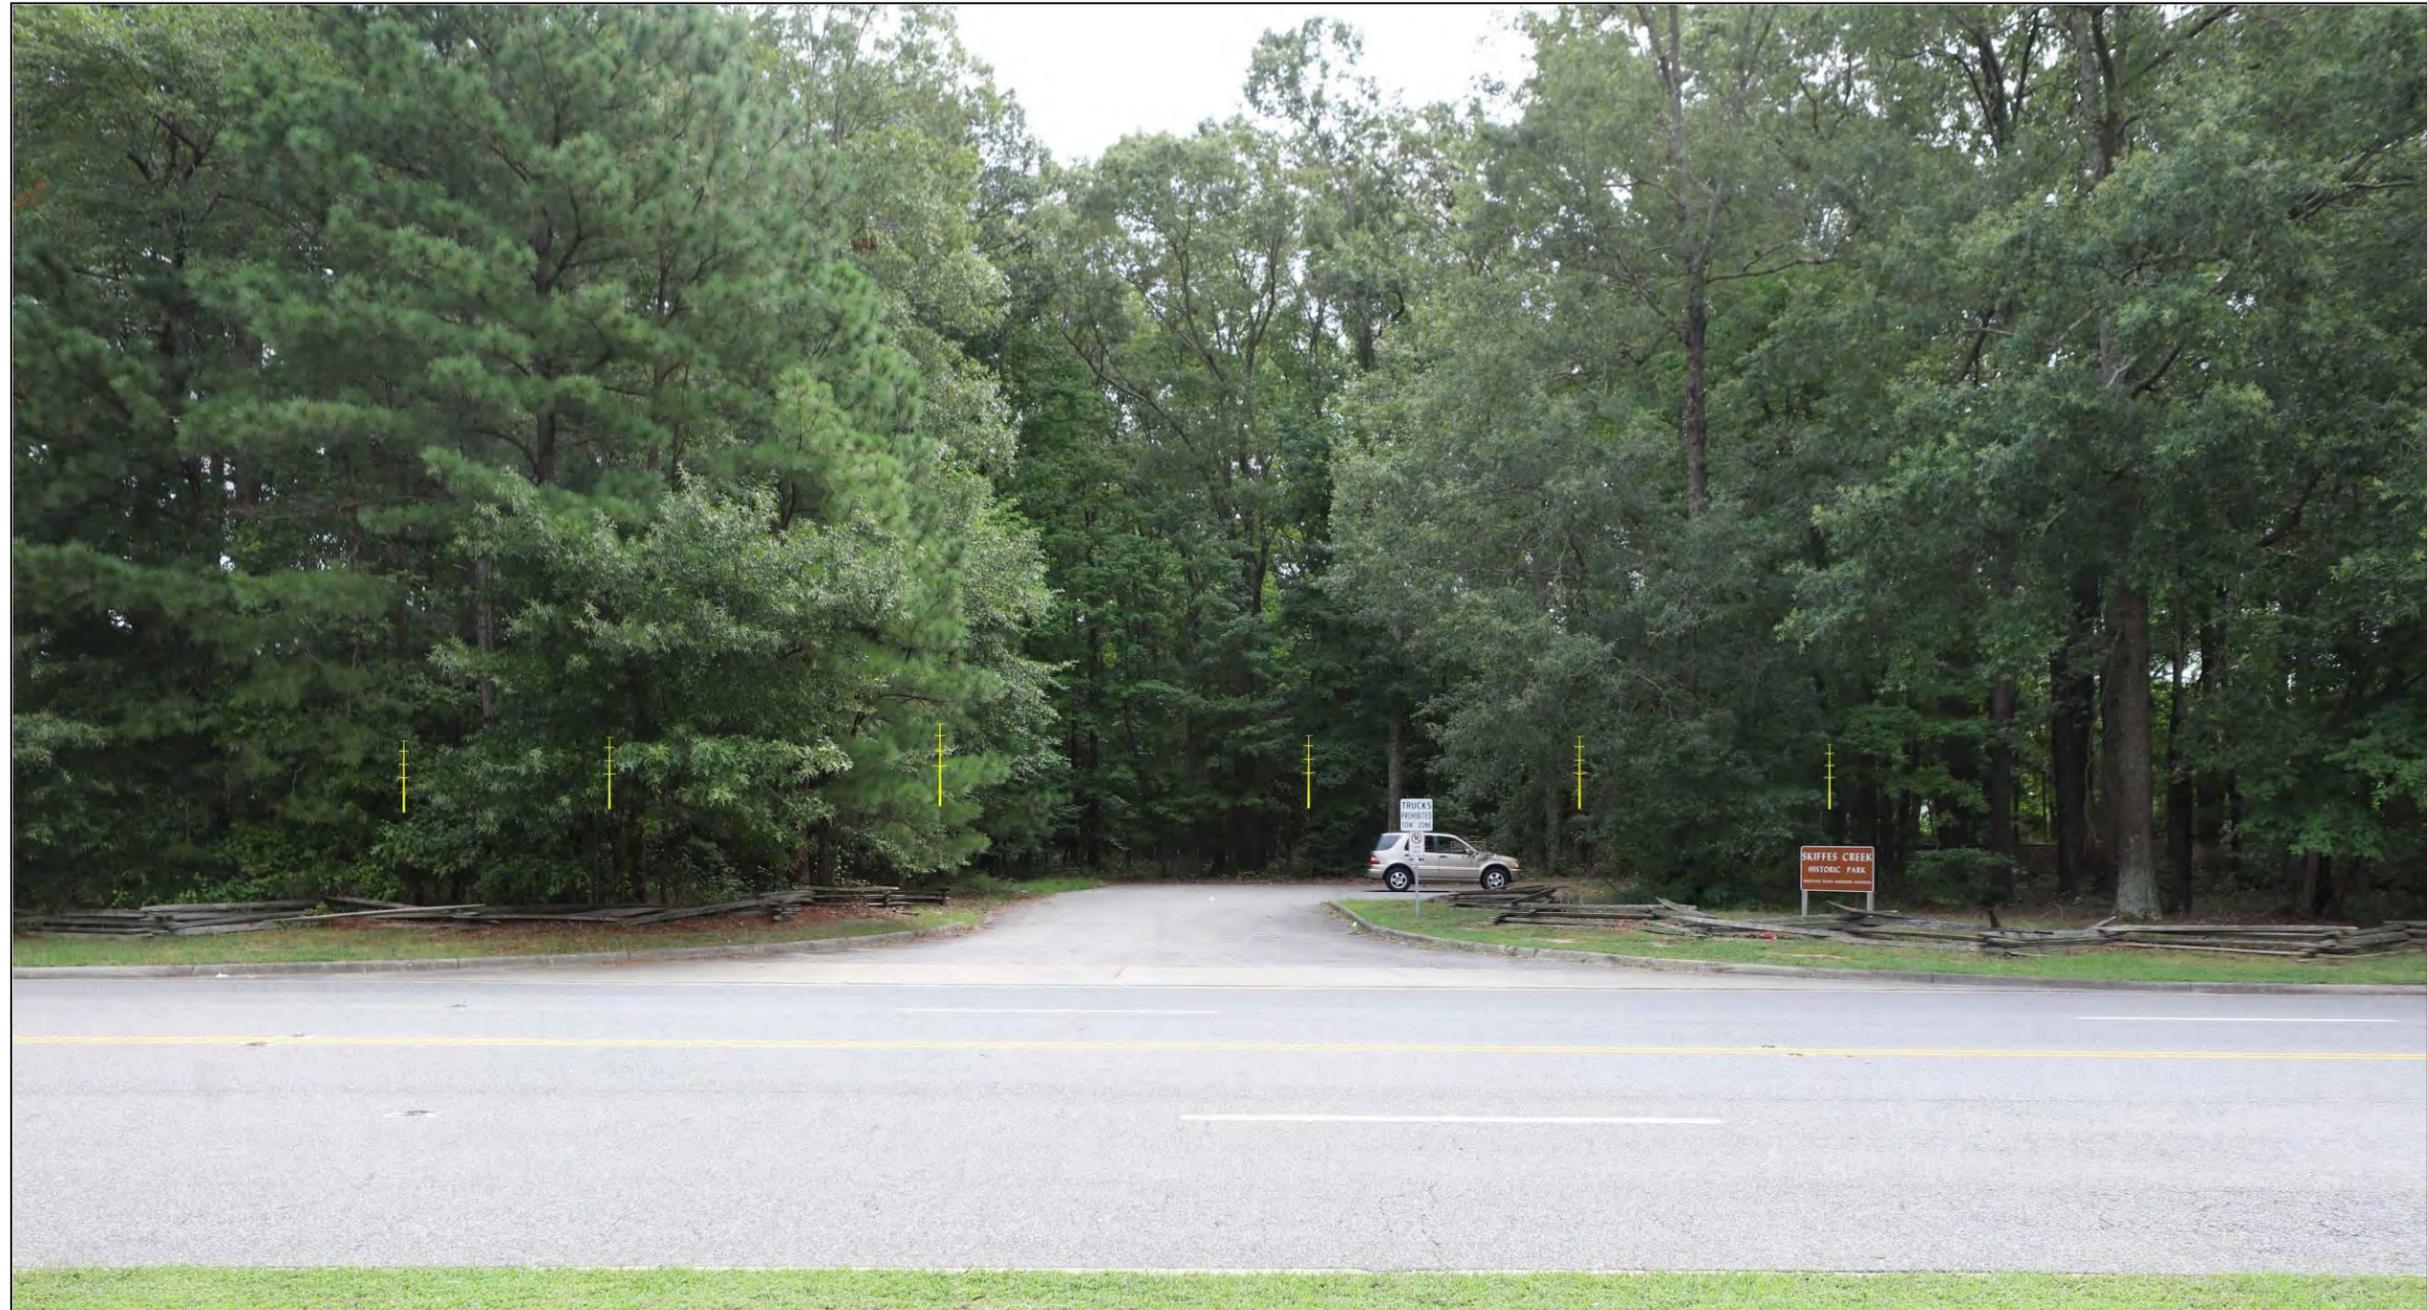
Photo Sim 2: Photo sim 2 depicting existing view from Southern Terminus Redoubt within Oakland Farm Industrial Park Multiple Resource Area. Source: GTTE LLC
