Phase I Cultural Resource Survey of the Fort Eustis Tap/Line 34 Rebuild Project

LOCATION > City of Newport News, Virginia

DATE > October 2020

PREPARED BY >
Dutton + Associates, LLC

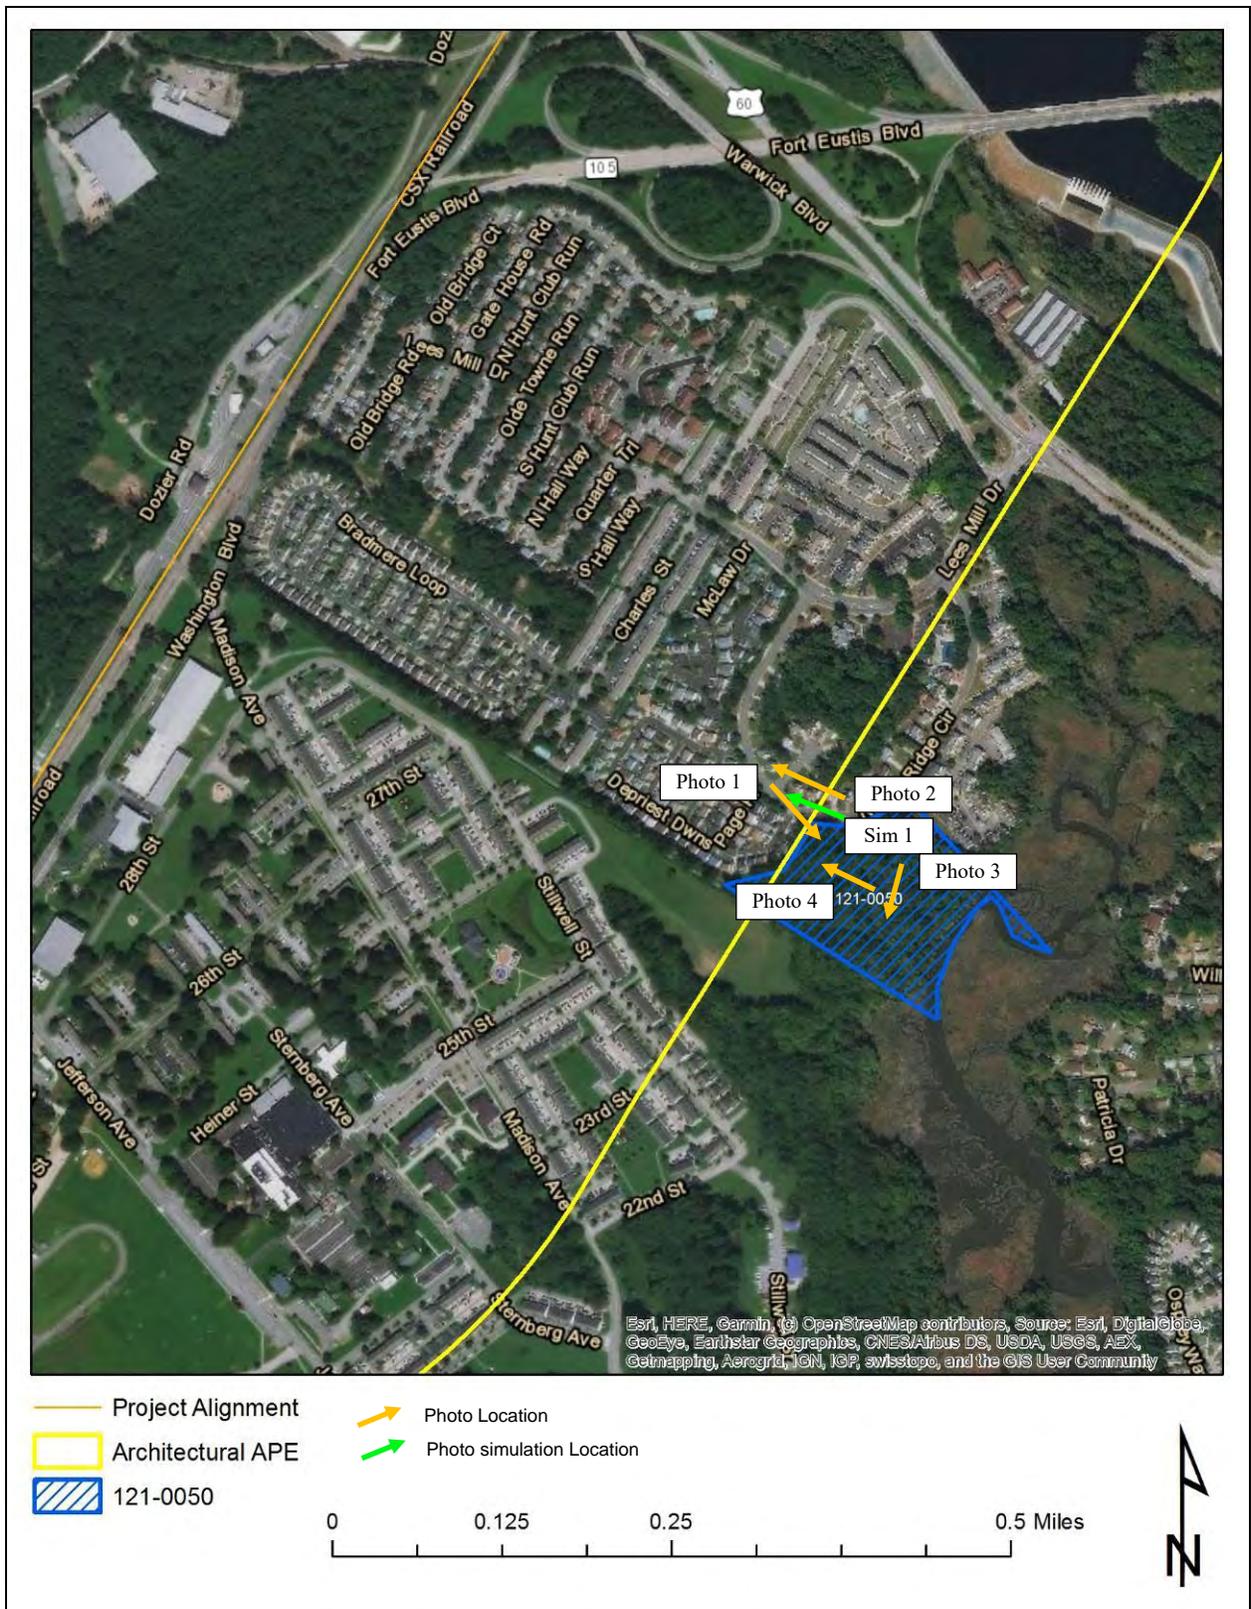
Figure 9-12: Location of Lee’s Mill Earthworks in relation to the project alignment and APE showing direction of representative and viewshed photos

To assess whether the project or any associated components may pose an effect to the resource, a viewshed assessment was conducted. Inspection was performed and photographs taken from the earthworks and property to document existing setting, visibility, and lines of sight (Figure 9-12; Photos 1 through 4; Photo Sim 1).

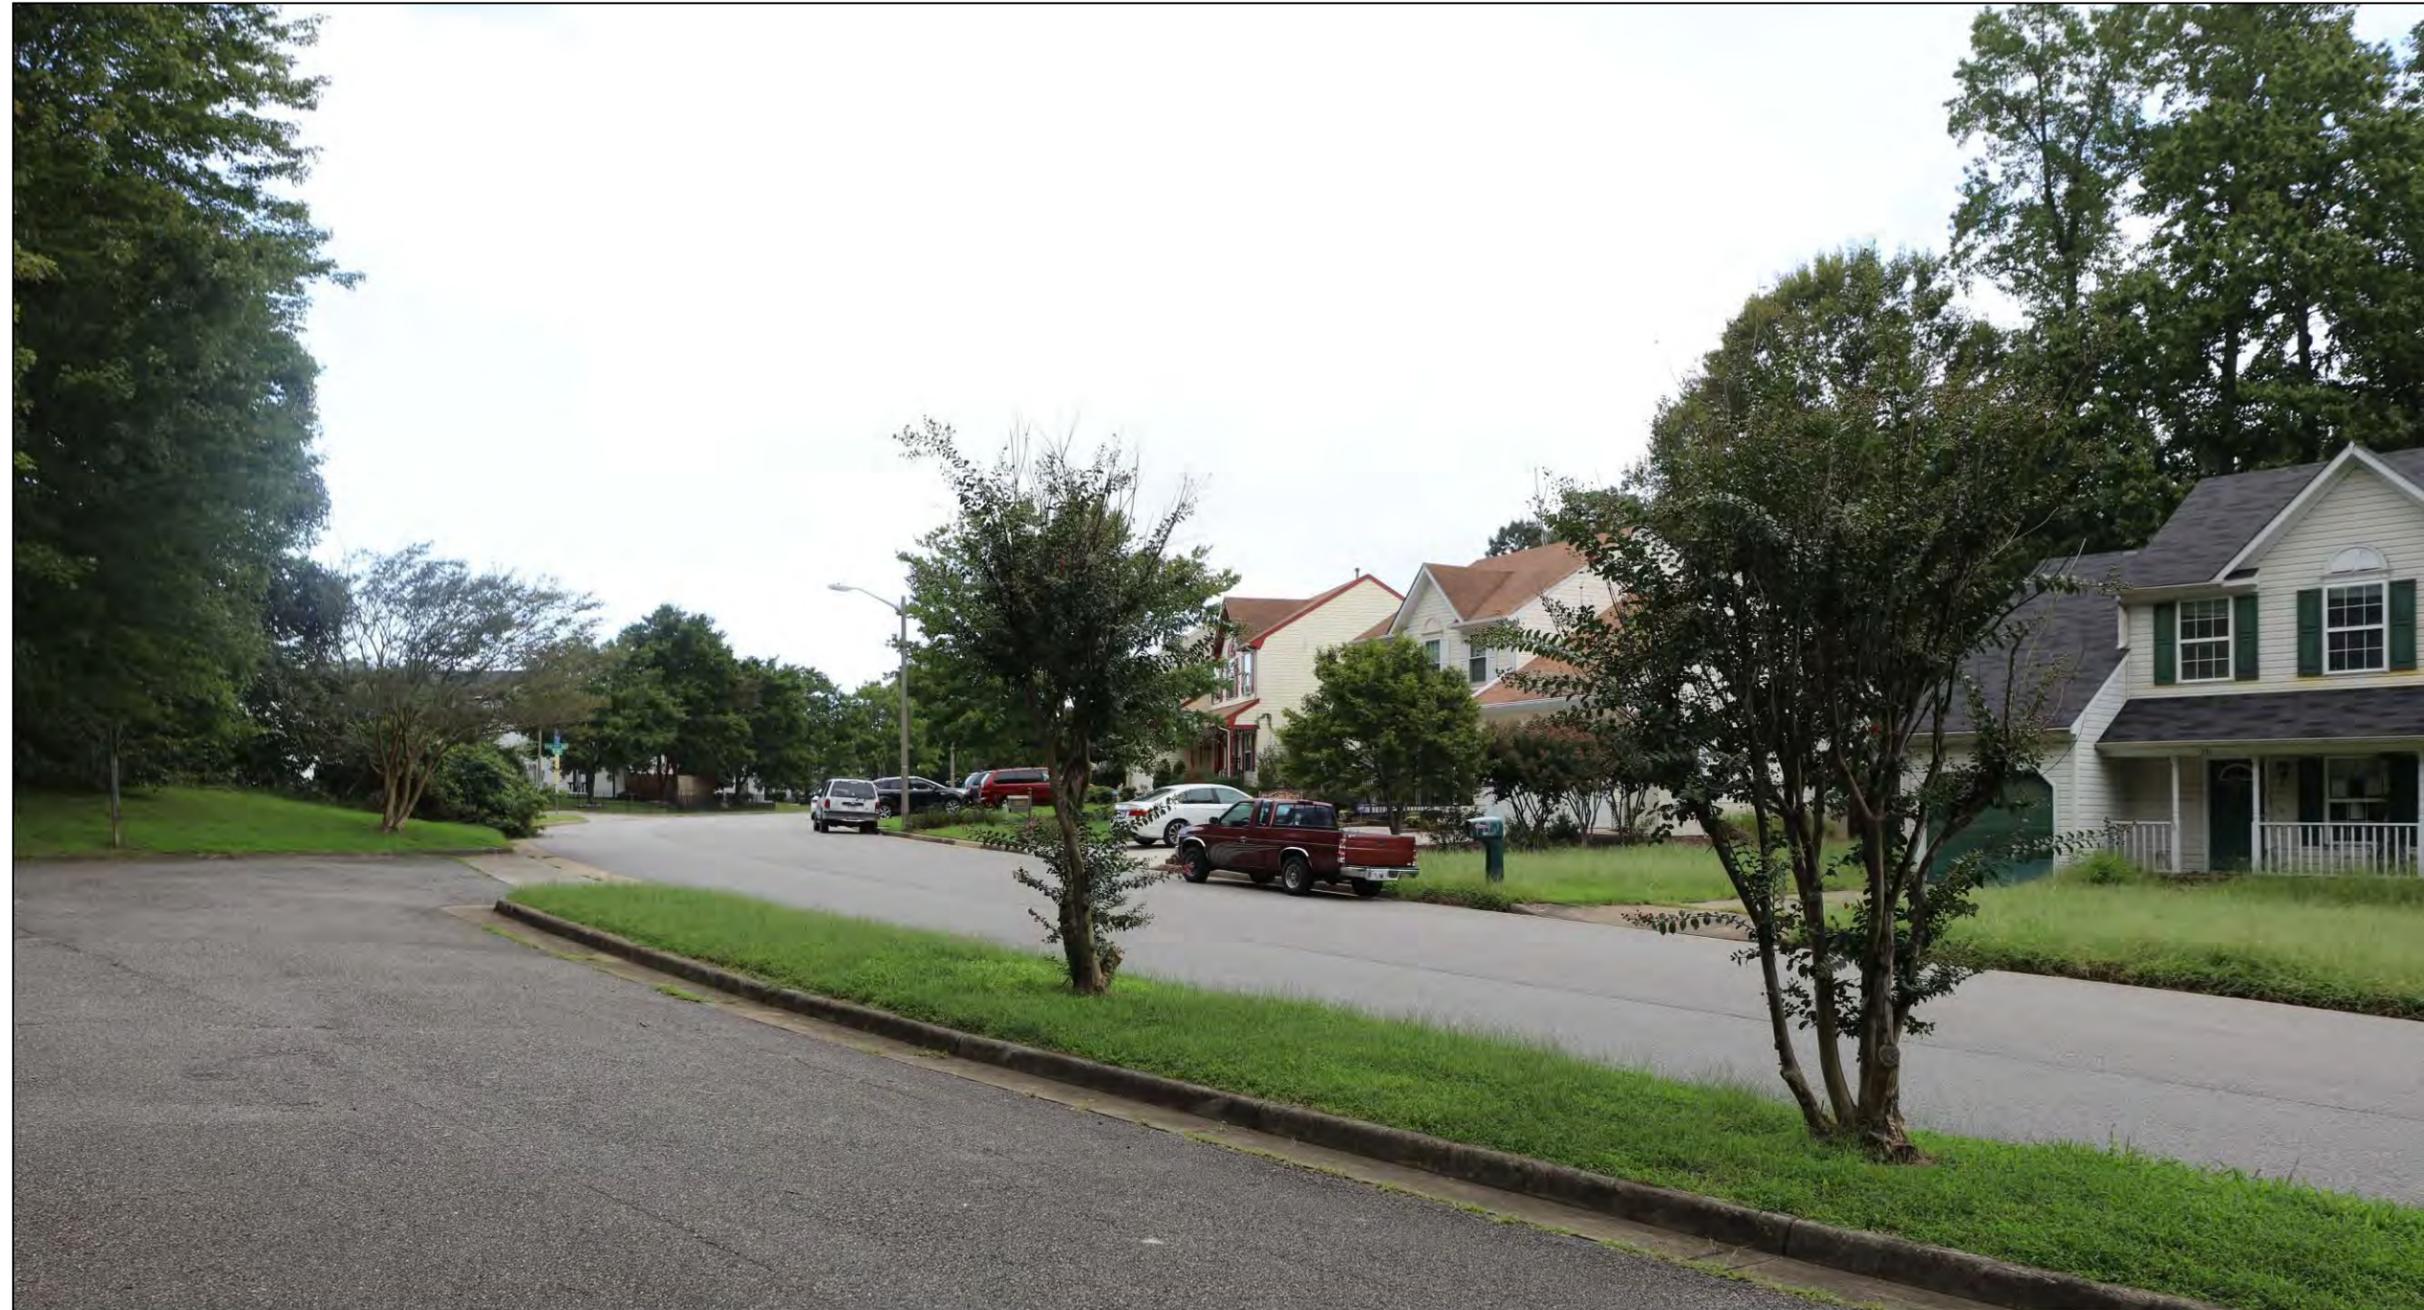
Photo simulations prepared by: GTTE LLC email: info@gttelle.com	Project: Dominion Energy Fort Eustis Tap Rebuild	34/617	1038/195, 34/163	110.00	3306.00	34/621	1038/199, 34/159	110.00	2841.00
		34/618	1038/196, 34/162	110.00	3097.00	34/622	1038/200, 34/158	110.00	2873.00
		34/619	1038/197, 34/161	110.00	2960.00	34/623	1038/201, 34/157	110.00	2983.00
		34/620	1038/198, 34/160	110.00	2864.00

Photo Sim 1: Location of photo sim 1 depicting field of view and modeled structures from Lee's Mill Earthworks. Source: GTTE LLC

Although the proposed replacement structures will average roughly 30-feet taller than the existing structures, it is anticipated that there will be no change in visibility from the Lee's Mill Earthworks. Photo simulation confirmed the replacement structures will continue to be completely screened by intervening vegetation and development. Further, this resource is considered significant for its archaeological potential and construction, and already has a compromised setting from modern development that does not contribute to its eligibility. As such, the Fort Eustis Tap/Line 34 Rebuild project is recommended to pose *no effect* on the Lee's Mill Earthworks.

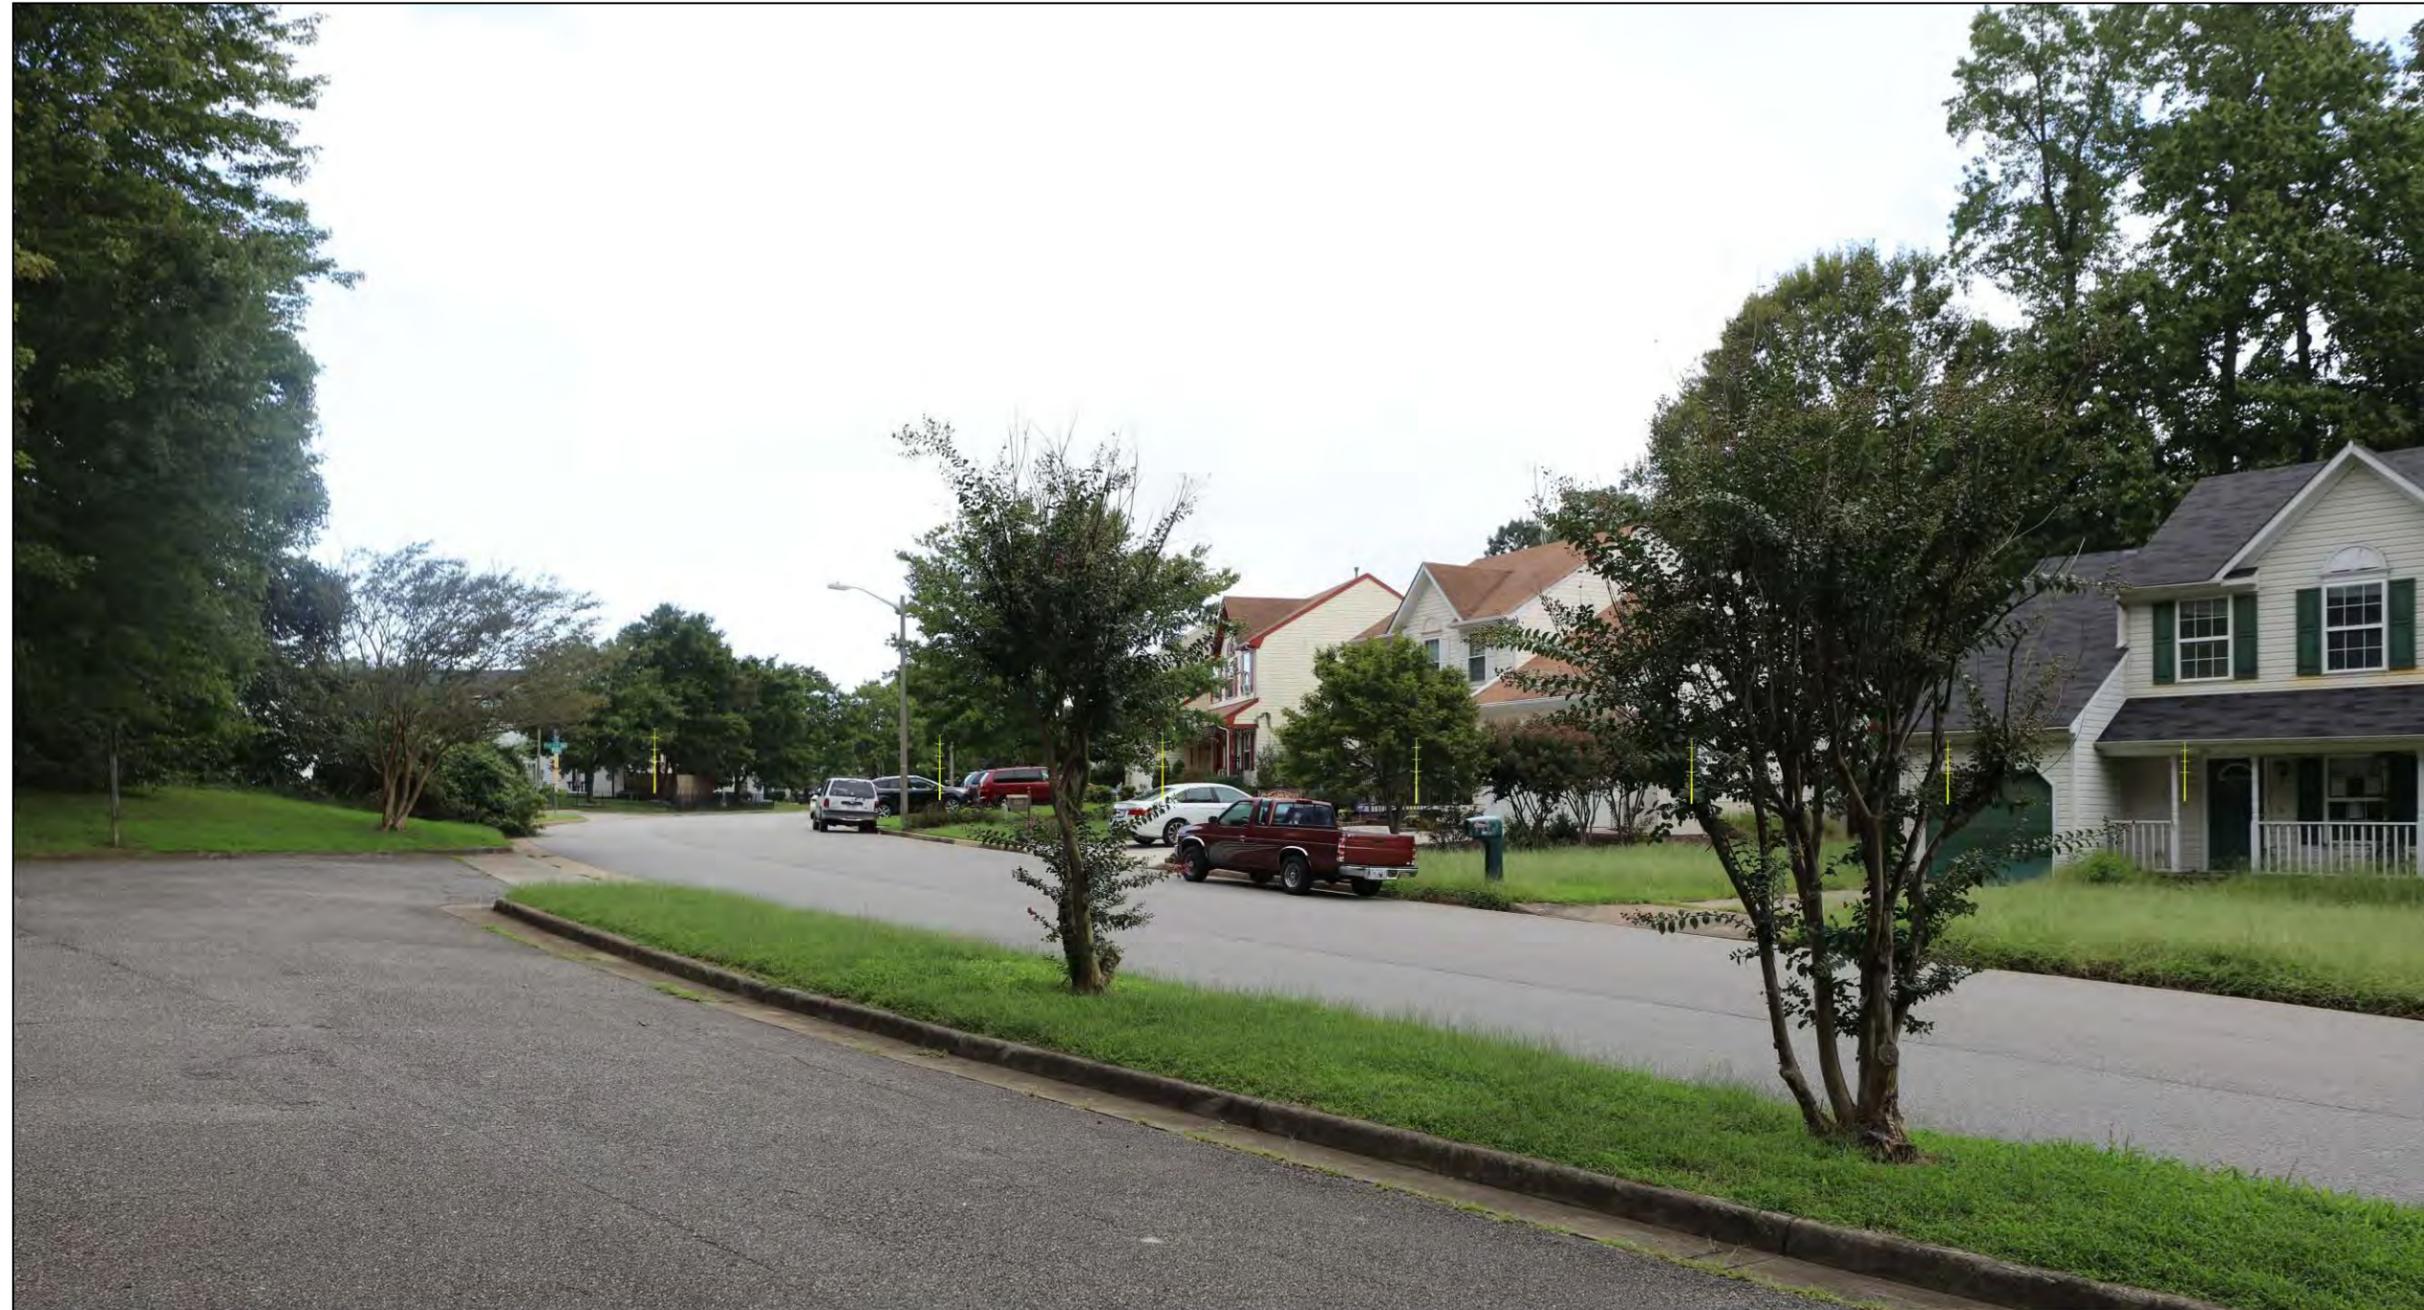
Photo Sim 1: Photo sim 1 depicting existing view from Lee's Mill Earthworks. Source: GTTE LLC

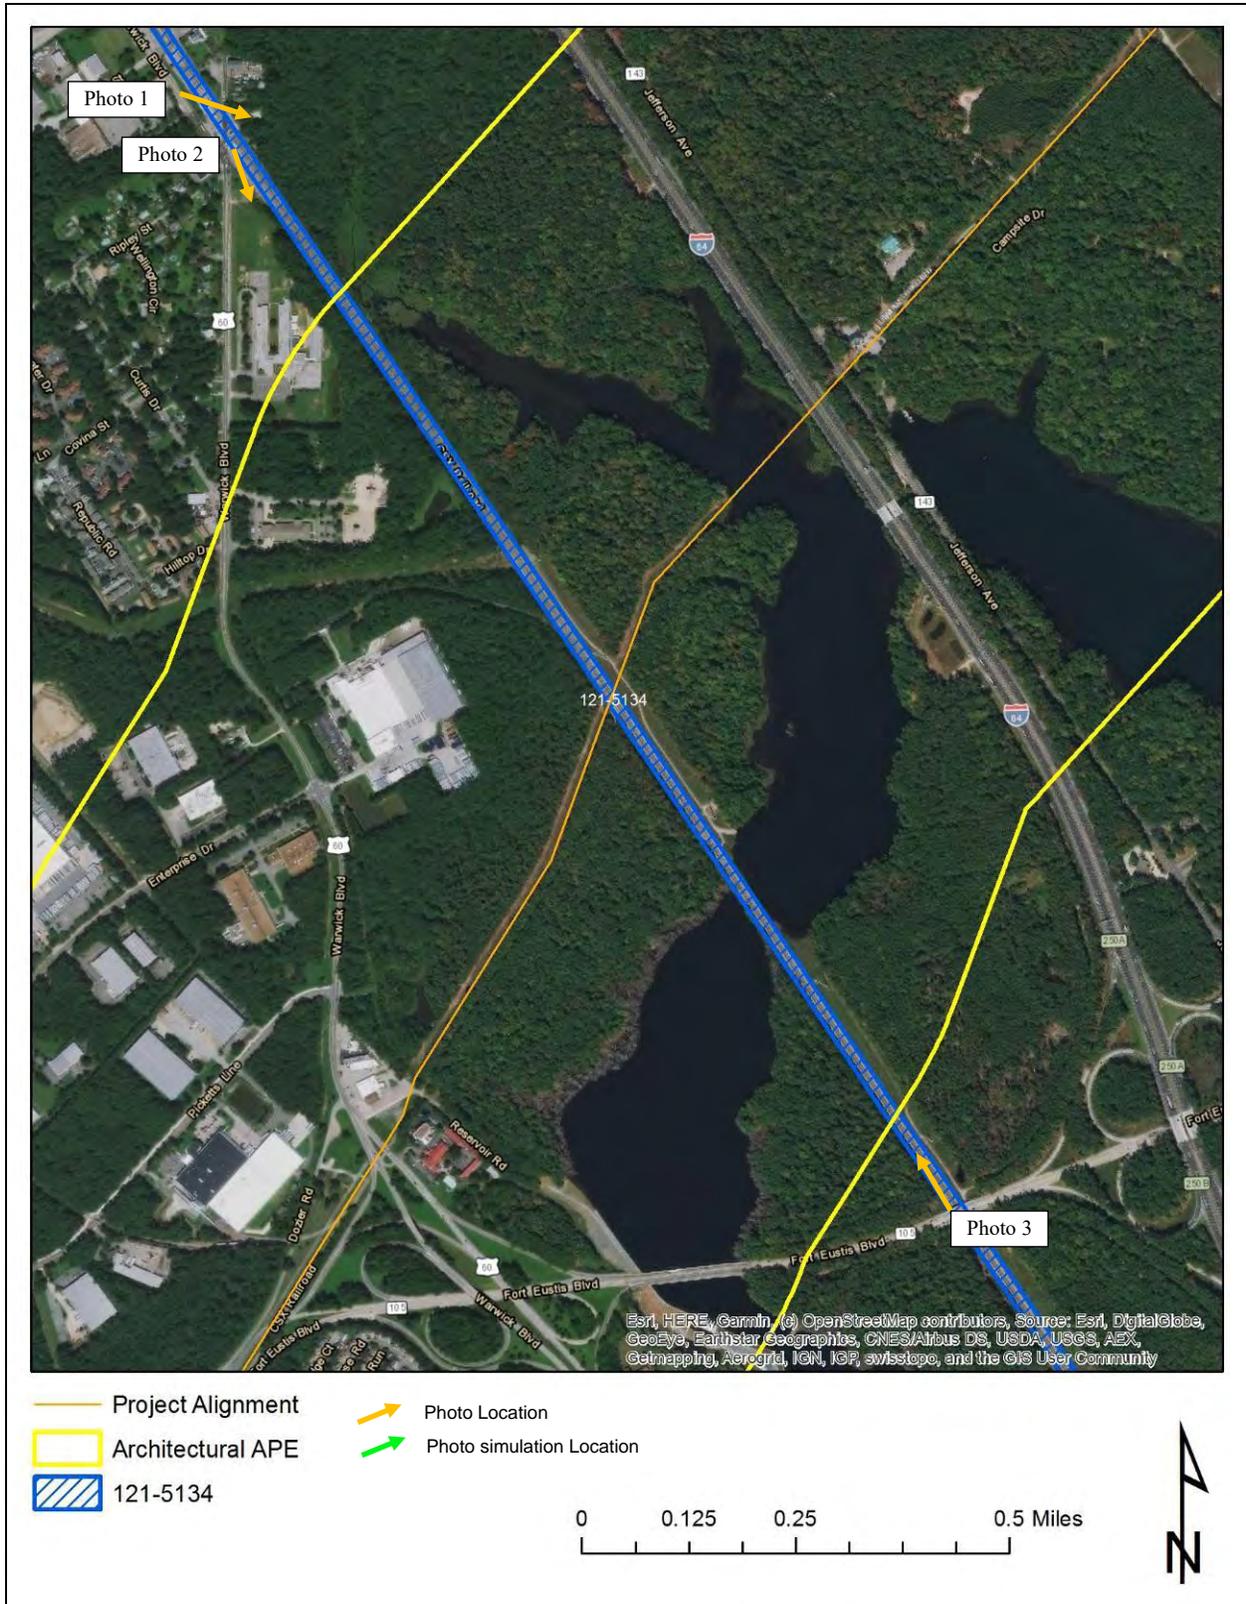
Figure 9-14: Location of C&O Railroad in relation to the project alignment and APE showing direction of representative and viewed photos

To assess whether the project or any associated components may pose an effect to the resource, a viewshed assessment was conducted. Inspection was performed and photographs taken from publicly accessible vantage points along or near the railroad to document existing setting, visibility, and lines of sight (Figure 9-14; Photos 1 through 3).
