Basis of Design

Repair and Preservation of Matthew Jones House

Project #: HERT 20-2645

100% Design Submission

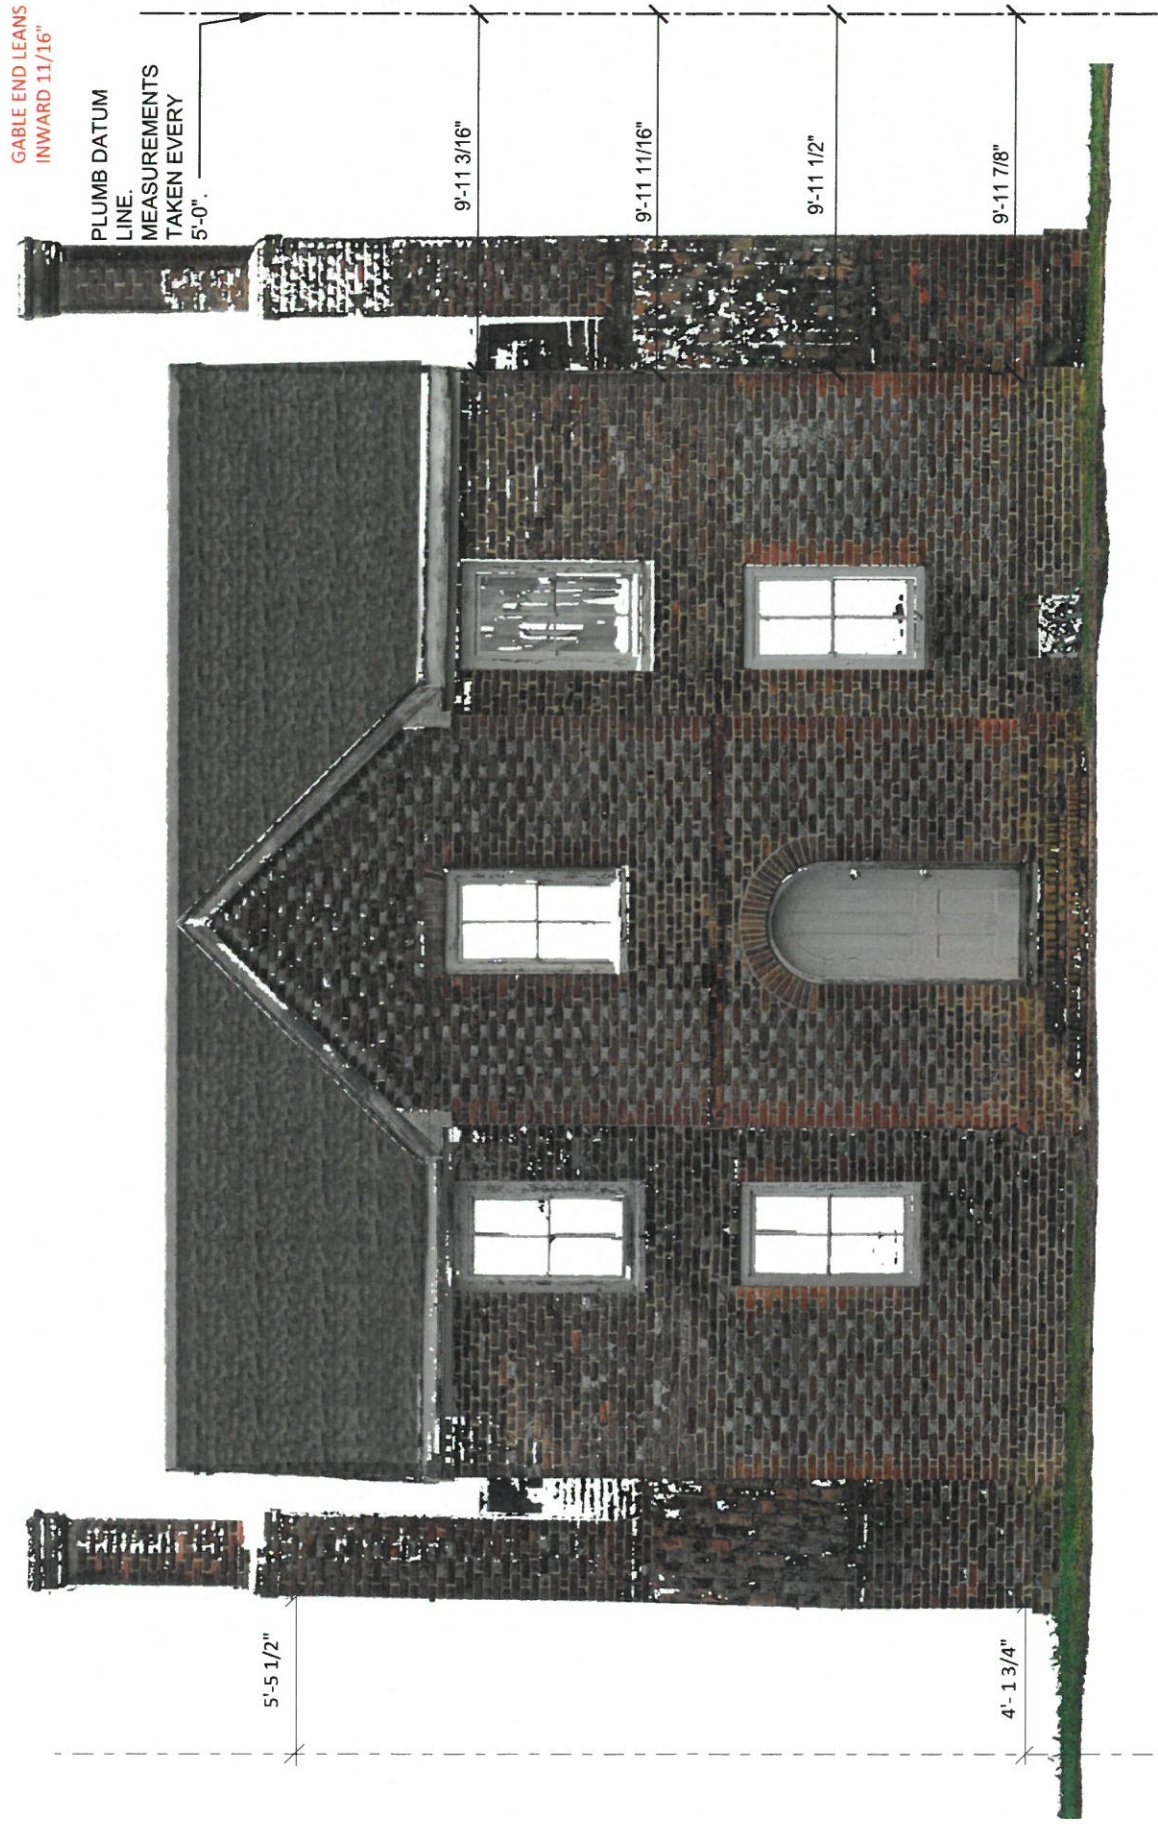
SOUTH ELEVATION

CHIMNEY LEANS
INWARD 4 3/34"

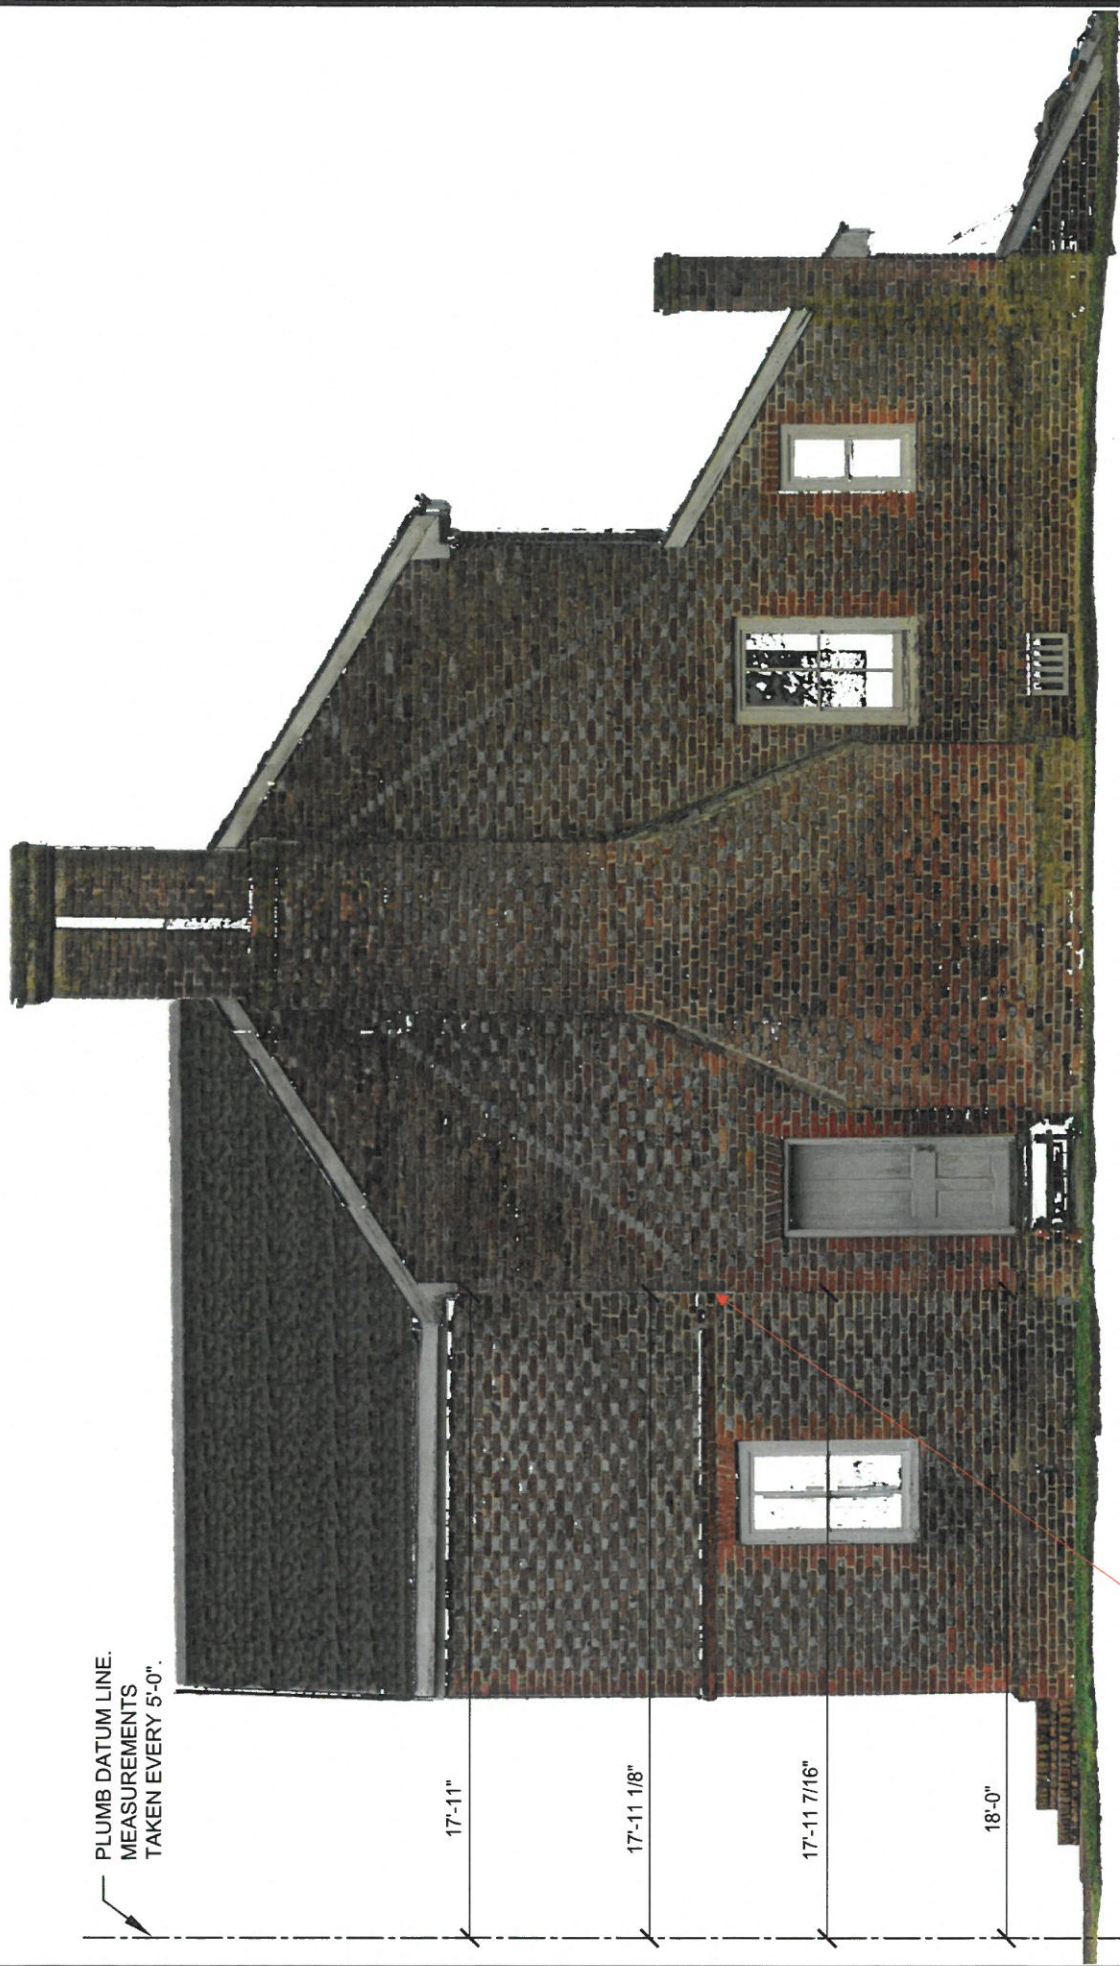
EAST ELEVATION

PLUMB DATUM LINE.
MEASUREMENTS
TAKEN EVERY 5'-0".

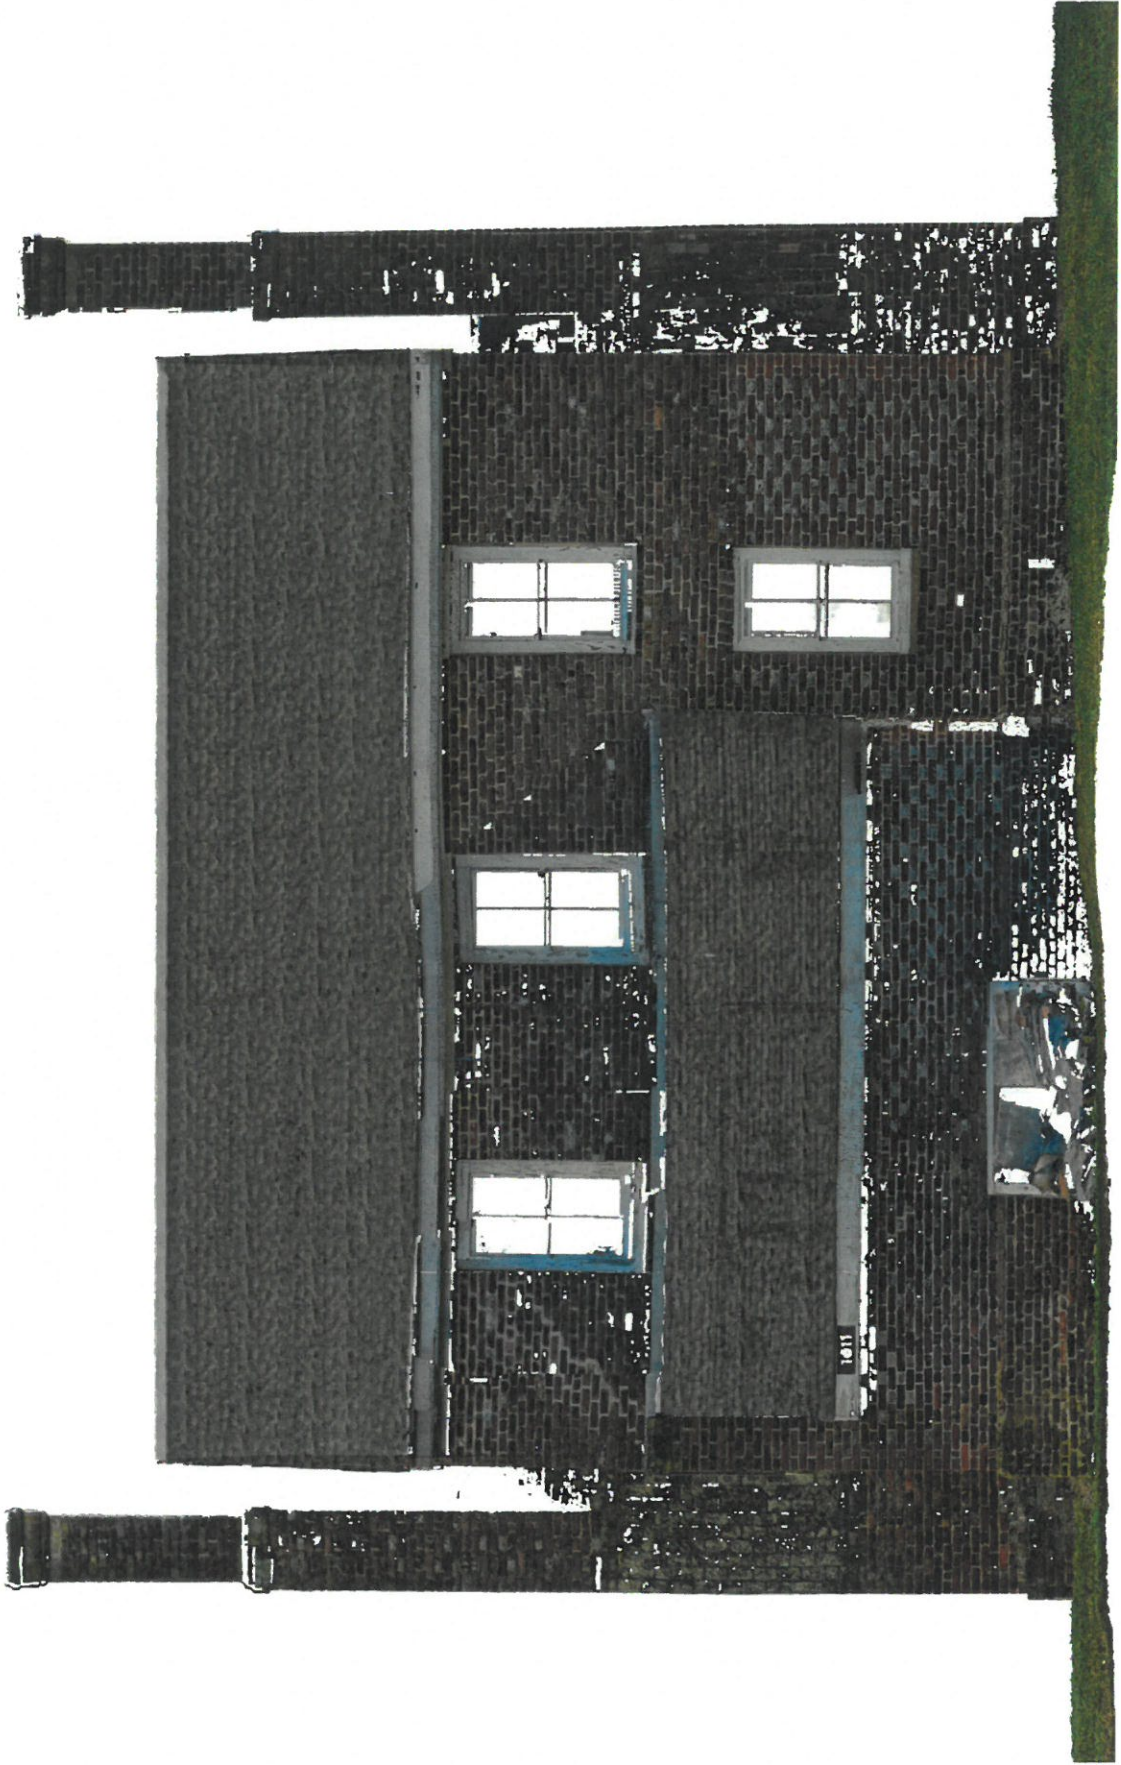
NORTH ELEVATION

LOWER STORY OF
FRONT WALL LEANS
OUTWARD 1"; UPPER
WALL PLUMB

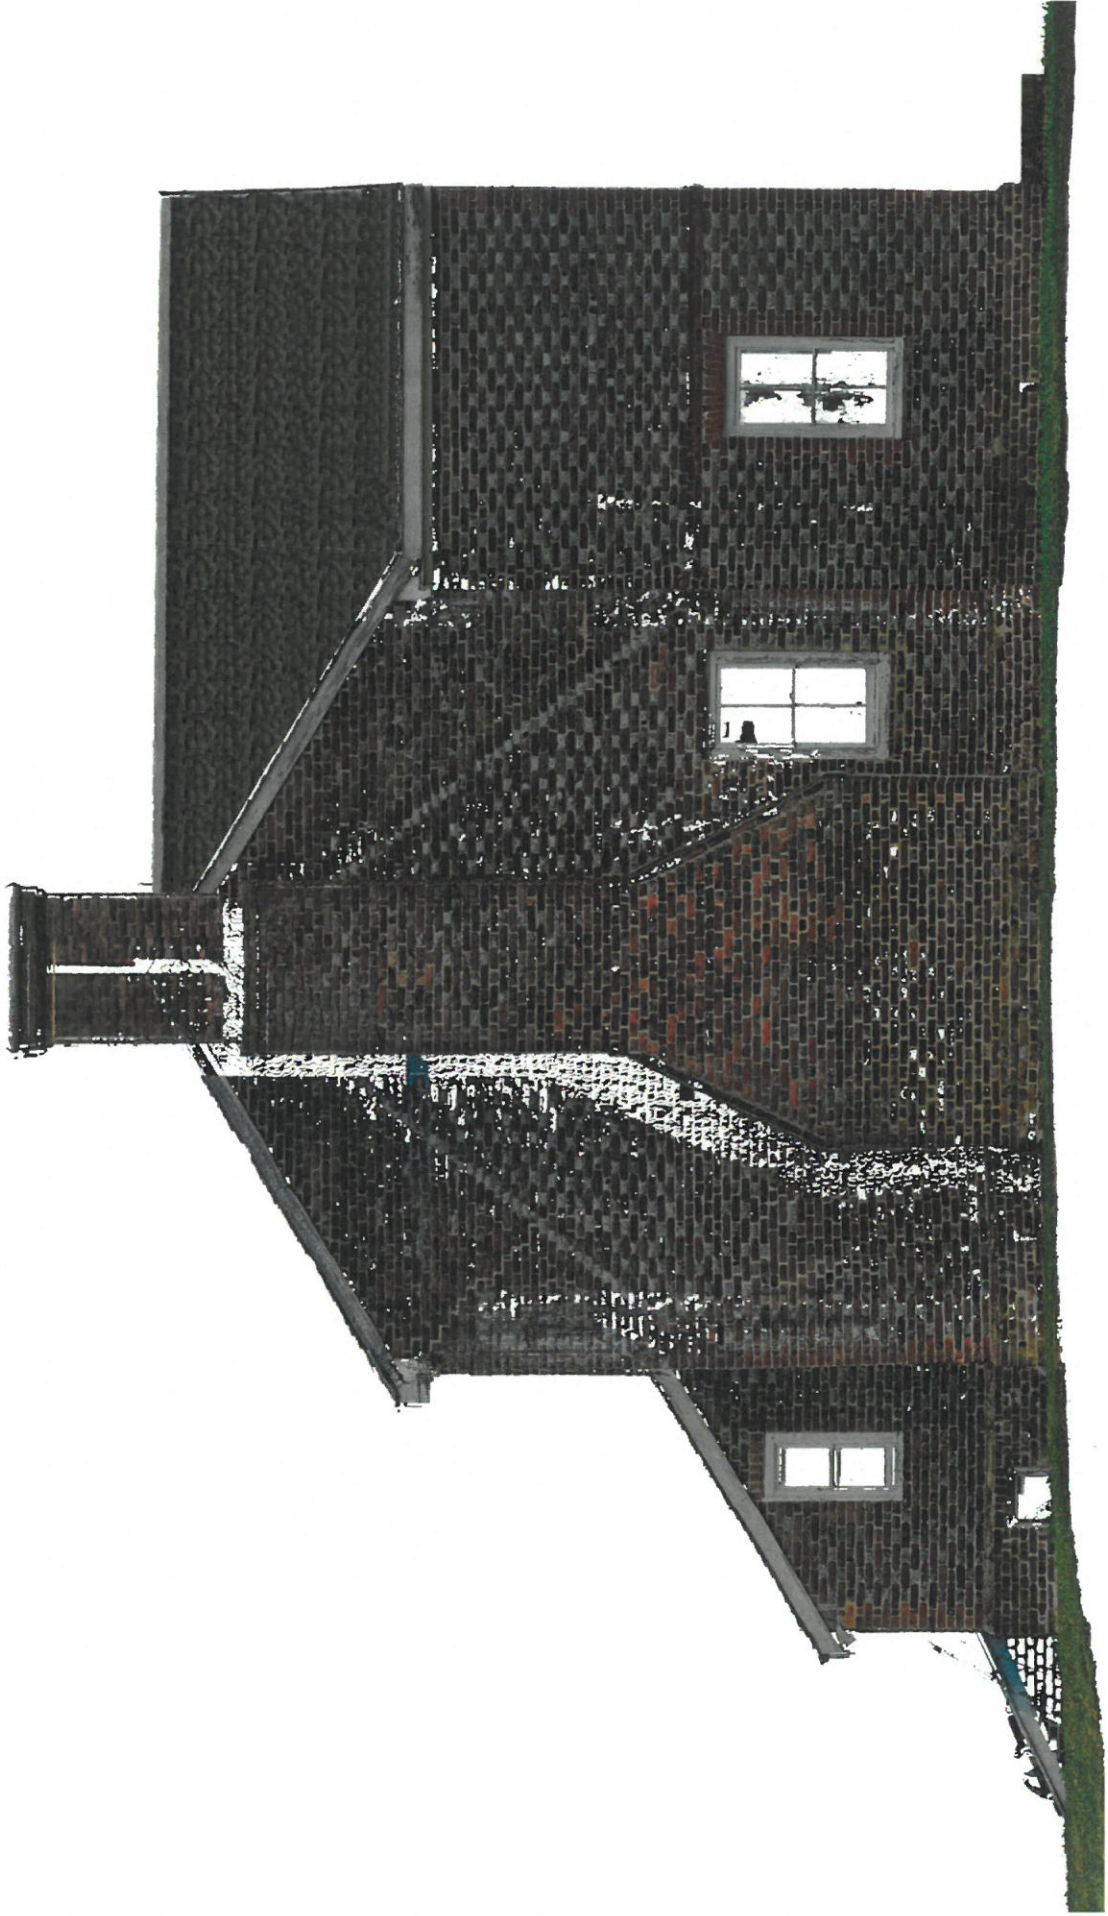
WEST ELEVATION

GABLE LEANS INWARD 2 1/8"

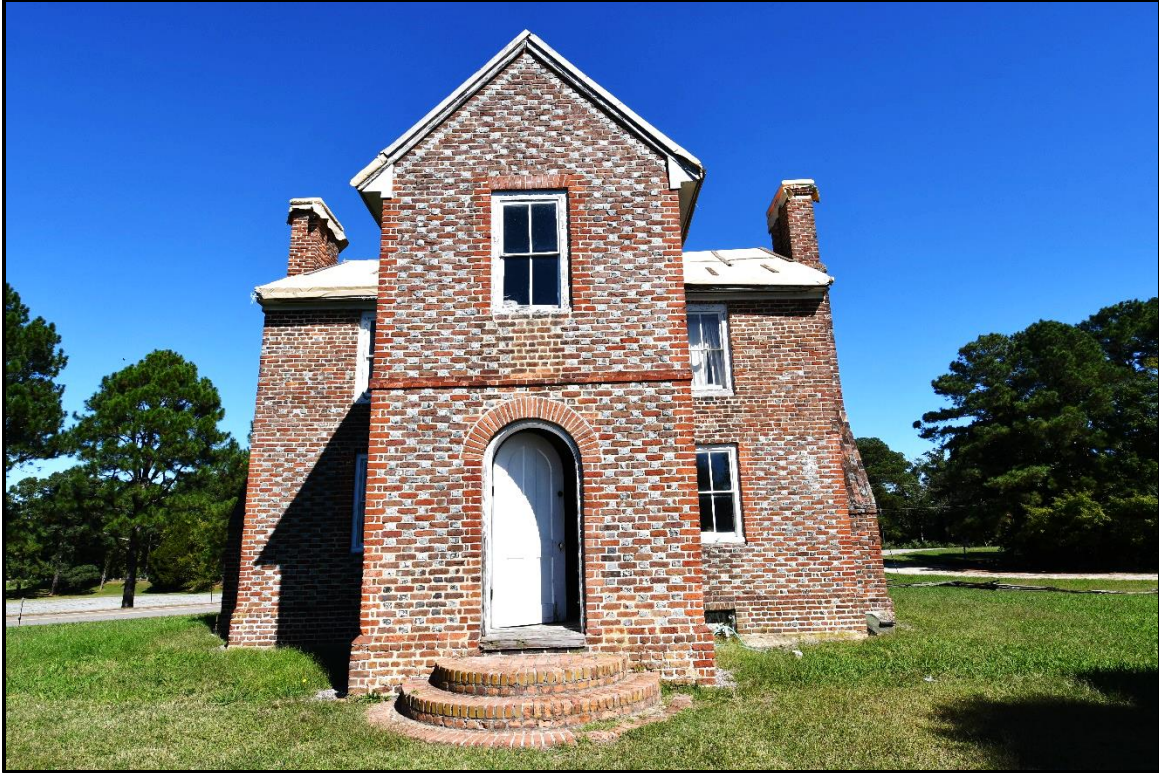
Photo 1: General view of the south (front) elevation.

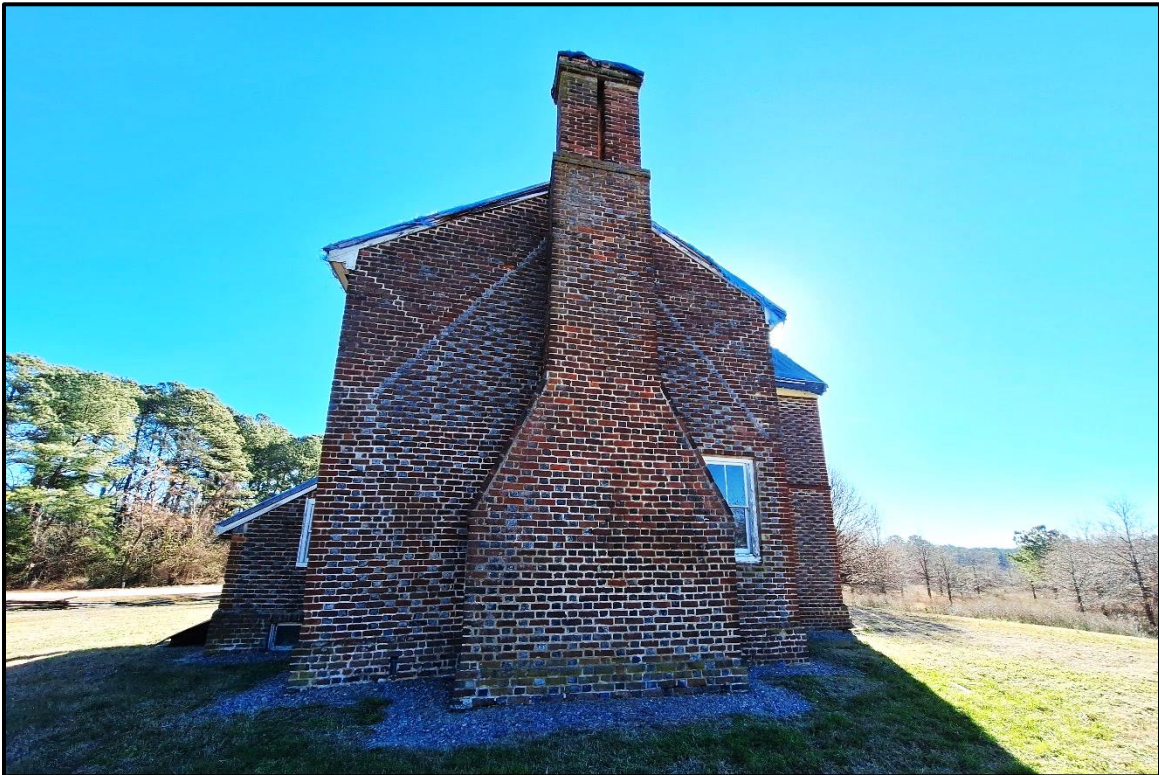
- At the west elevation, we noted a significant step crack in brick masonry joints running from the northwest corner of the house and extending diagonally across the wall north of the chimney. This step crack transitions into a vertical crack where it crosses to the original brickwork and compromises the brick masonry units in that area. This crack was documented in the 2015 report and was noted to have been previously repaired but has since recurred.

- We noted that the upper portion of the west gable end wall is bowing or deflecting toward the interior of the house. This condition is visually apparent when viewing along the face of the wall parallel to the west elevation. This condition was previously noted in the 2015 and 2018 report. Displacements along this wall were documented as part of the 2018 report. Measurements in the field do not indicate significant changes in these displacements.

Photo 2: General view of the west (left) elevation.

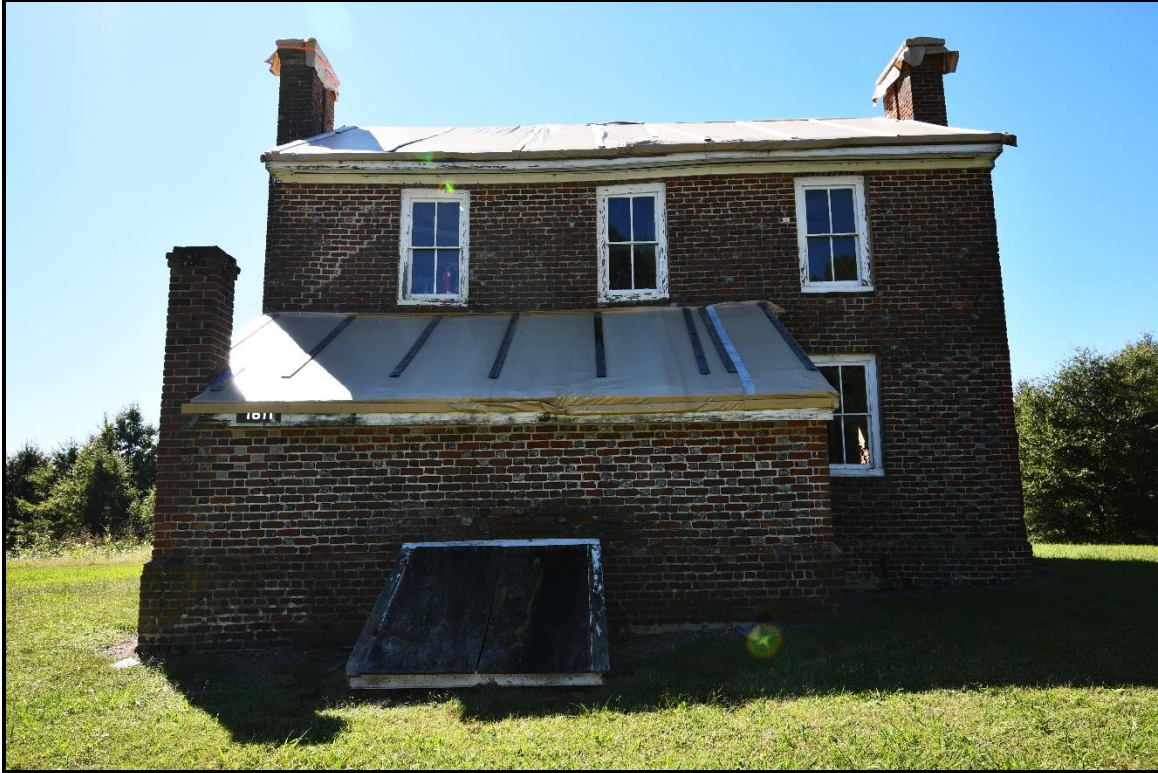
- At the west end of the north wall, we noted an area where the brick wall bows outward. In general, the condition is apparent from the exterior at the first floor level. A 6' level was used to measure the difference in vertical planes of the wall. The bowed portion of the wall was measured to be at least 2" out of plumb with the rest of the wall. Displacements along this wall were documented in the 2018 report. Measurements in the field do not indicate significant changes in these displacements.

- At the north wall above the lower shed roof, the second floor brick wall was found to be deflected downward. The deflection is visually apparent when viewing along the face of the wall parallel to the north elevation. Step cracking in brick units and mortar joints at the upper corners of the north elevation appear to be caused by this brick masonry deflection. These cracks have been repaired and do not appear to have recurred in the time since the repair.

Photo 3: General view of the north (rear) elevation.

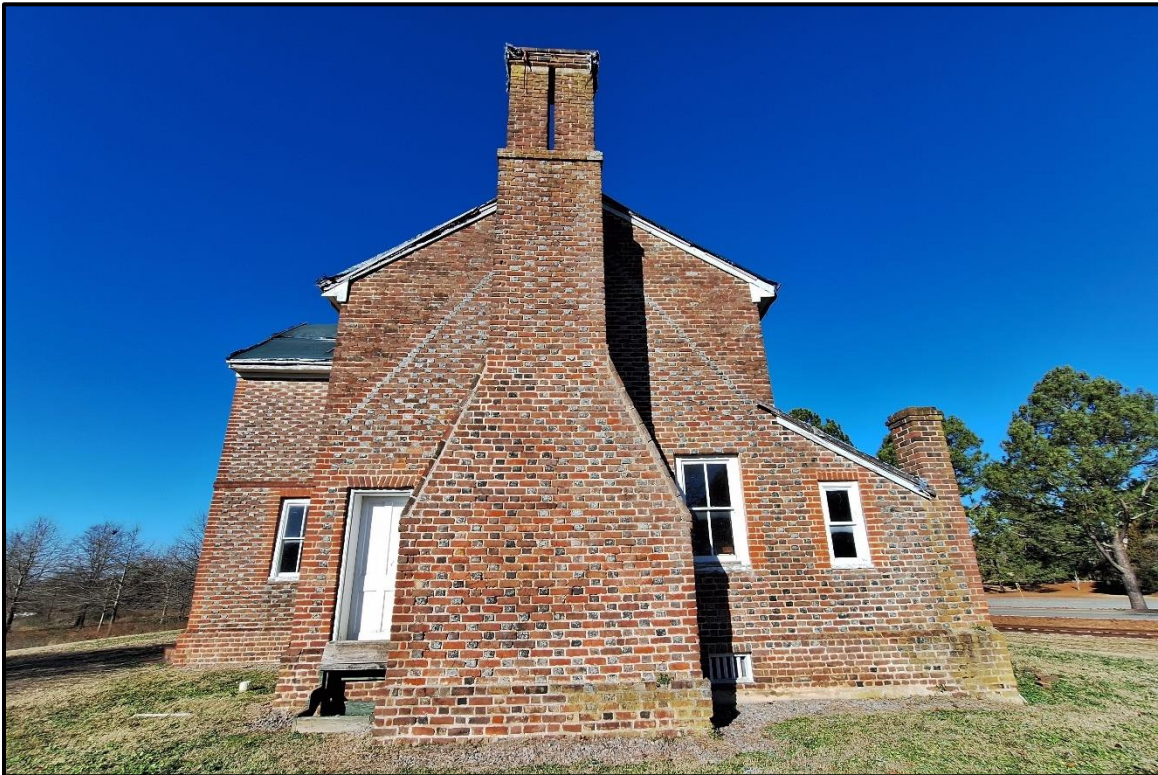
Photo 4: General view of the east (right) elevation.

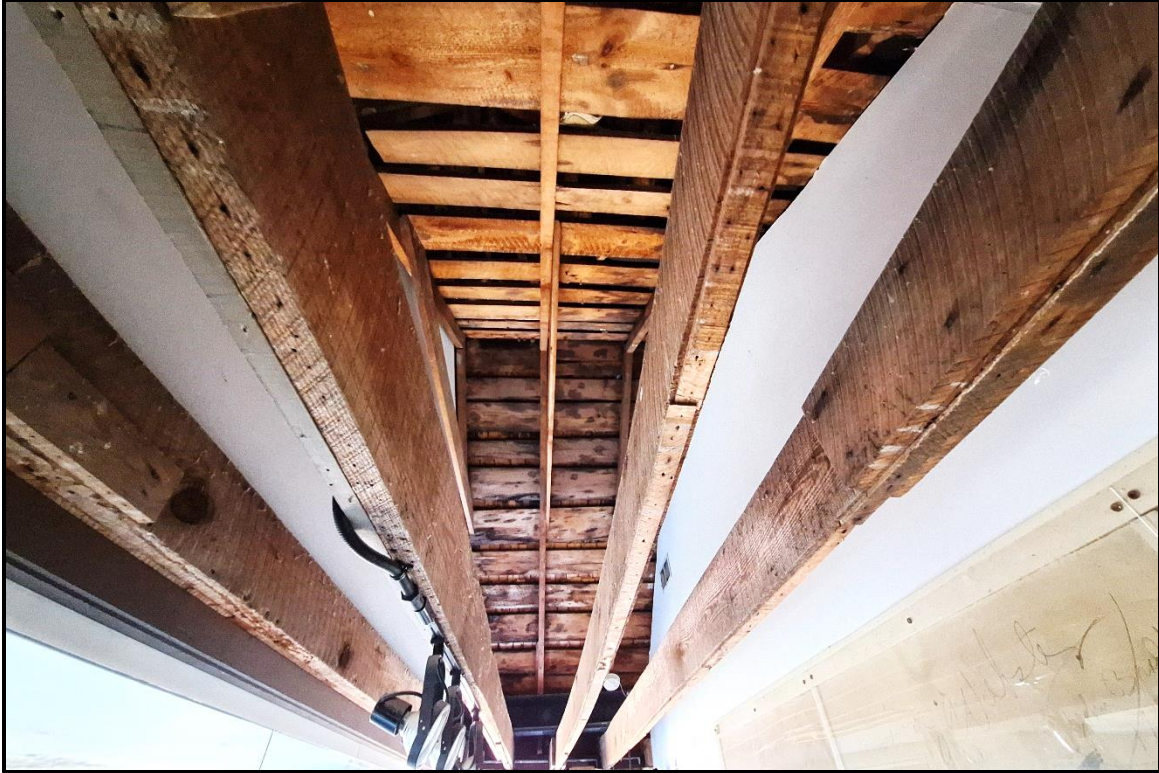
Photo 23: General view of the main roof and ceiling structure located in the hallway of the second floor.
